Building and Pest Report

Property Address:
64 Acqua St, Burpengary, QLD

BUILDING & TIMBER PEST INSPECTION REPORT TO AS4349.1 2007 & AS4349.3 2010

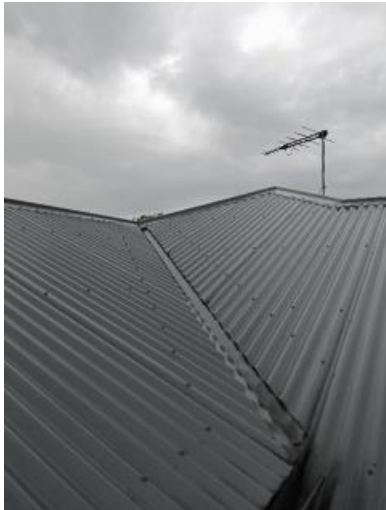
SHEET ROOFING

Satisfactory

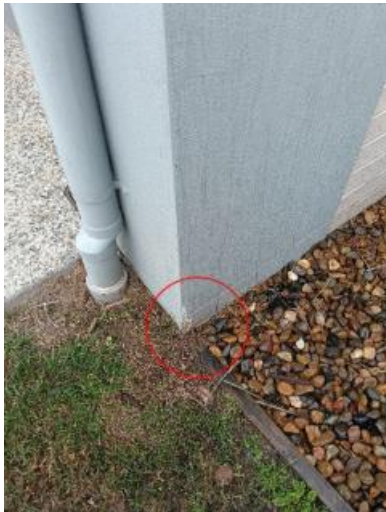
EXTERNAL CLADDING

Minor damage noted to render.

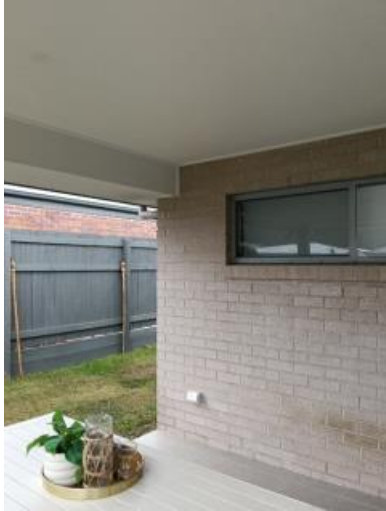
TIMBER STRUCTURES / DECKING / BALCONIES / VERANDAHS / PATIOS / STAIRS & HANDRAILS

General Condition:
Satisfactory

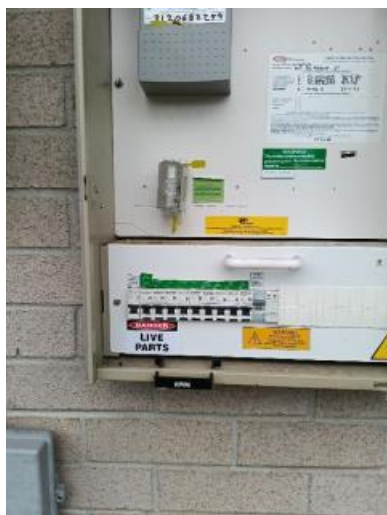
ELECTRICAL SAFETY SWITCH/SMOKE ALARMS

Whilst not a electrician we note that a safety switch is present.

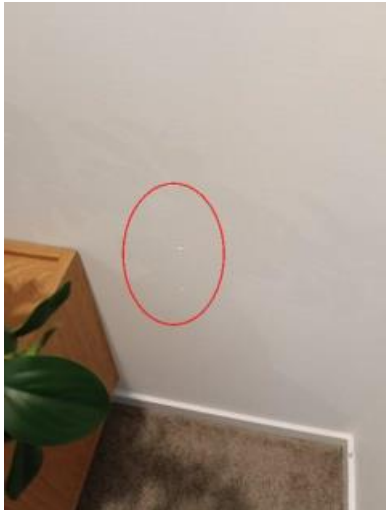
Internal Walls Condition:

Defective or poor surfaces were noted to wall materials and will need repair prior to next painting.

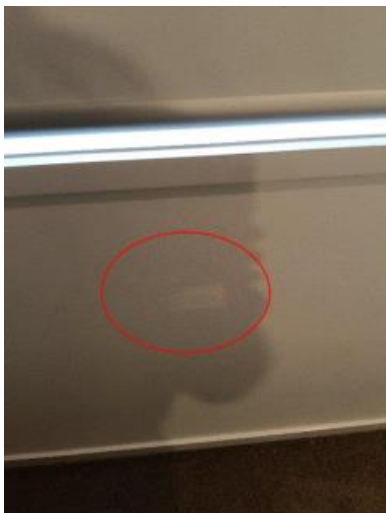
Internal Walls Condition:

Defective or poor surfaces were noted to wall materials and will need repair prior to next painting.

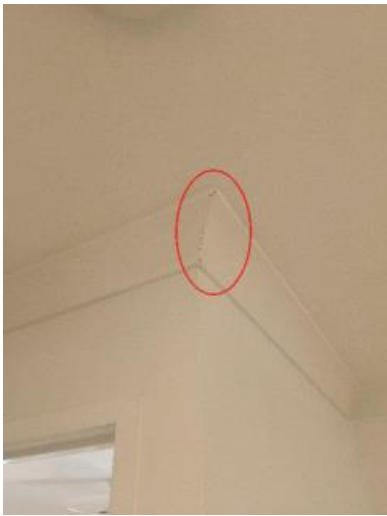
Ceiling Condition:

Minor cracking is present to cornices.

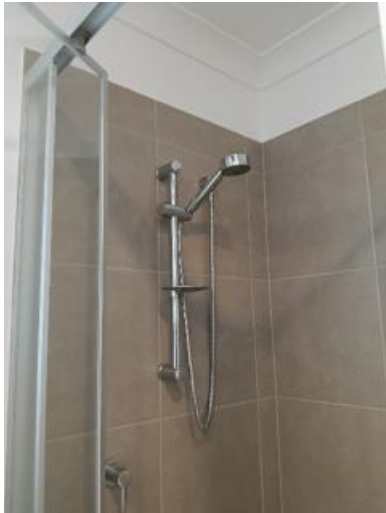
Shower/Bath Condition:

The shower recess was tested and there was no visible water penetration to surrounding areas.

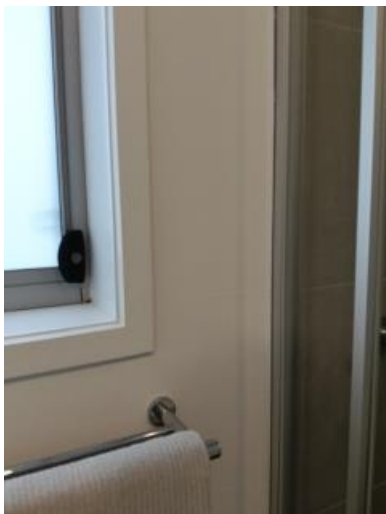
Internal Walls Condition:

Minor cracking is evident to wall linings. Periodic maintenance may be required.

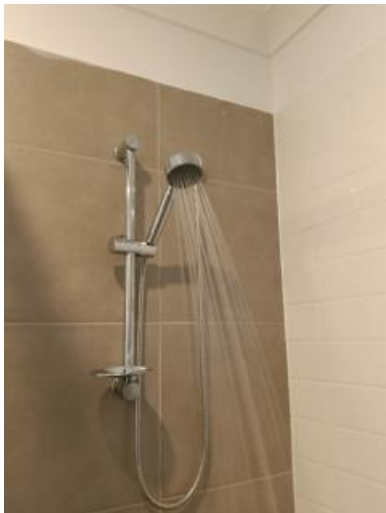
Shower/Bath Condition:

The shower recess was tested and there was no visible water penetration to surrounding areas.

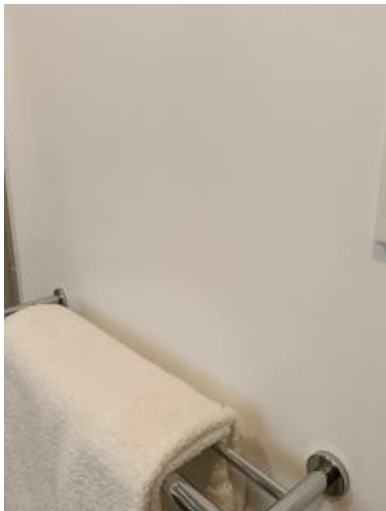
Internal Walls Condition:

Minor cracking is evident to wall linings. Periodic maintenance may be required.

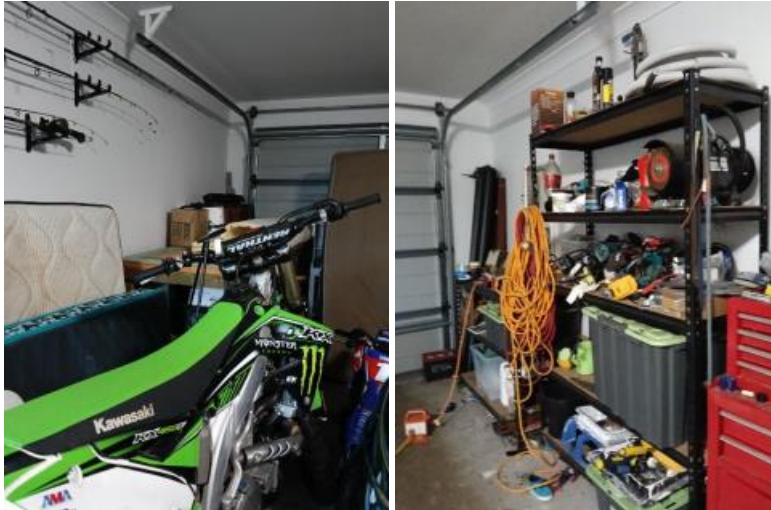
Restrictions:

Inspection within this room was restricted by stored goods.

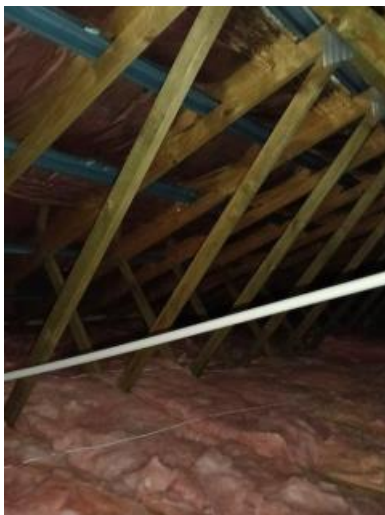
Restrictions to Inspection

Sarking paper and insulation are present in the roof cavity. This restricted inspection to some roofing members. Removal of insulation and sarking paper is not within the scope of a standard building inspection.

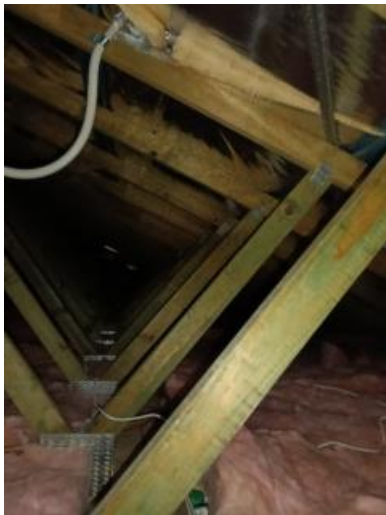
Roof Space & Framing - Condition

Satisfactory

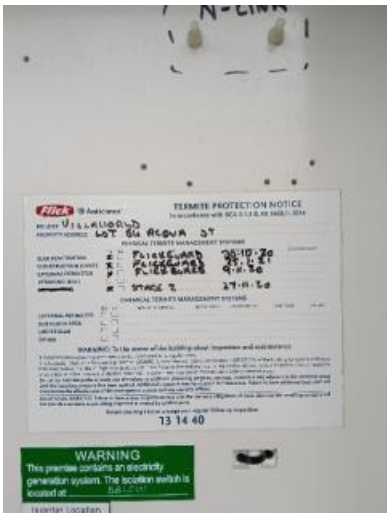
EVIDENCE OF TERMITE TREATMENTS / BARRIERS TO THE PROPERTY

Description:
Yes, there is evidence of a previous termite treatment.

Recommendations:
We strongly recommend any prospective purchaser attempt to verify any treatment information and obtain copies of all relevant documentation.
