# Building and Pest Report

Property Address:  
5 Hera Court, Burpengary, QLD

# BAYSIDE BUILDING & PEST INSPECTIONS

# **BUILDING & TIMBER PEST INSPECTION REPORT TO AS4349.1 2007 & AS4349.3 2010**

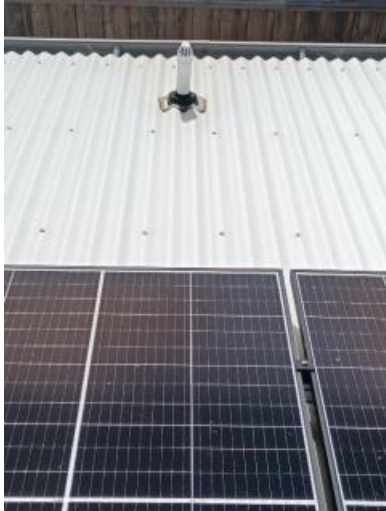
#### SKYLIGHTS / VENTS / FLUES

Satisfactory, however these penetrations are sealed with a rubber dektite, and can perish over time. Period maintenance is recommended.

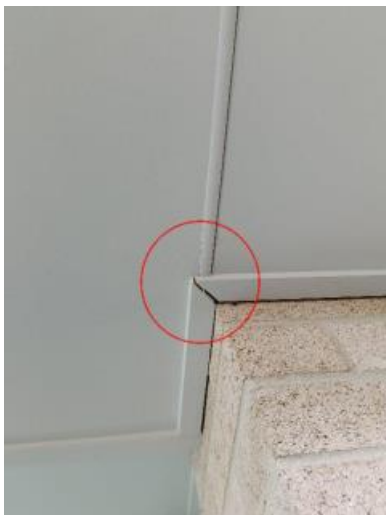
## OTHER (SPECIFY)

Small gap to soffit noted.

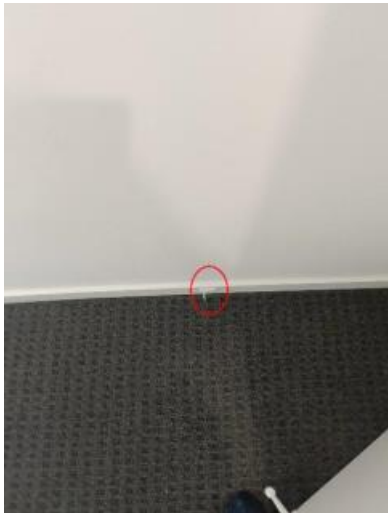
**Doors Condition:**

Door keeper broken (minor defect)

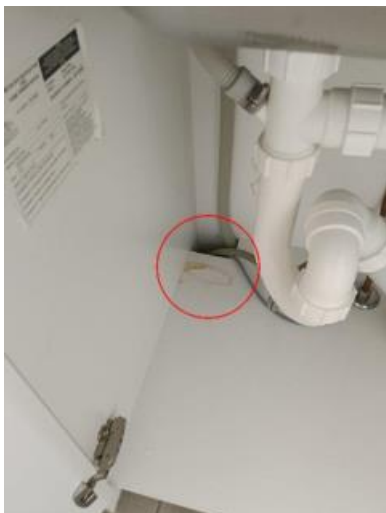
### Kitchen Fixtures:

Minor decay noted within cupboard.

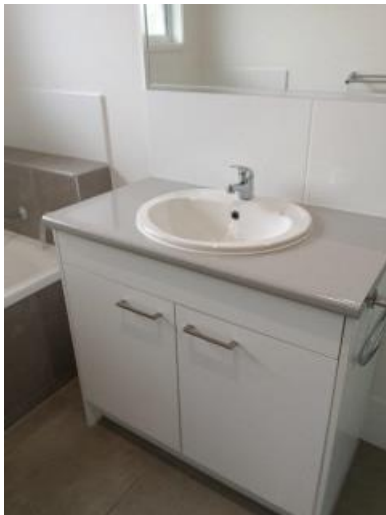
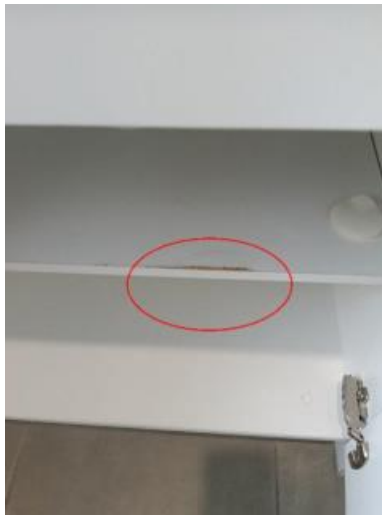
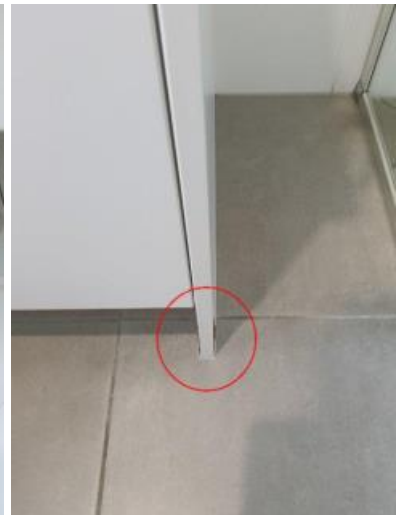
**Vanity Unit:**

Wear and tear is noted to vanity cabinet.

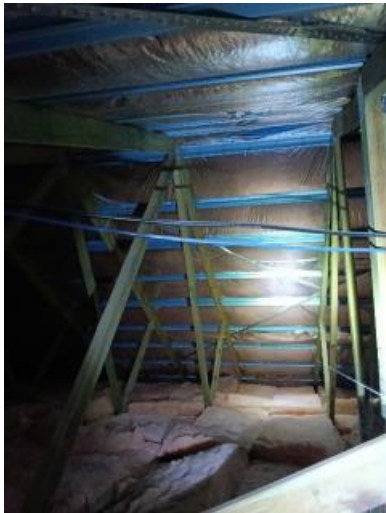
## Restrictions to Inspection

Sarking paper and insulation are present in the roof cavity. This restricted inspection to some roofing members. Removal of insulation and sarking paper is not within the scope of a standard building inspection.

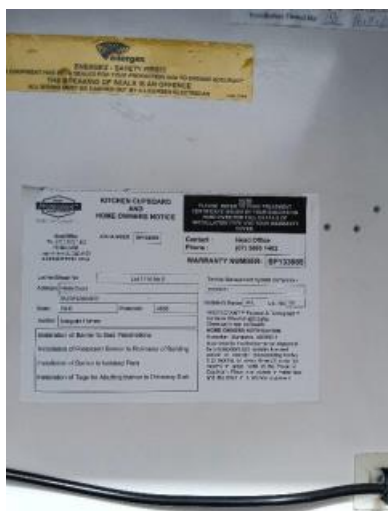
#### Description:

Yes, there is evidence of a previous termite treatment.
