BUILDING INSPECTION REPORT

Inspection Date: 11/02/2026.

13 Oakey Fields Crt, Burpengary Qld 4505.

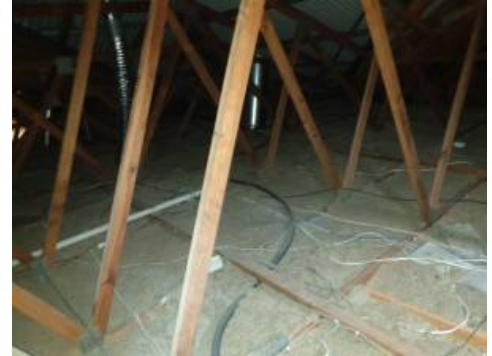
Cellulose Insulation is present in the roof cavity. This restricted inspection to some of the buildings framework. Removal of insulation is not within the scope of a standard visual inspection report. Inspection over the eaves was restricted due to the low pitch and construction allowing only a limited visual inspection.

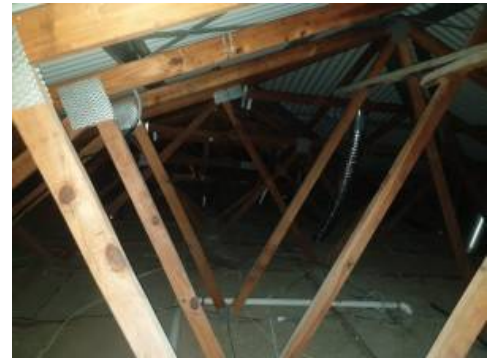
The truss roof system is adequate for the roof covering.

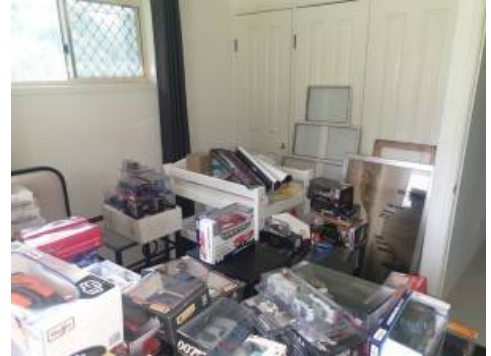
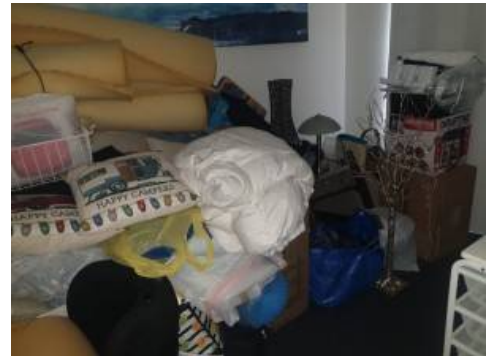
Some stored goods were present to the area(s) listed below which restricted the inspection. Stored items should be removed to allow a more complete inspection to be carried out. Inspection within various cupboards was restricted by stored items.

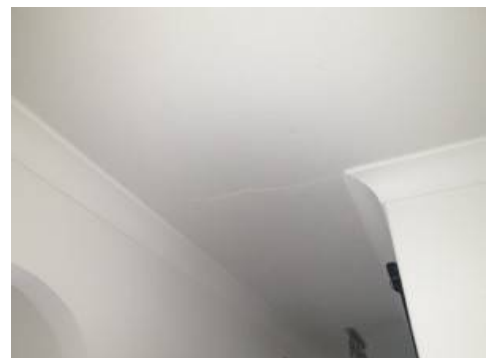
The condition of the ceilings is generally good. Some minor defects noted. This is deemed typical in a building of this age.
Plastering defects, minor cracking was noted.

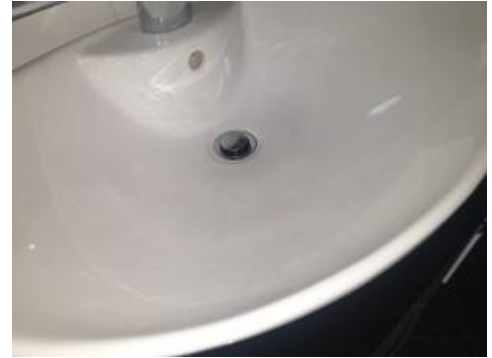
The basin & taps appear serviceable. Plug is damaged. Repairs are required.

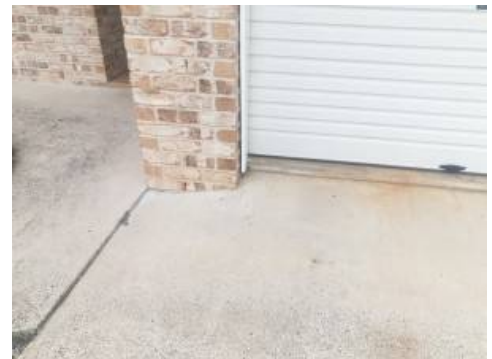
The weep holes to the base of the brick walls are partially blocked by gardens or pathway heights and should be cleared to help stop moisture and pest problems. If rectification is not possible than regular inspections to these is recommended. Front elevation. Right hand side elevation.

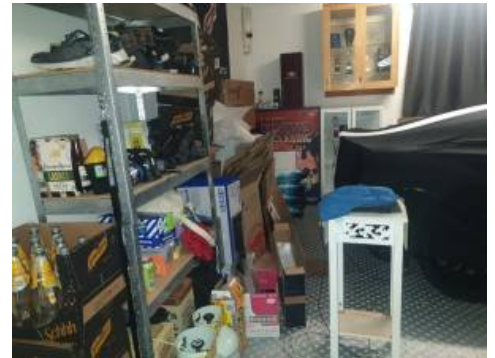
Restrictions: Stored items restricted inspection to the interior of this area.

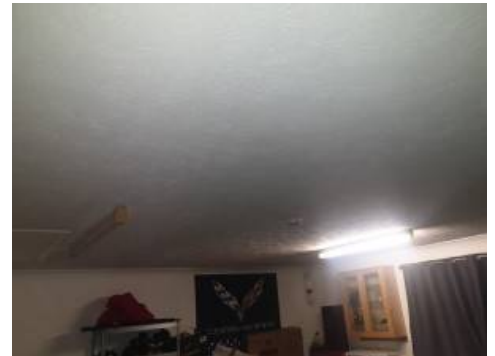
Ceiling Condition: Minor undulations were noted to the ceiling lining. This is deemed typical in a house of this age. Some future maintenance/repairs may be required.

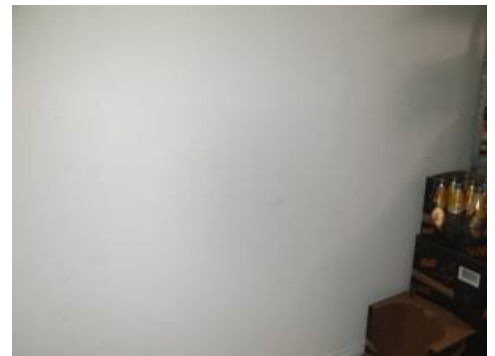
Internal Walls Condition: General wear and tear noted throughout. Minor marks to plaster and paint work.

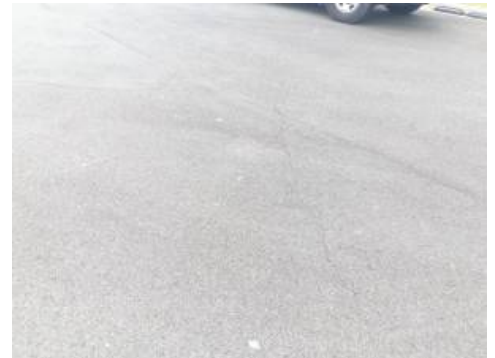
Cracking of Building Elements The bitumen shows signs of minor cracking. This is considered an appearance cracking, recommend to monitor these areas regularly for any changes. Refer Important information section of this report, 4.7 Cracking of building elements note.

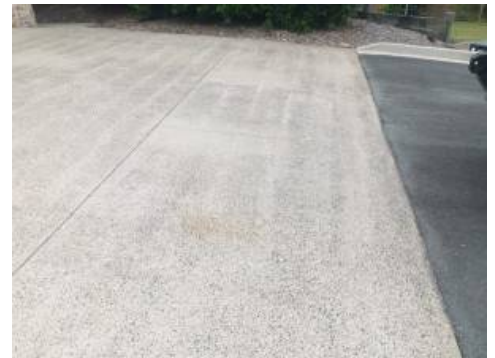
The concrete shows signs of minor cracking. This is considered an appearance cracking, recommend to monitor these areas regularly for any changes. Refer 4.7 Cracking of building elements note.

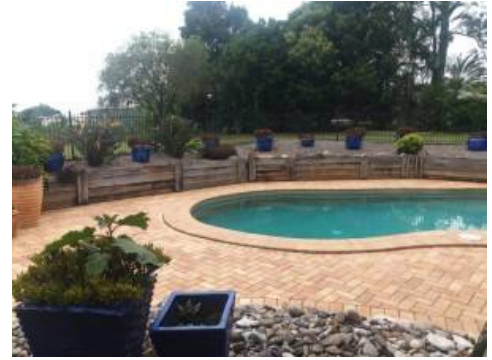
Type & Condition: The timber retaining walls appear in good to fair condition, some areas show normal deterioration due to age and should be monitored.

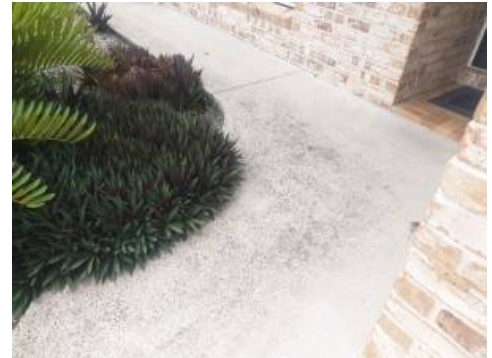
The concrete paths/paved areas are in fair condition. The surface of the paths is deteriorating.

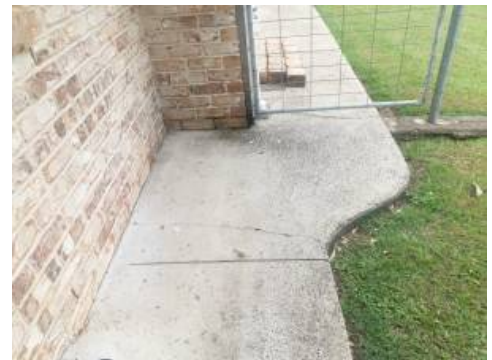
The concrete shows signs of minor cracking. This is considered an appearance cracking, recommend to monitor these areas regularly for any changes. Refer 4.7 Cracking of building elements note.

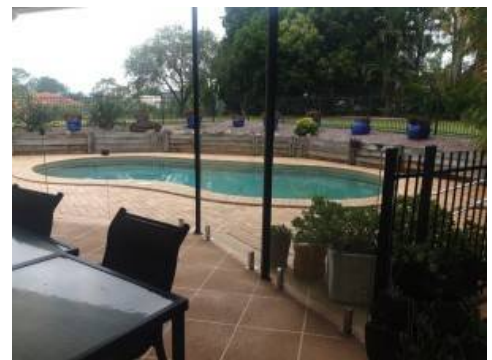
As defined in the limitations of this inspection all swimming pools /spa pools and associated filtration equipment is excluded from the inspection.

An inspection should be sort from by a specialist pool inspector to determine the condition of the pool and associated equipment. All pool fencing is required to be compliant for safety reasons, the pool fencing will need to be certified by a building certifier if the correct documentation cannot be obtained.
