## BUILDING INSPECTION REPORT

Complies with Australian Standard AS 4349.1-2007  
Inspection of Buildings Part 1: Pre-Purchase Inspections - Residential Buildings - Appendix "C"

Inspection Date: 06/11/2025.

2 Keel Ln, Burpengary QLD 4505.

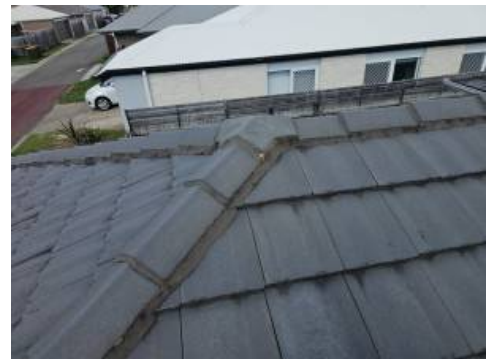
The overall condition of the roof coverings is generally good. The mortar bed to the ridge and hip capping is cracked and requires re bedding and pointing.

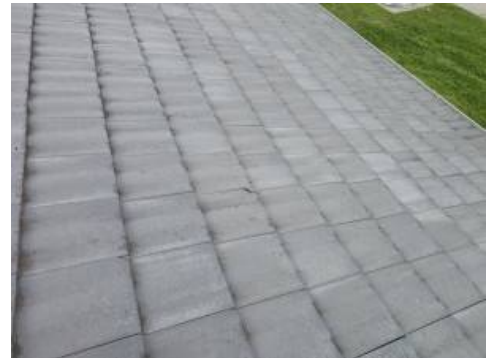
Some cracked corners and edges to roof tiles. Whilst no leaking was noted on the day of inspection, replacement of these tiles is recommended.

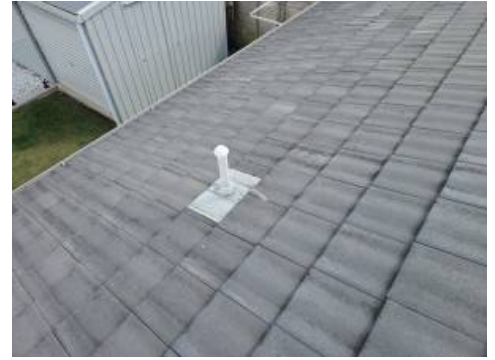
Silicon has been installed to some roofing tiles to prevent leaking. Whilst no leaking was noted on the day of inspection, this can only be deemed a temporary repair and replacement of these tiles is recommended. Rear elevation.

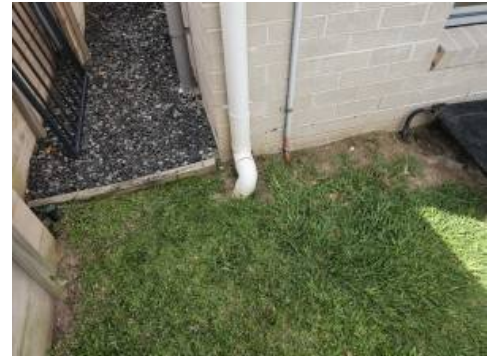
Down Pipe(s), Broken/disconnected at ground level. Some maintenance required. Dampness is conducive to movement and settlement of the building foundations. Rear elevation. A licensed plumbing contractor should be called to make further evaluation and repairs as needed.

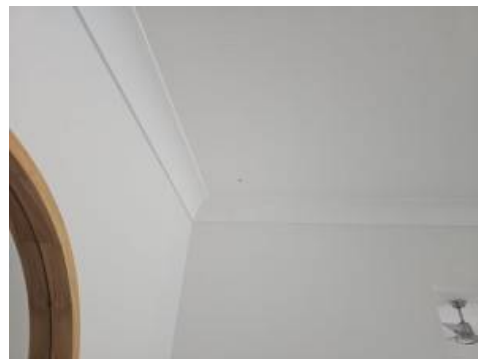
The condition of the ceilings is generally fair. Defective or poor surfaces were noted to ceiling materials in areas and will need repair prior to next painting. Dining room.

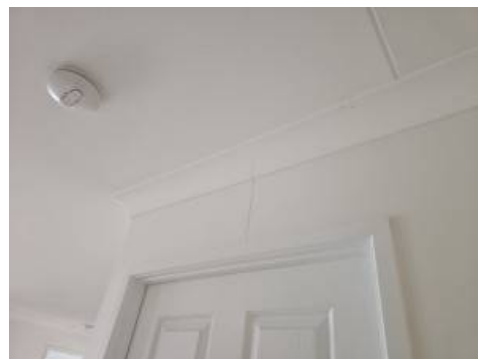
Hallway.

Minor cracking to cornice joints. This is considered a appearance defect. Refer 4.7 Cracking of building elements note. Minor cracking noted and these are typical of this type of material. This is considered to be an appearance defect. Periodic maintenance may be required. Refer 4.7 Cracking of building elements note.

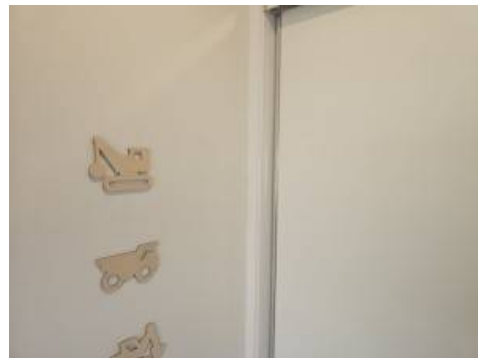
Paintwork has deteriorated and requires repainting. Bedroom three.

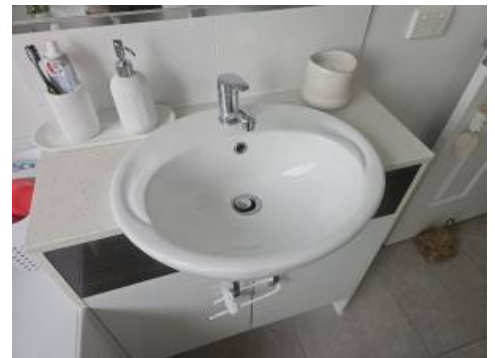
Plug is damaged. Repairs are required.

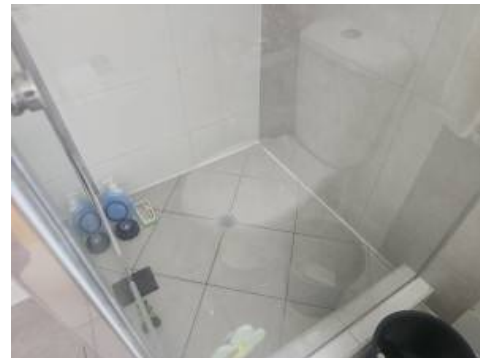
Shower appears to be in a serviceable condition. Gaps noted to internal corners of shower base.

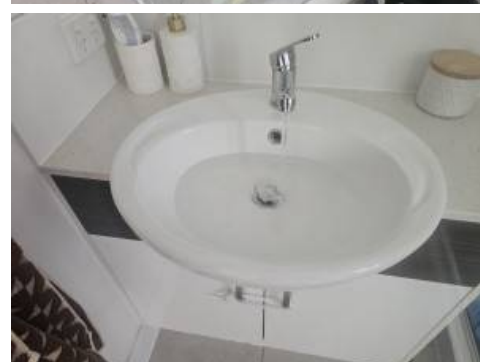
Drainage appears slower than normal. A licensed plumber should be called to make further evaluation and repairs as needed.

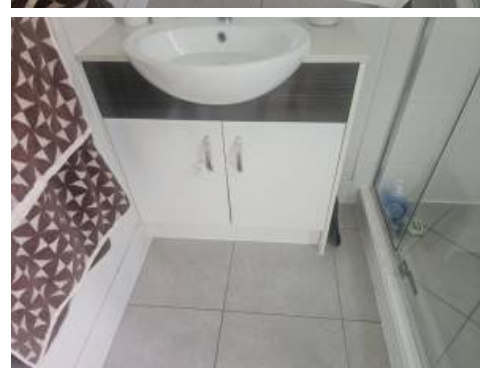
General wear and tear is noted to vanity cabinet due to age.

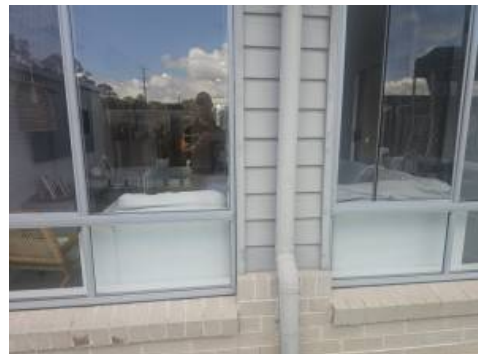
The condition of the walls is generally good. Some gaps/holes are present to wall exterior. These gaps/holes should be sealed to prevent moisture and vermin entry to wall cavities. Various sections of all elevations.

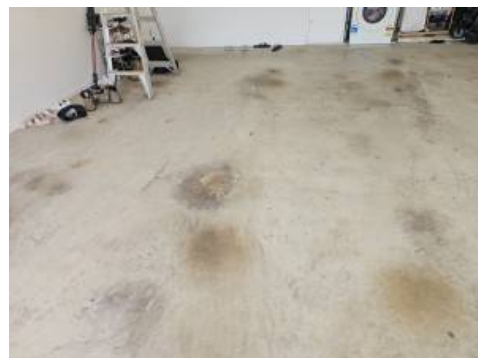
Common cracks and settlement were observed to the concrete floor.

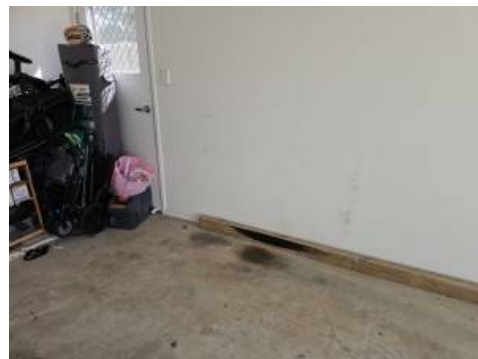
The condition of the walls is generally fair. General wear and tear noted throughout. Minor marks to plaster and paint work.

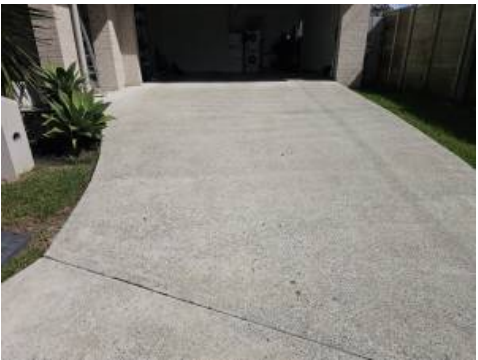
The concrete driveway stands in good condition. Common cracks and settlement were observed to the driveway.

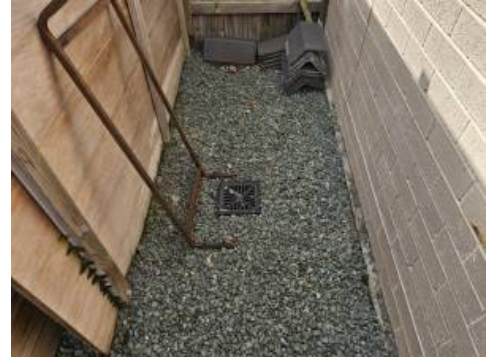
Pit/ Grate drains are higher than finished ground levels, recommend to lower these drains or relocate to lowest point in yard to improve drainage.

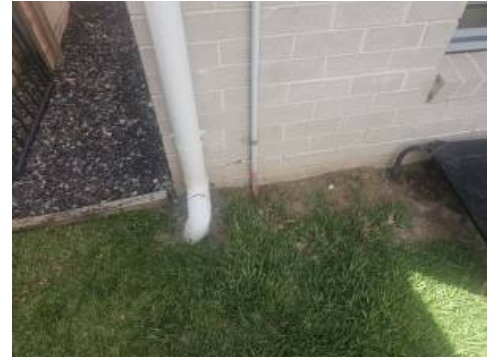
Electrical conduit is damaged and should be checked by an appropriately qualified contractor.
