Visual Timber Pest Inspection and Report in Accordance with AS 4349.3-2010

Type of inspection:	Timber Pest Inspection AS 4349.3-2010
Timber Pest Inspection Agreement No:	
Date of Agreement:	09/03/2026
Property Inspected Details:	7 Allure St Morayfield, QLD, 4506 Morayfeild QLD
Inspection Date/Time:	09/03/2026 4:00 PM
Weather Condition(s):	Intermittent Rain
Standard Tools Used:	Binoculars, Compass, Knife, Ladder (3.6m), Magnifying Glass (x10), Moisture meter, Powerful Torch, Sounding Device, Stepladder (2.1m), Screwdriver
Persons Present At Inspection:	Owner

1 STRUCTURE NAME: Freestanding House

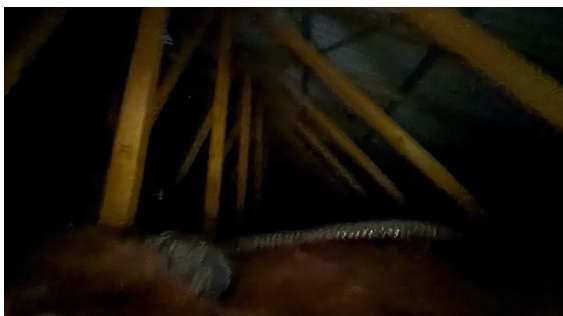
Access Issue Type: Restricted Access
Reason(s) Why: Insulation, Pitch, Roof Frame

Important: If a complete inspection of the above areas was not possible, timber pest activity and/or damage may exist in these areas. Further Inspections are strongly recommended to areas where Reasonable Access is Unavailable, Obstructed or Restricted or a High Risk of possible Timber Pests and /or Damage exists.

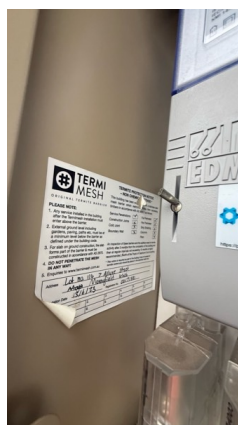
Image of Termite Management Sticker

Yes

Pre-Construction

WARNING: This firm can give no assurances with regard to work that may have been previously performed by other firms. You should obtain copies of all paperwork and make your own inquiries as to the quality of the treatment, when it was carried out and warranty information. In most cases you should arrange for a treatment in accordance with 'Australian Standard 3660' be carried out to reduce the risk of further attack.
