# Building and Pest Report

Property Address:  
73 Lynfield Dr, Caboolture, QLD

# BAYSIDE BUILDING & PEST INSPECTIONS

# BUILDING & TIMBER PEST INSPECTION REPORT TO AS4349.1 2007 & AS4349.3 2010

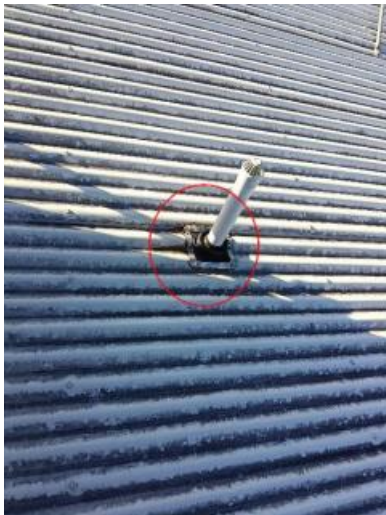
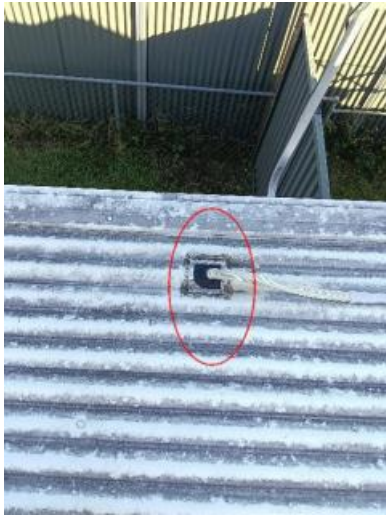
#### SKYLIGHTS / VENTS / FLUES

Satisfactory, however these penetrations are sealed with a rubber dektite, and can perish over time. Period maintenance is recommended.

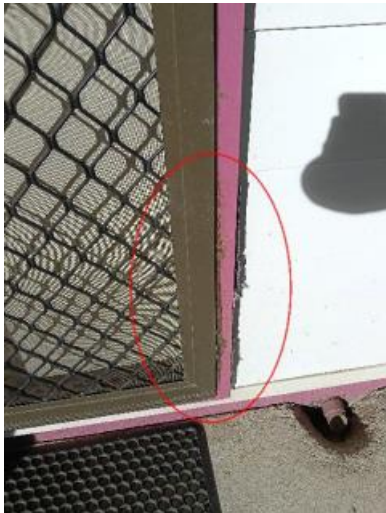
### VISIBLE TIMBER (ROTTING OR DAMAGE)

Minor timber damage noted to door jamb.

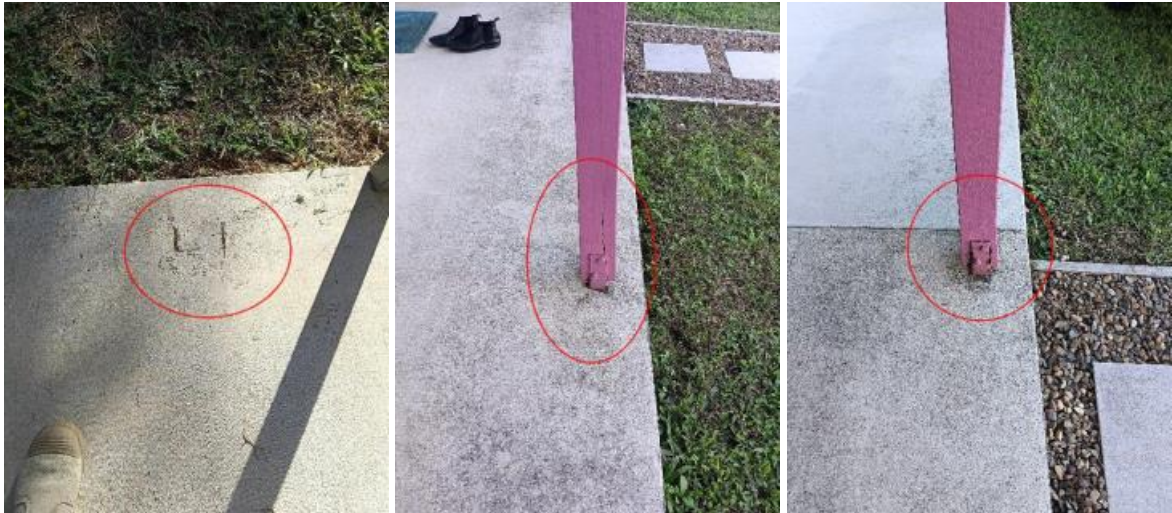
#### Defects or Maintenance Items:

The metal is rusting and treatment is required. The posts may need replacement. A qualified carpenter should further investigate.

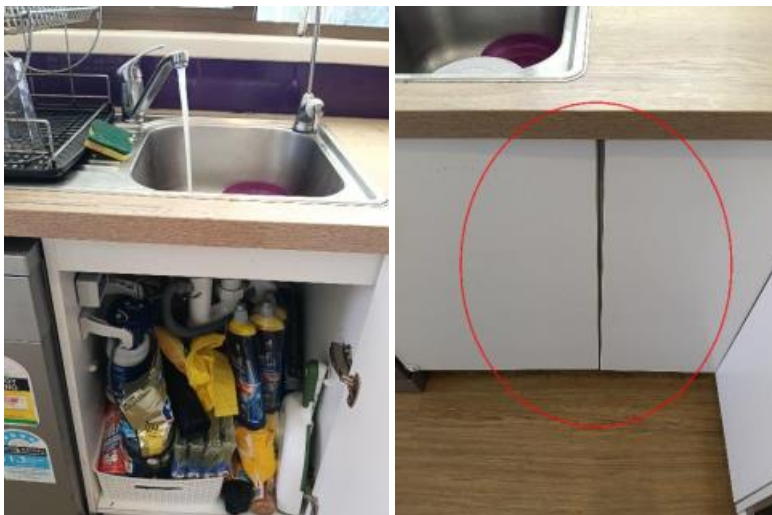
### Kitchen Fixtures:

The condition of the fixtures is generally fair.

Adjustment is required to some door and drawers to ensure smooth operation.

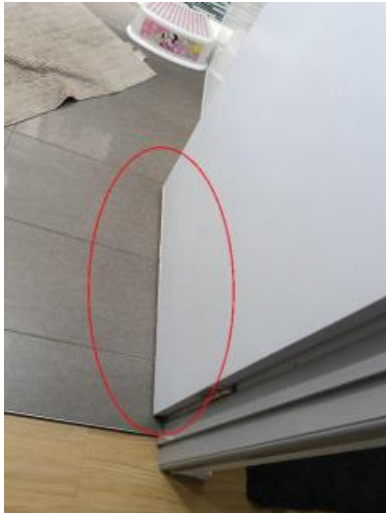
**Doors Condition:**

Water damage was noted to some doors and will require repair or replacement.

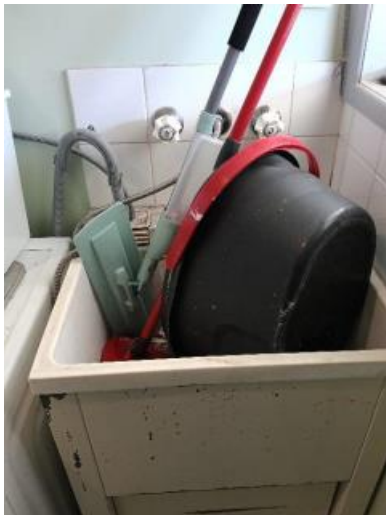
**Basin & Taps:**

Stored goods prevented inspection below this area.

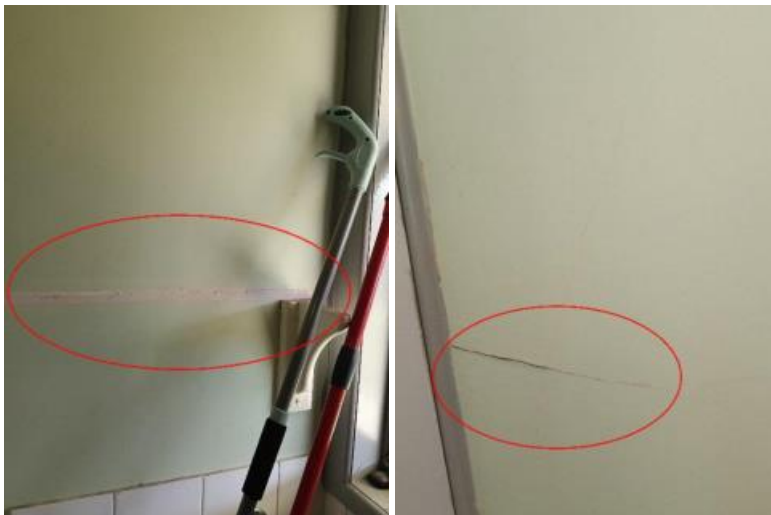
**Internal Walls Condition:**

Defective or poor surfaces were noted to wall materials and will need repair prior to next painting.

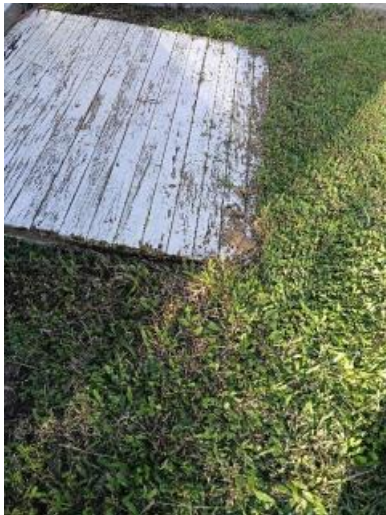
Evidence of damage resulting from wood decay fungi (wood rot) was found in the following areas / timbers:

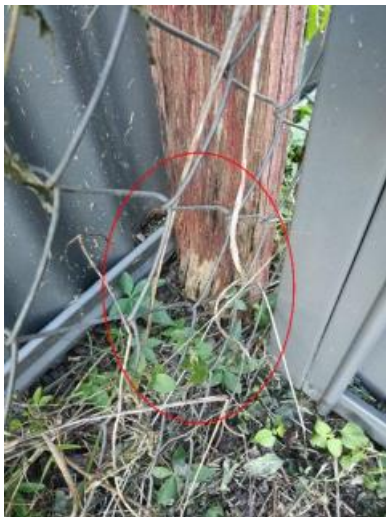
Timber damage caused by termites and/or termite workings was found. Where damage or workings are found but no live termites were present at the time of the inspection then you must realise that it may be possible that termites are active in the immediate vicinity and that the termites may return and cause further damage to the property. It is not possible, without the benefit of further investigation and a number of inspections over a period of months, to ascertain whether any infestation is active or not. The termites may simply not be present at the time of this inspection due to a disturbance, climatic conditions, or they may be utilising an alternative food source. **Regular inspections are essential. Unless written evidence of a termite protection program that fully meets the requirements of the Australian Standard "AS 3660" is provided, a treatment to this standard is strongly recommended.** The termite damage was mainly but not limited to the areas listed below but there may well be concealed damage.

Timber post

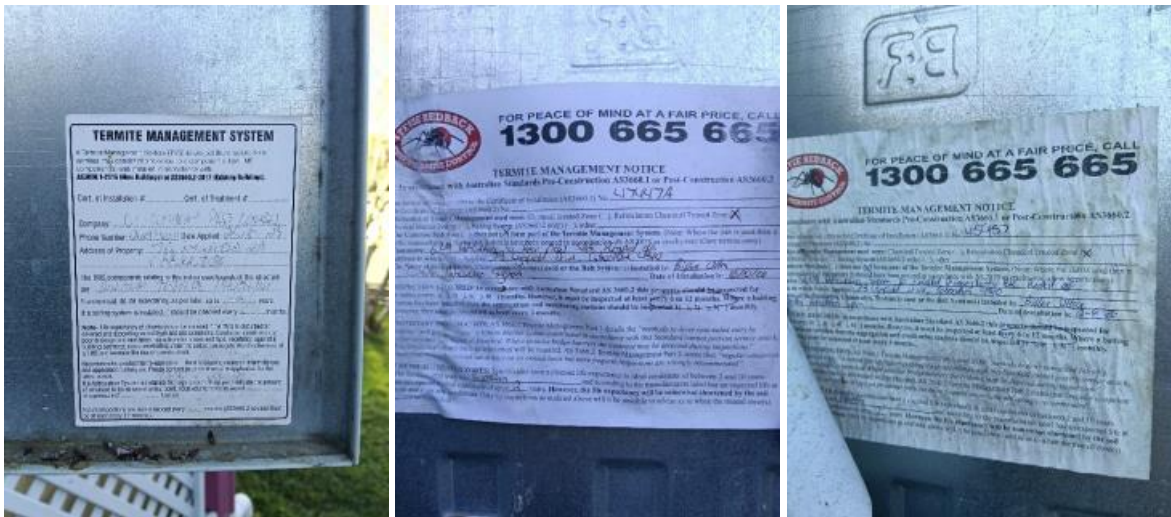
Yes, there is evidence of a previous termite treatment.

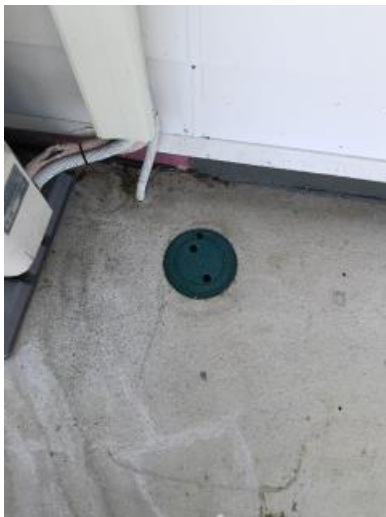
We found bait boxes to the perimeter of the residence. These may have been installed in respect to termite control or protection. We strongly recommend any prospective purchaser attempt to verify this information and obtain copies of all relevant documentation.
