TIMBER PEST INSPECTION REPORT

Inspection Date: 11/02/2026.

13 Oakey Fields Crt, Burpengary Qld 4505.

ABN: 91169916385 Compass Building & Pest North Pty Ltd Phone (07) 3886 4654

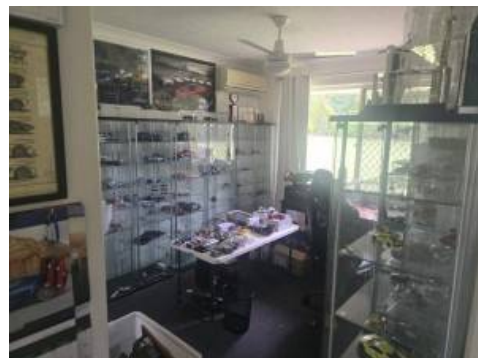
Some stored goods were present to the area(s) listed below which restricted the inspection. Stored items should be removed to allow a more complete inspection to be carried out. Inspection within various cupboards was restricted by stored items.

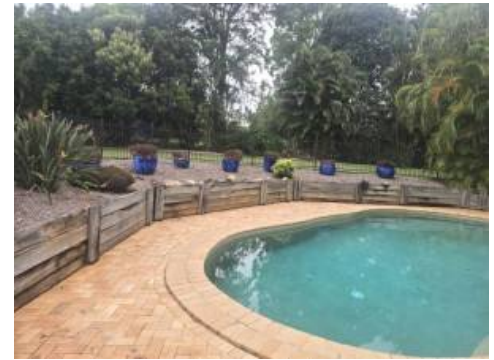
Inactive workings caused by termites

Yes - Inspection revealed currently inactive termite attack (damaged timbers and/or termite workings) within this area including but not necessarily limited to the following timbers and the areas listed below.

Timber retaining walls.

Yard areas.

Visible timber damage appears minor to moderate however, this opinion is based on a visual inspection. A special purpose report can offer a more detailed description. Refer to the definitions section of this report.

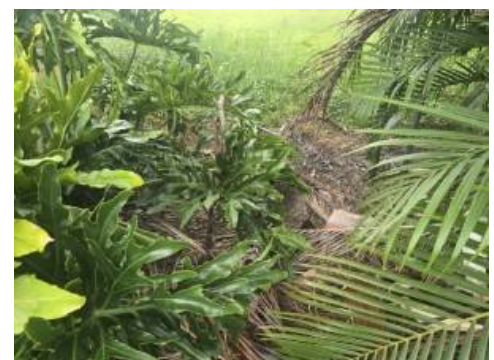
Timbers such as these are attractive to subterranean termite attack and should be removed.
Tree stumps.

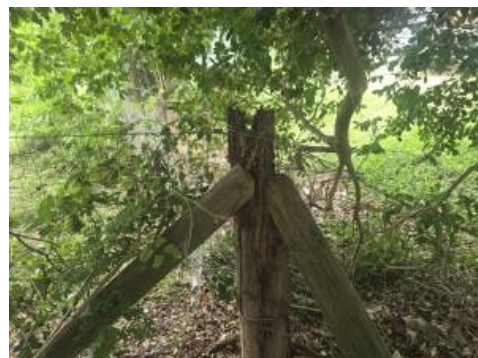
Yes - Inspection revealed currently inactive termite attack (damaged timbers and/or termite workings) within this area including but not necessarily limited to the following timbers and the areas listed below.

Rear fence:

Visible timber damage appears moderate to severe however, this opinion is based on a visual inspection. We recommend a special purpose report to this area be carried out by a licenced and practicing Builder. Refer to the definitions section of this report.

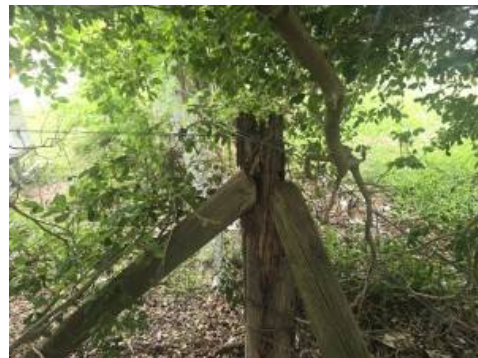
Yes - Wood decay damage was noted to the following timbers/areas.

Rear fence:

Visible timber damage appears moderate to severe however, this opinion is based on a visual inspection. We recommend a special purpose report to this area be carried out by a licenced and practicing Builder. Refer to the definitions section of this report.

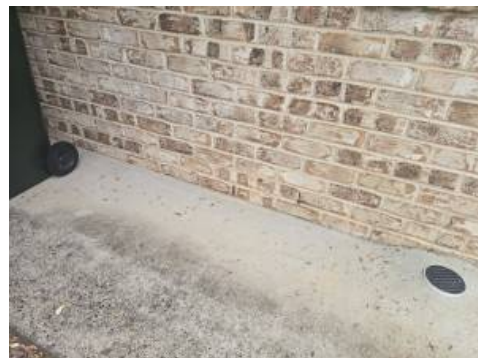
The property is constructed on a concrete slab foundation to which there is no subfloor for inspection. See important information in Section 4.0 Concrete Slab Homes (Part or Full Slab). The external weep holes are either covered completely or partly concealed to garage section, this is due to step down to slab of garage and consistent with type of construction. This can allow concealed termite entry and moisture problems in principle we recommend that all weep holes be exposed and kept clear of soil, foliage, concrete, stored items or other obstructions. If this can not

be achieved than regular inspection to garage should be carried out.

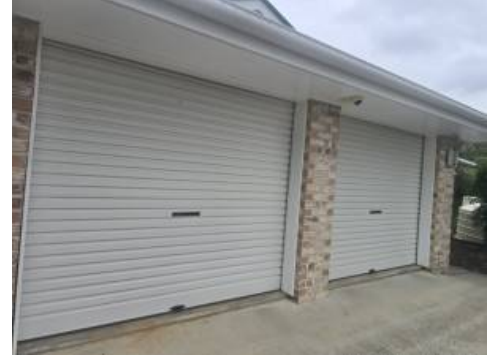
A garage: Part of main structure.

Stored items restricted inspection to the interior of this area.

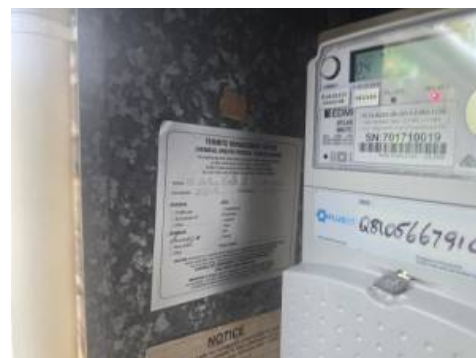
A notice indicates that the property may have been treated in respect to termite management. A chemical soil barrier to the perimeter of the building. Chemical Barriers have life spans up to 10 years. We recommend the client attempt to verify this information and obtain copies of all relevant documentation. The notice indicates that a termite management treatment was carried out on the 7/2/23. This treatment is due to be replenished on the 7/2/28. See Treatment Recommendations below.
