# Building and Pest Report

Property Address:  
76 Shaun Parade, Elimbah

# BAYSIDE BUILDING & PEST INSPECTIONS

# **BUILDING & TIMBER PEST INSPECTION REPORT TO AS4349.1 2007 & AS4349.3 2010**

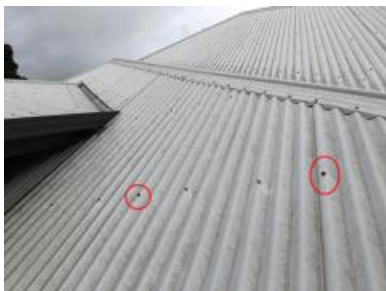
## ROOFING SCREWS / NAILS

Some roofing screws show signs of rust and require replacement.

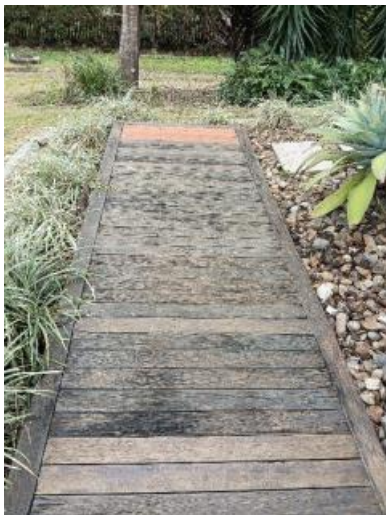
## **PATHS**

Timber paths on entry are suffering from wear and tear. Repairs/replacement recommended.

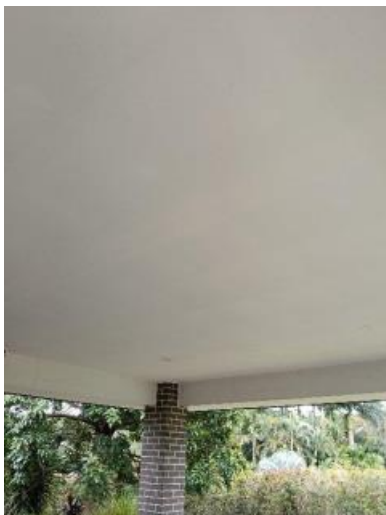
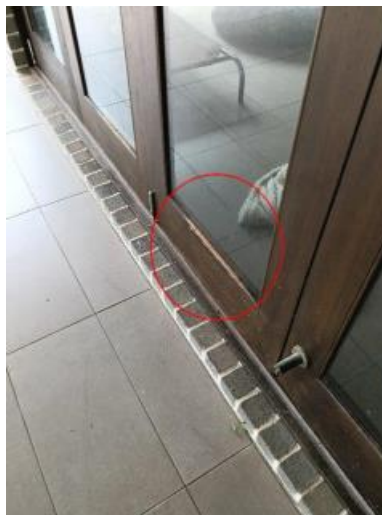
#### Defects or Maintenance Items:

Minor undulations were noted to the ceiling lining. This is to be expected in a house of this age. Periodic maintenance may be required.

Minor wood decay is present to the structure.

A licensed builder should be called to make a further evaluation and repairs or rectification as needed.

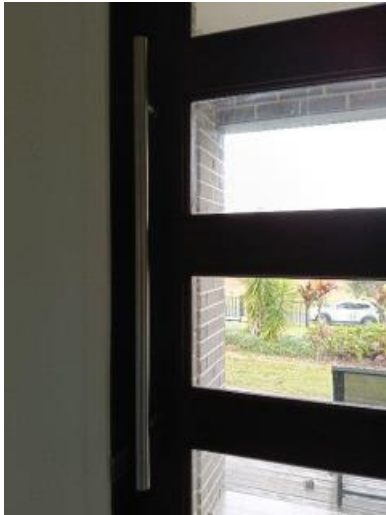
#### Doors Condition:

The condition of the door hardware is generally fair. Some repairs or maintenance will be required.

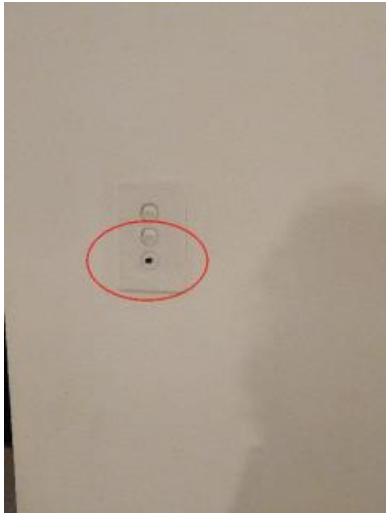
**Internal Walls Condition:**

Fan controller missing.

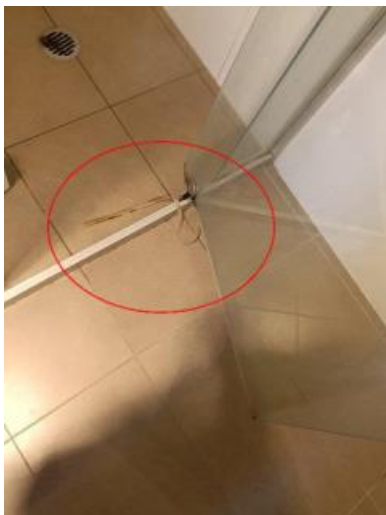
**Shower/Bath Condition:**

Repairs to shower door sealant required.

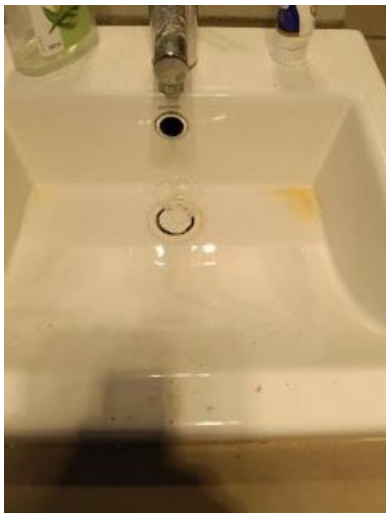
**Basin & Taps:**

Drainage appears slower than normal. This should be investigated by a licensed plumber.

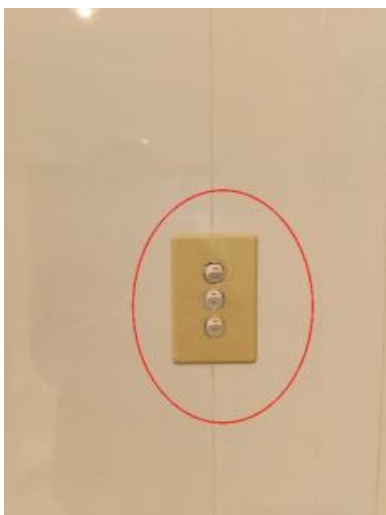
**Internal Walls Condition:**

Repairs to light switch required. A qualified electrician should further investigate.

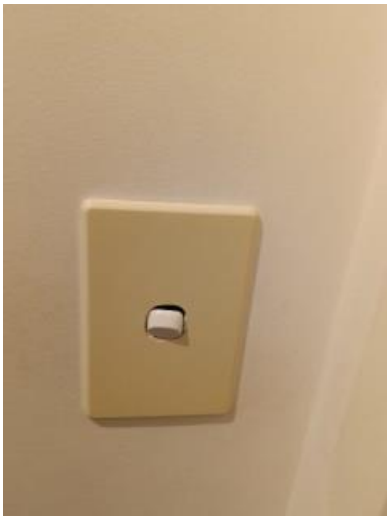
**Internal Walls Condition:**

Repairs to light switch required. A qualified electrician should further investigate.

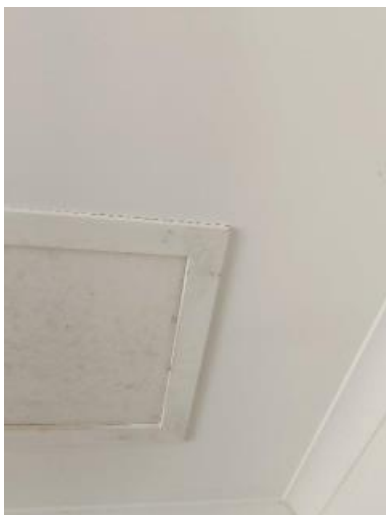
**Ceiling Condition:**

Defective surfaces were noted and maintenance will be required.

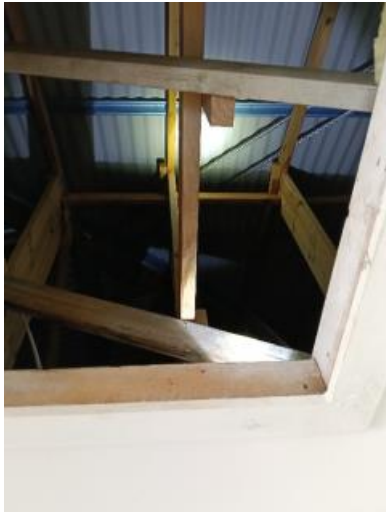
### Restrictions to Access

A large portion of the roof void is not accessible due to framing constrictions. Additional access points should be installed.

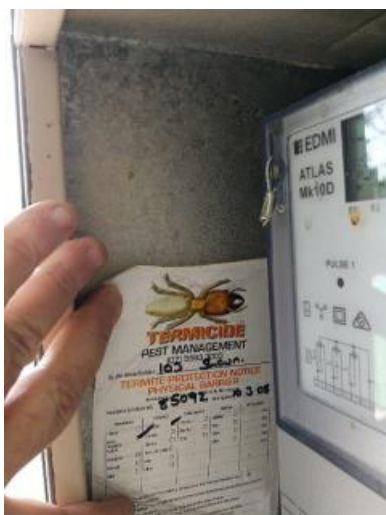
#### **Description:**

Yes, there is evidence of a previous termite treatment.
