Building and Pest Report

Property Address:
34-38 Hawthorn Rd, Burpengary

BUILDING & TIMBER PEST INSPECTION REPORT TO AS4349.1 2007 & AS4349.3 2010

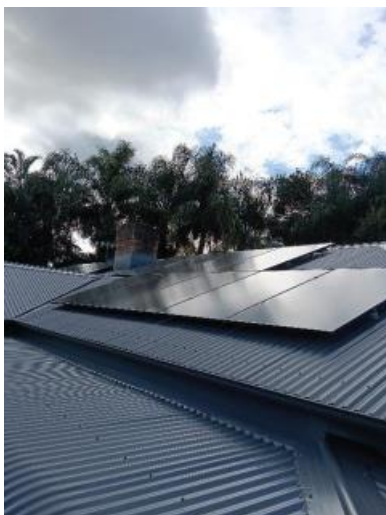
SHEET ROOFING

Roof has been recently replaced.

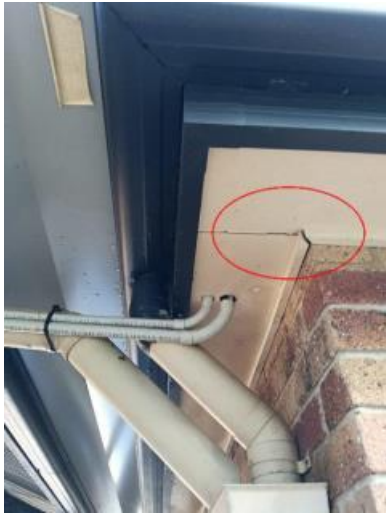
EAVES / FASCIAS / BARGES

Some soffit sheeting shows signs of sagging and requires refixing.

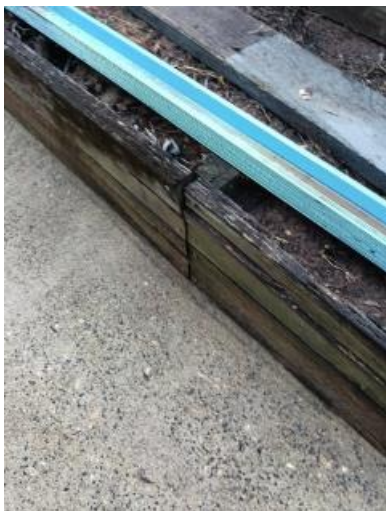
Some retaining wall timbers require repair / reinforcement / replacement.

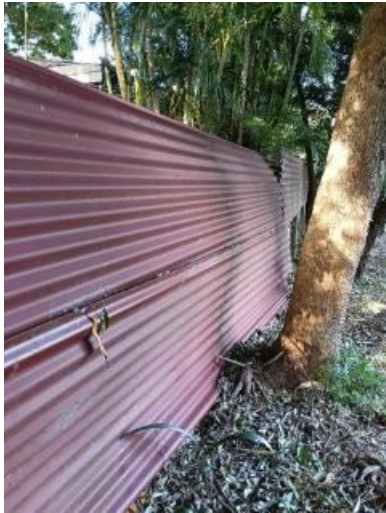
FENCING

Some fencing requires repair / refixing.

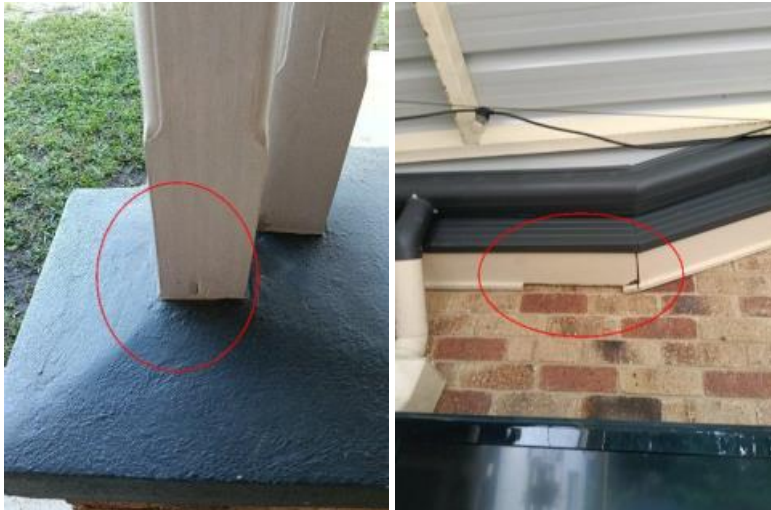
Post appears to have been repaired.

Minor damage noted to soffit.

A licensed carpenter should be called to make a further evaluation and repairs or rectification as needed.

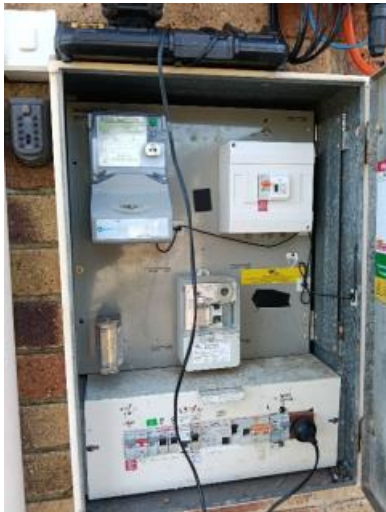
Whilst not a electrician we note that a safety switch is present.

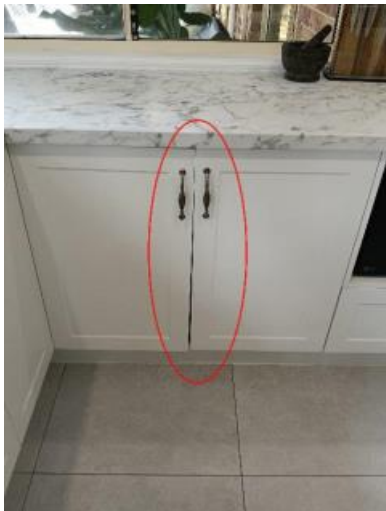
Kitchen Fixtures:

Adjustment is required to some door and drawers to ensure smooth operation.

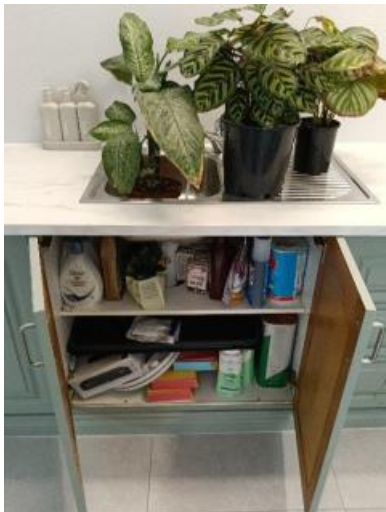
Sink & Taps:

Stored goods restricted inspection of the area below the sink.

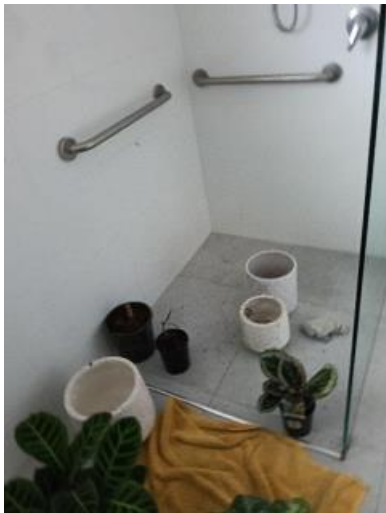
Shower/Bath Condition:

The shower recess was not tested due to stored goods or other limitations. No comment is made on this area. Defects may be present and not reported at this stage. Further tests should be carried out.

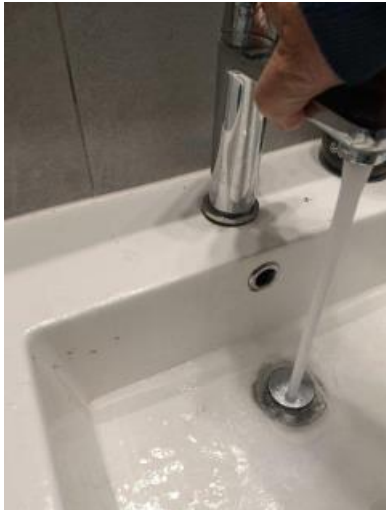
Vanity Unit:

Tap loose

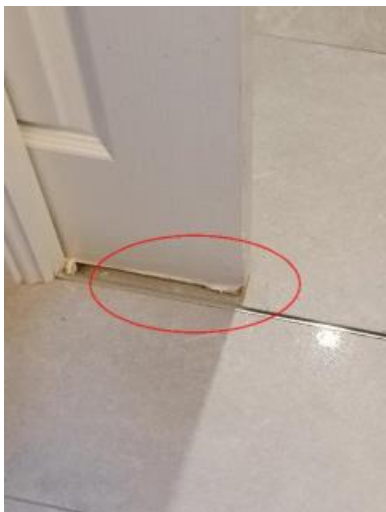
Doors Condition:

Water damage was noted to some doors and will require repair or replacement.

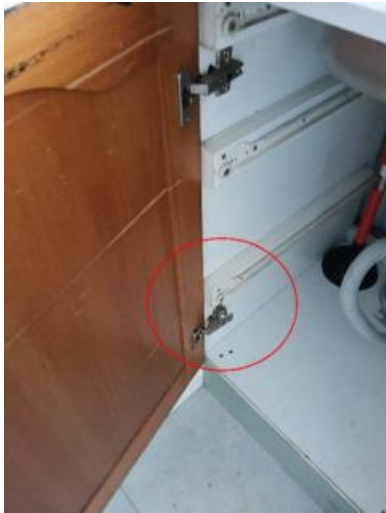
Doors Condition:

The door hinge needs adjusting and/or repair.

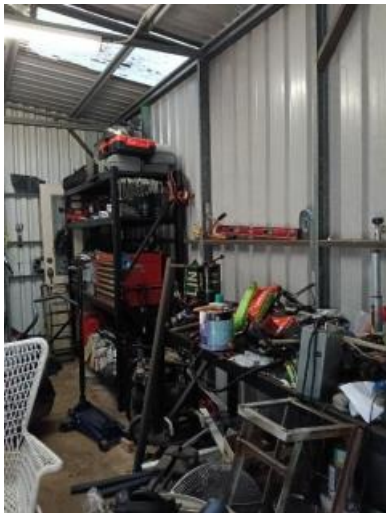
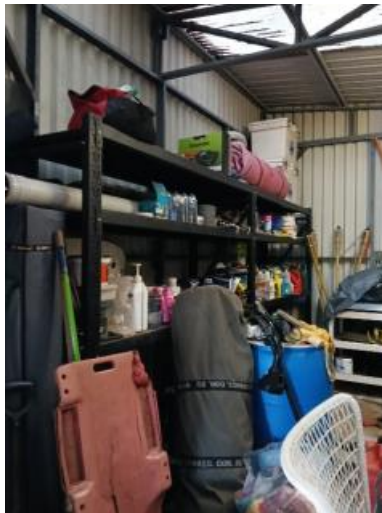
Restrictions:

Inspection within this room was restricted by stored goods.

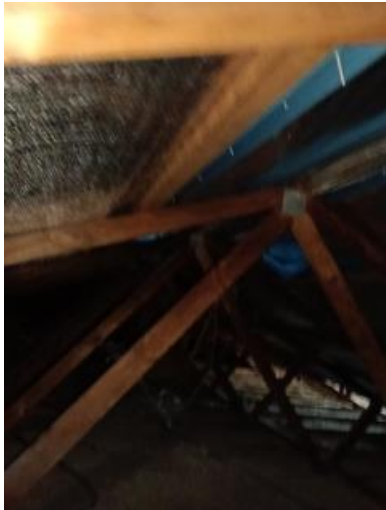
Roof Space & Framing - Condition

Members of the roof frame have been repaired. The current owners should be asked for more information.

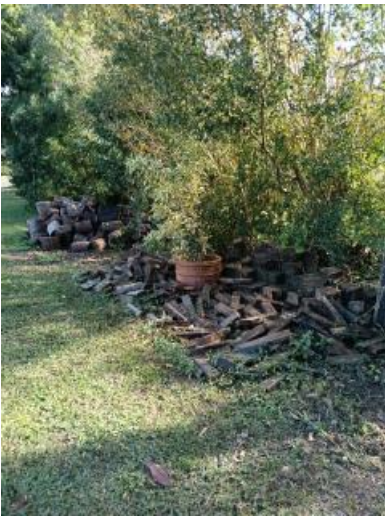
Affected timbers / Areas:

Fire timber. Left side of the yard.

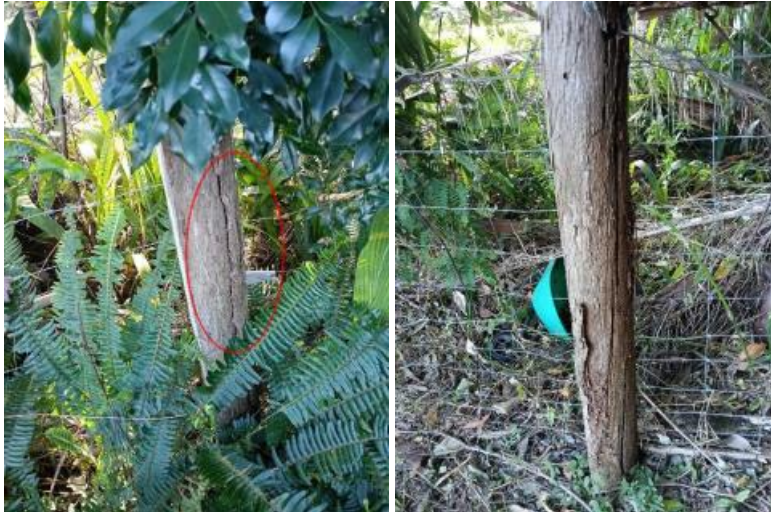
Timber damage caused by termites and/or termite workings was found. Where damage or workings are found but no live termites were present at the time of the inspection then you must realise that it may be possible that termites are active in the immediate vicinity and that the termites may return and cause

Fence posts.

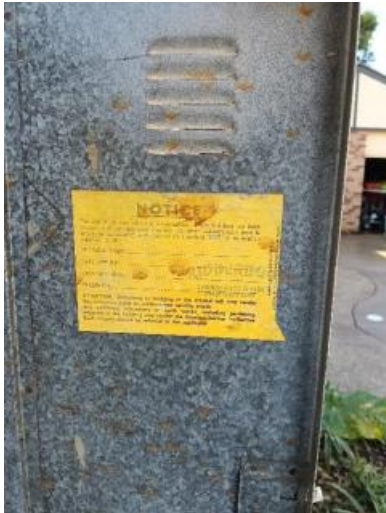
Description:

A treatment notice appears to be present however, we are unable to determine the type of treatment carried out as the notice was unreadable.
