# Property Inspection Report

25 Orchard Street,  
Caboolture South, 4510, QLD

Inspection Prepared for:  
Leonie Elchelmaier

Date of Inspection: 19/8/2026 | Time: 3:00 PM

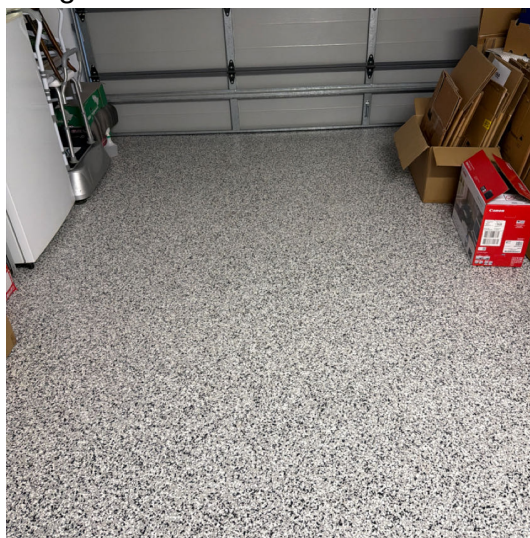
- Visible sections of the concrete slab appeared satisfactory.
- Most areas of the concrete slab not visible due to floor coverings.
- All concrete floor slabs experience some degree of cracking due to shrinkage in the drying process. In most instances floor coverings prevent recognition of cracks or settlement in all but the most severe cases. Where carpeting and other floor coverings are installed, the materials and condition of the flooring underneath cannot be determined.

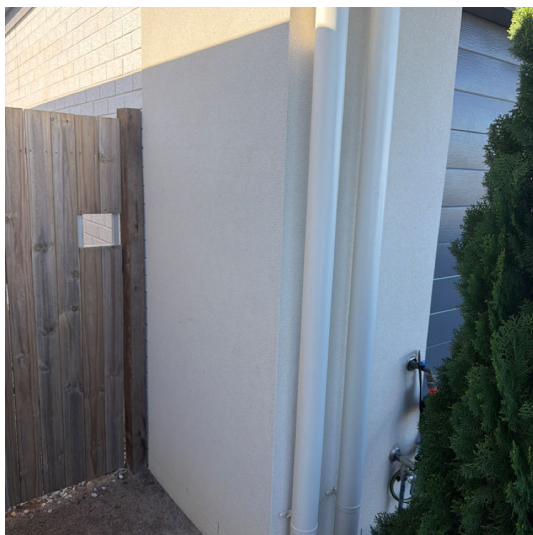
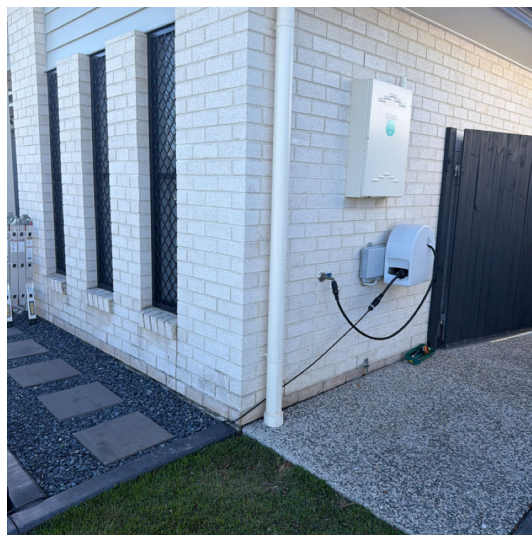
- The wall structure components appeared functional.
- Externals walls are of a timber frame and brick veneer construction.
- Externals walls are of cladded timber frame construction.

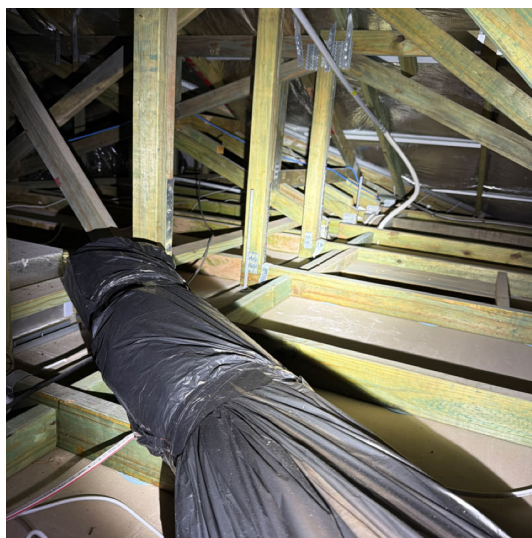
- The ceiling structure appeared functional.

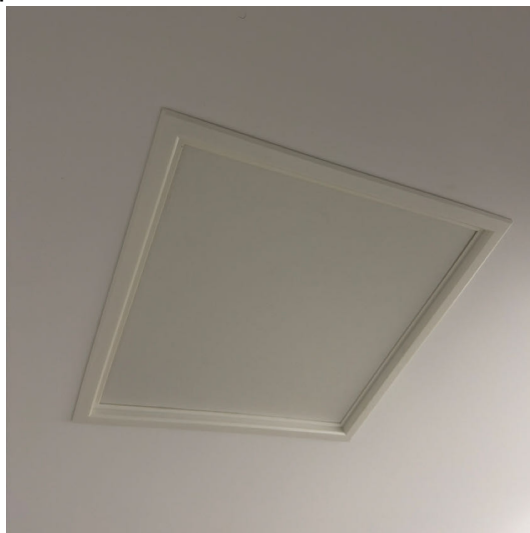
- Limited visibility and access due to air conditioner duct work throughout the ceiling space.

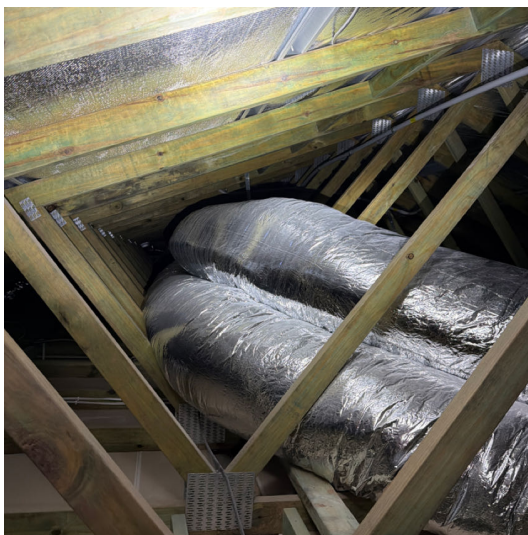
- Where visible, the air conditioning duct work appeared to be in a satisfactory condition.

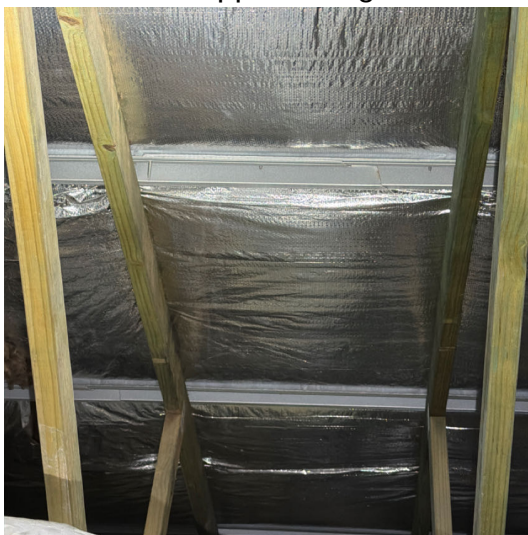
- The anticon material appears in good condition.

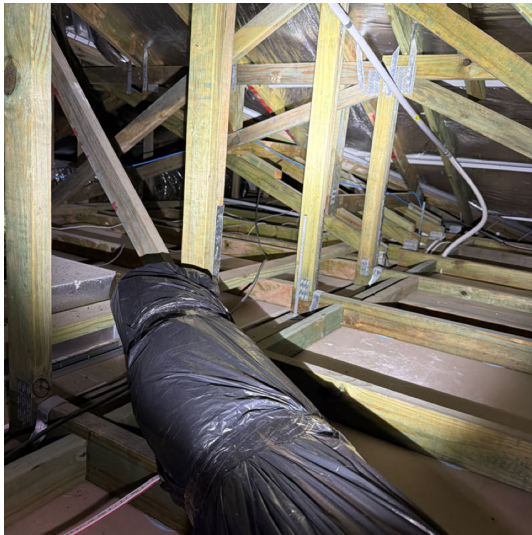
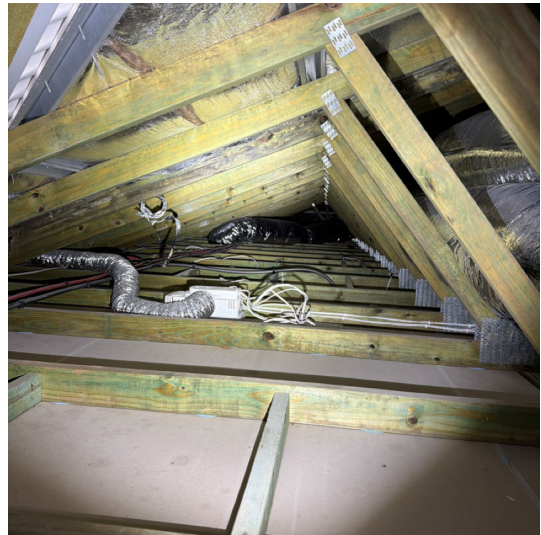
- The timber roof structure appears sound.

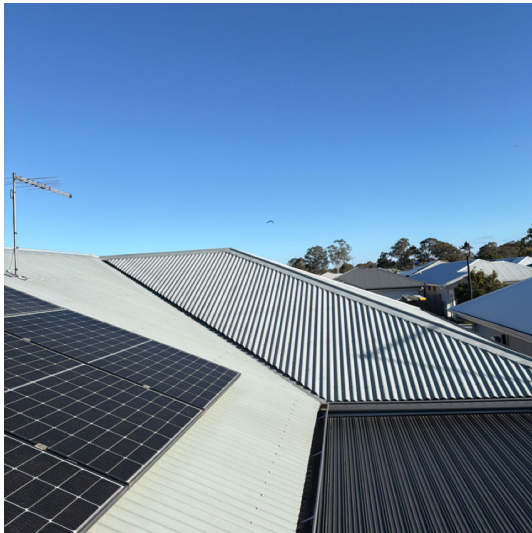
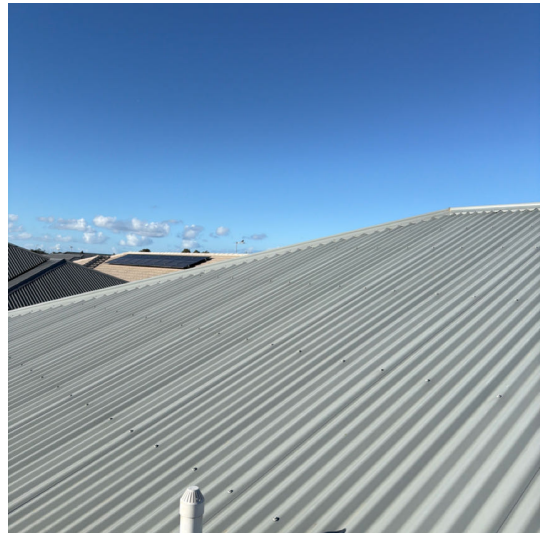
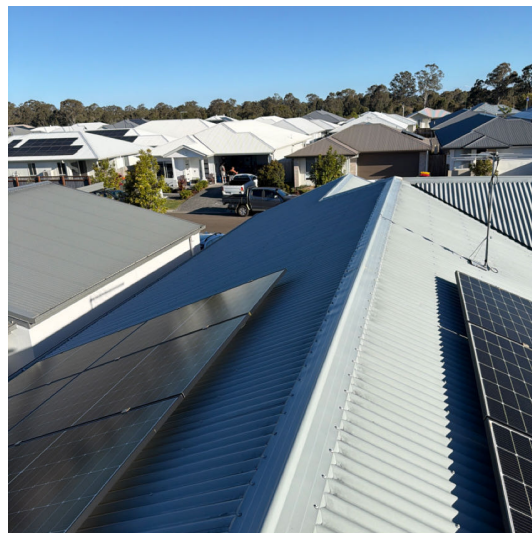
- The colourbond iron roof sheeting appears to be in satisfactory condition.

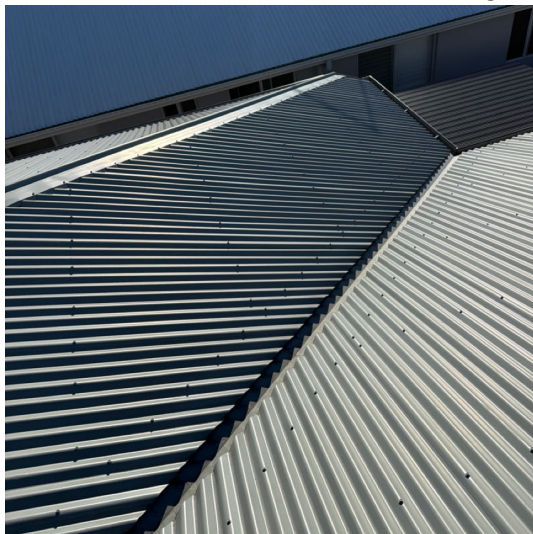
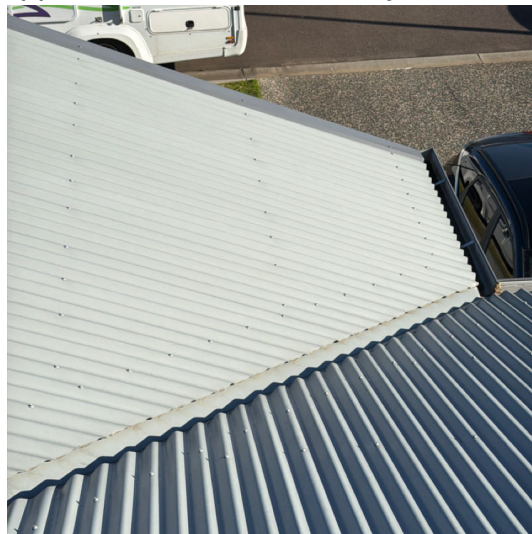
- Flashing is an impervious material (usually galvanized sheet metal) that comes in a variety of shapes and sizes and is used to cover, waterproof, and direct water away from roof penetrations and from valleys and intersections between the roof covering and other materials.
- The roof flashing, where visible, appears to be in satisfactory condition.

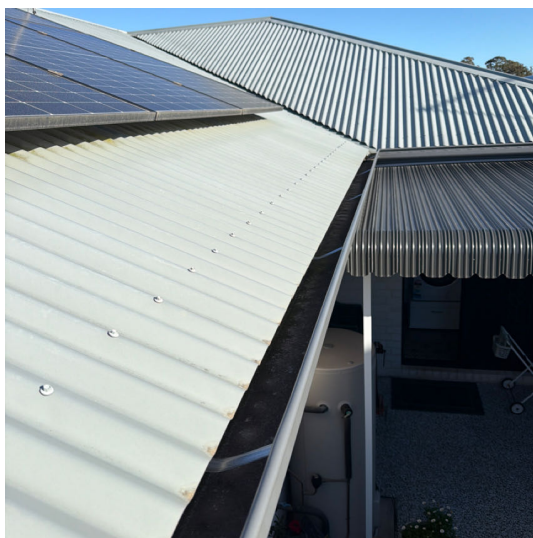
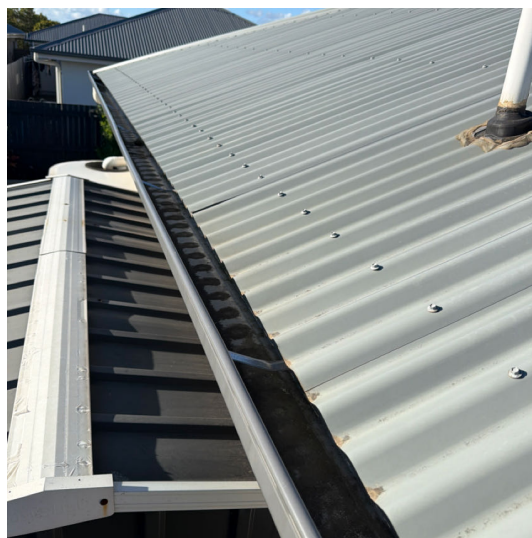
- No major function concerns noted at the time of inspection.

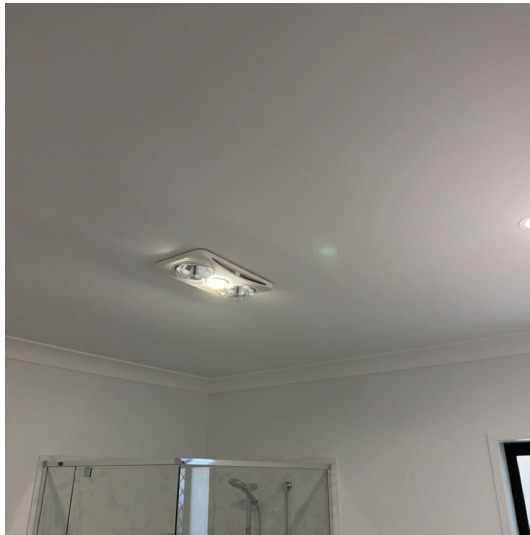
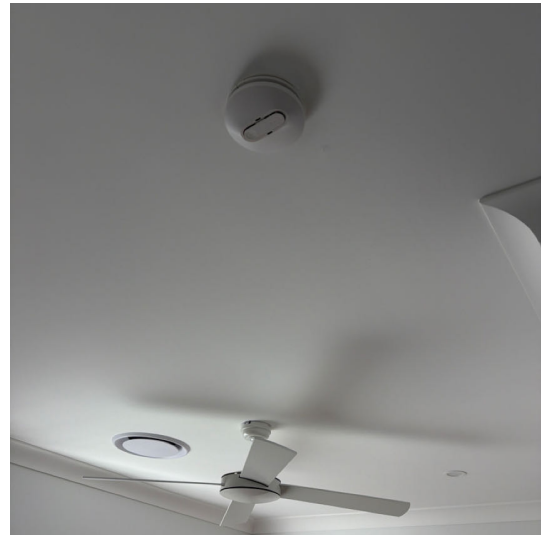
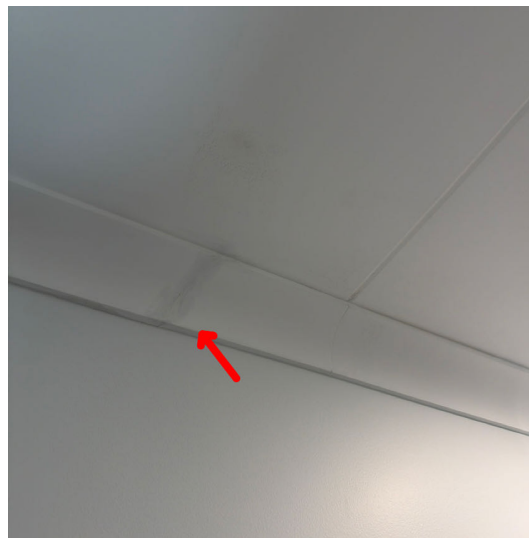
- There is minor cracking which has occurred at the interface between the ceiling cornice and the wall at various locations. This can be a result of foundation settlement and/or movement in the roof structure. This does not appear to have affected the structural integrity of the home and can be repaired normally.

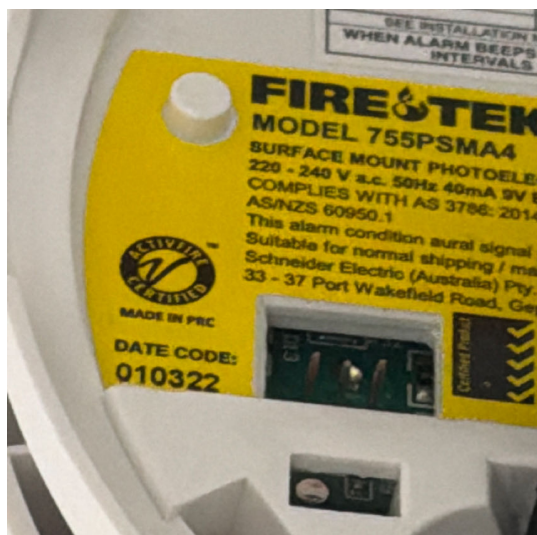
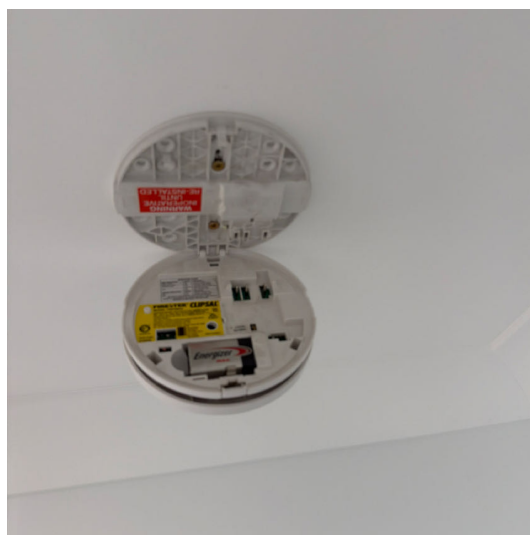
- The property seller must declare on a "form 24" to the buyer as part of the transfer process that the obligation has been discharged.
  - There appears to be interconnected smoke alarms installed in the hallways and bedrooms of the home. The service replacement year is noted as 2032

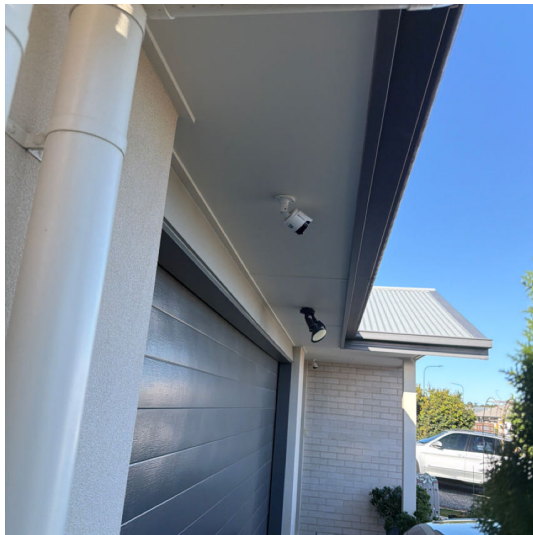
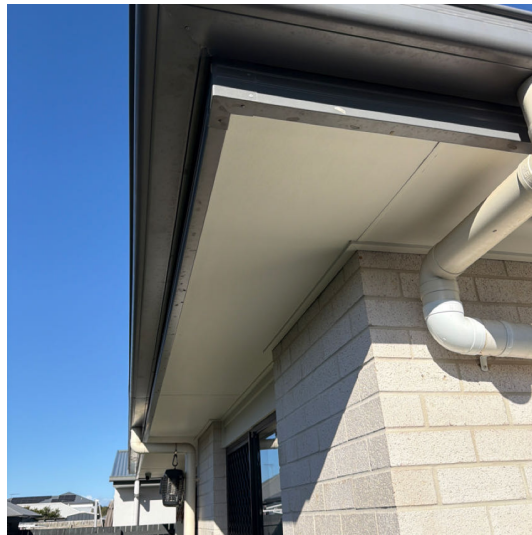
- The eaves are in satisfactory condition.

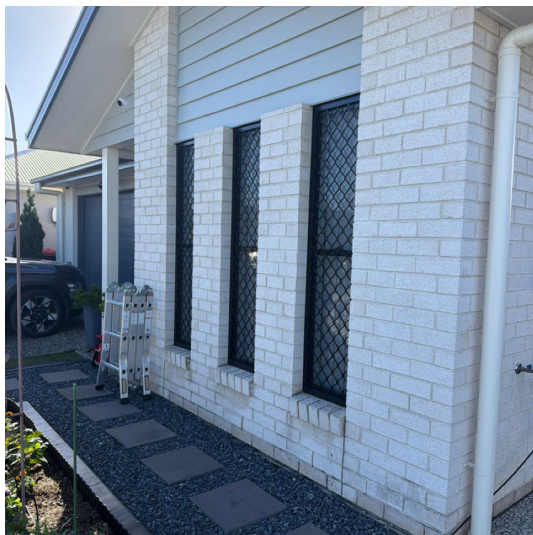
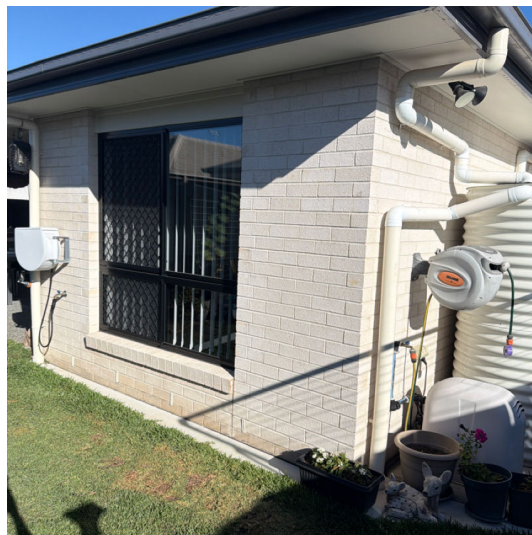
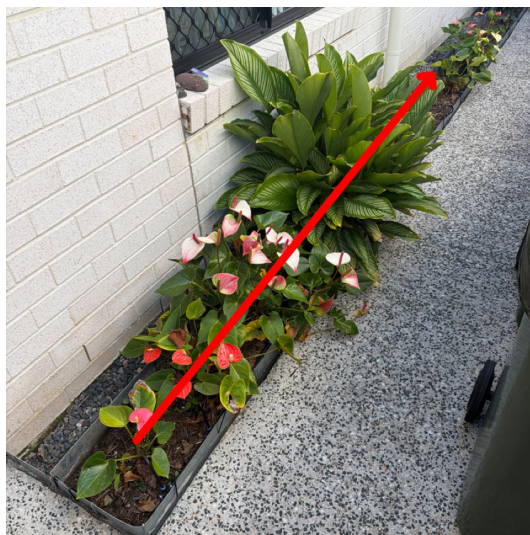
- There are a number of garden beds which are adjacent to the external walls. This can result in water moisture affecting the structure over time. It is recommended that either the beds be removed or a water barrier be placed between the garden bed and the external walls. If these beds are retained it is important that any watering is directed away from the building and kept to an absolute minimum and is controlled.

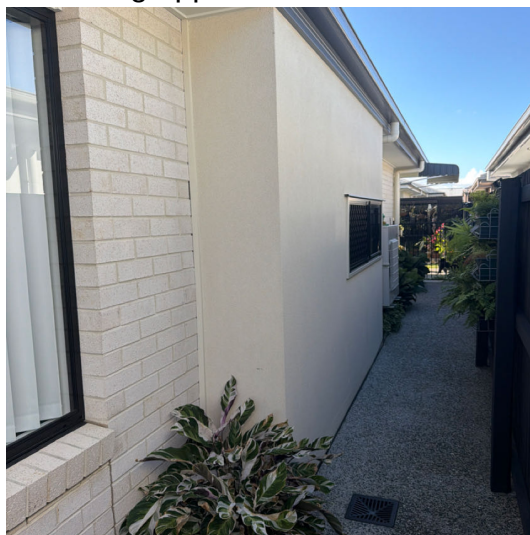
- External cladding appears to be in satisfactory condition relative to its age.

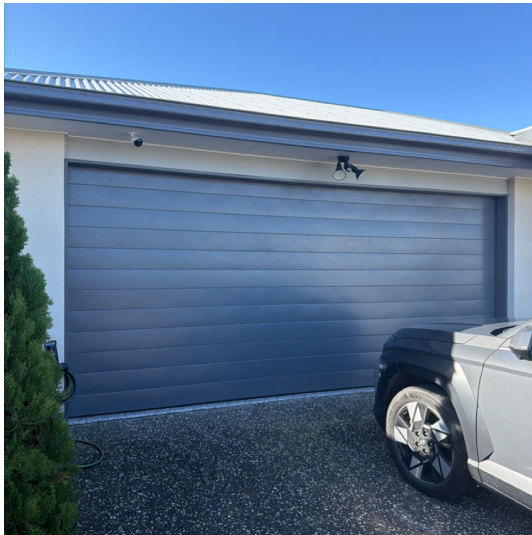
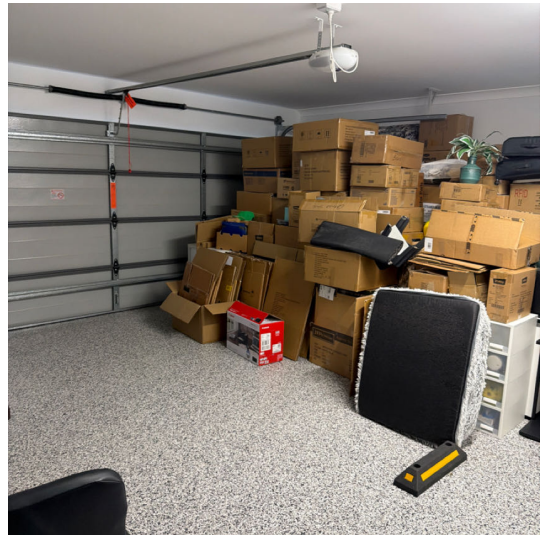
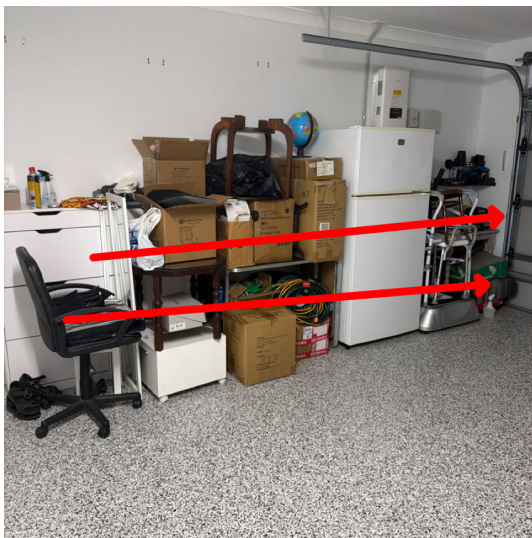
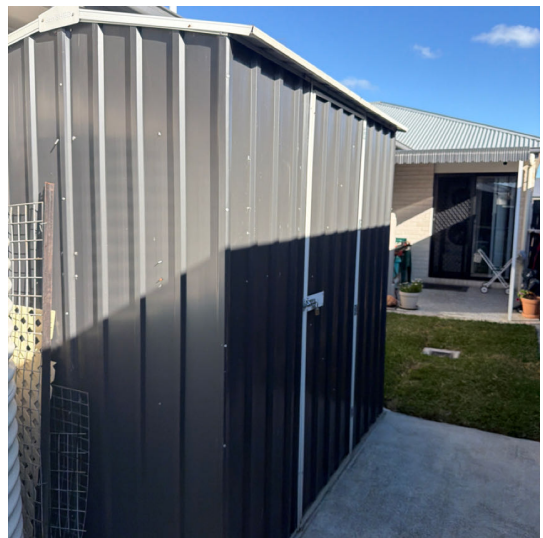
- Due to the extensive amount of personal storage items, most areas of the garage were obstructed and restricted from view. It is recommended that the items are removed and further inspection of the garage be conducted. Inspection limited.

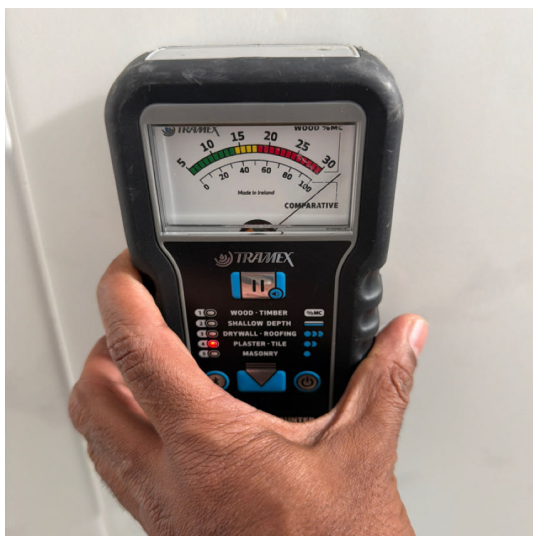
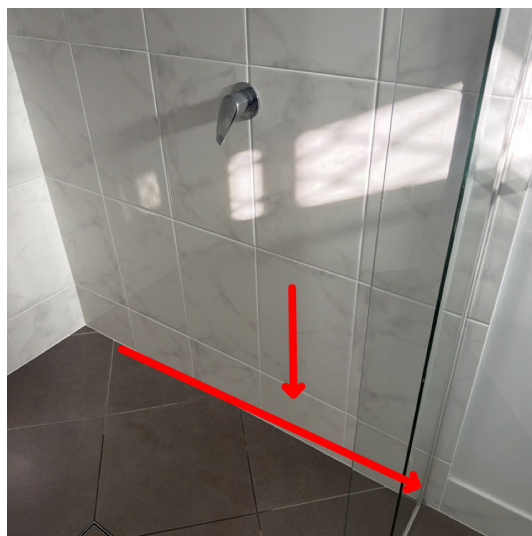
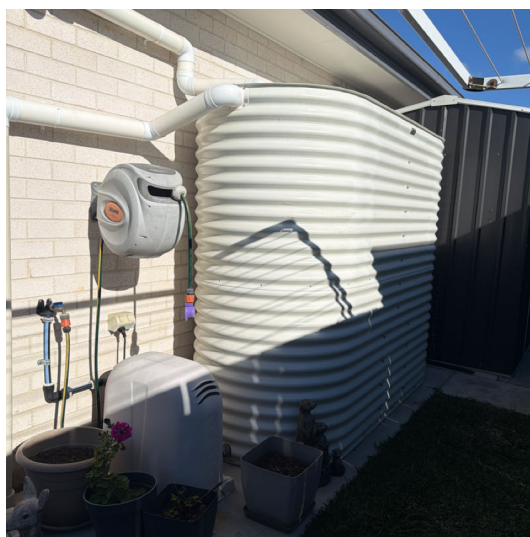
Observations: Excessive moisture was present to the ensuite shower walls, which appear to require resealing.

Ensure water tanks and pumps are free of leaks as this condition will create excessive moisture.

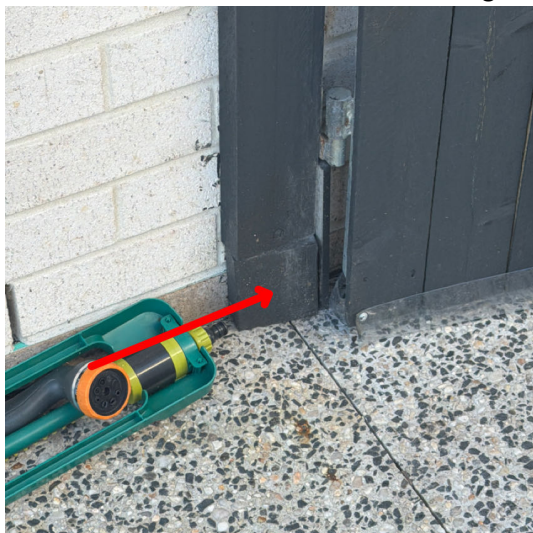
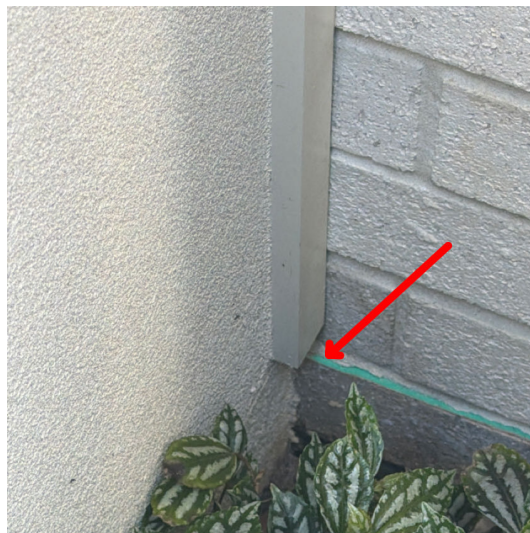
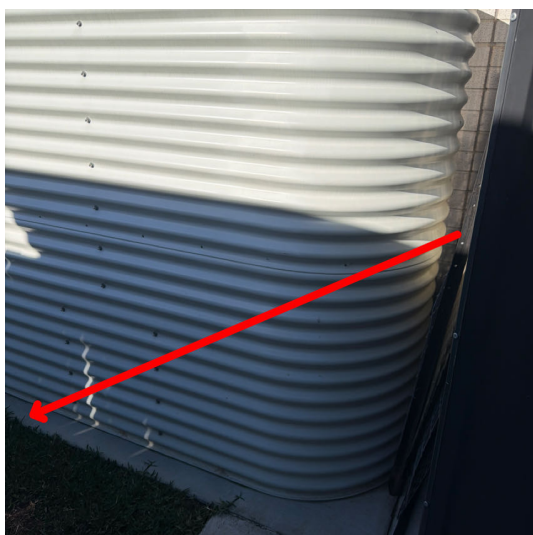
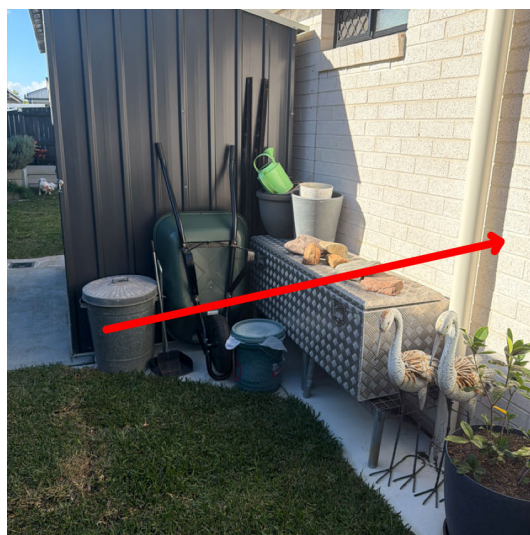
The water tank is positioned close to the external wall, restricting visual access and potentially concealing signs of termite entry. Where practical, sufficient clearance should be maintained to allow effective inspection and ongoing termite monitoring.

Stored items were noted against the external wall, restricting visual access and potentially concealing evidence of termite entry. The items should be moved away from the wall to maintain a clear inspection zone for ongoing termite monitoring.

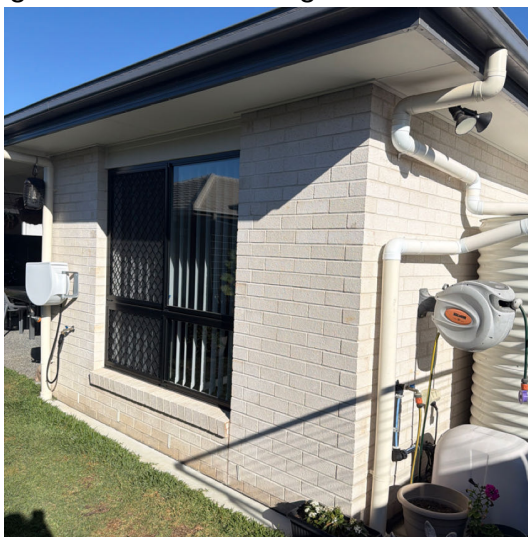
- Slab edges are clear and in good condition, unless noted.

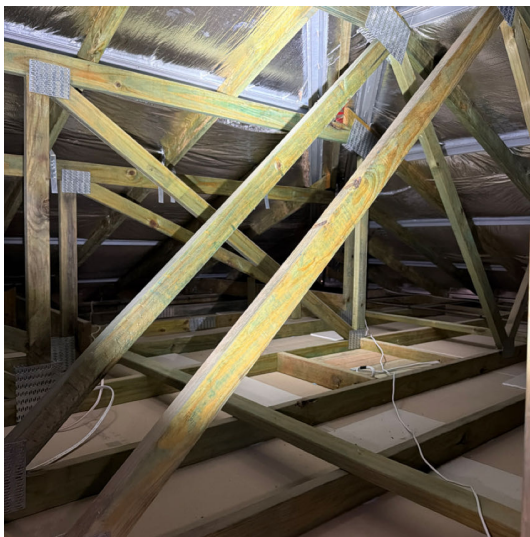
- Access was available through a manhole in the garage.
- Could not access all areas of the roof space due to limited space.
- Limited visibility and access due to pitch and ducting.
- Inspected from access hole only, access restrictions prevented entry.

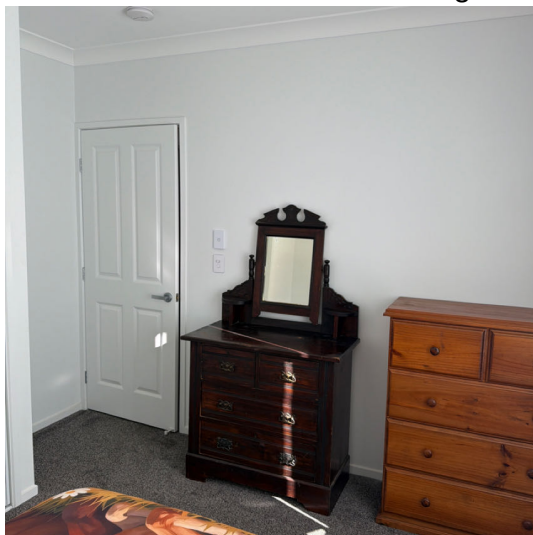
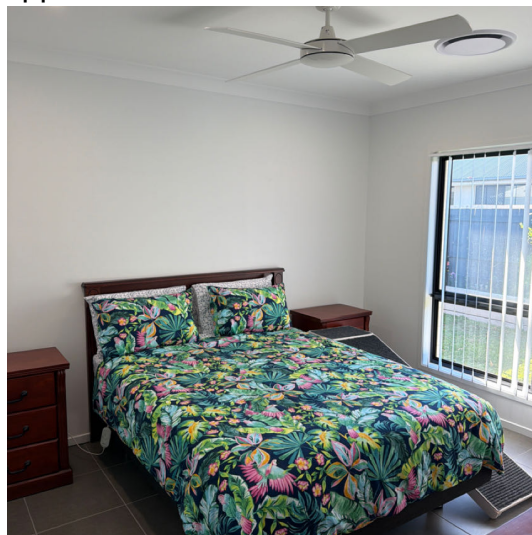
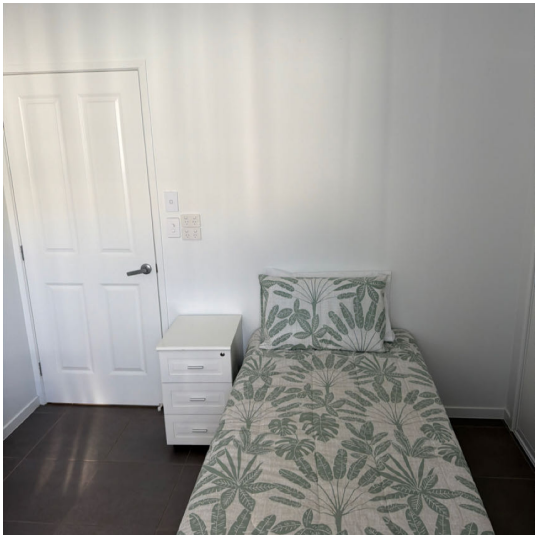
- Timber skirting and door frames appear functional.

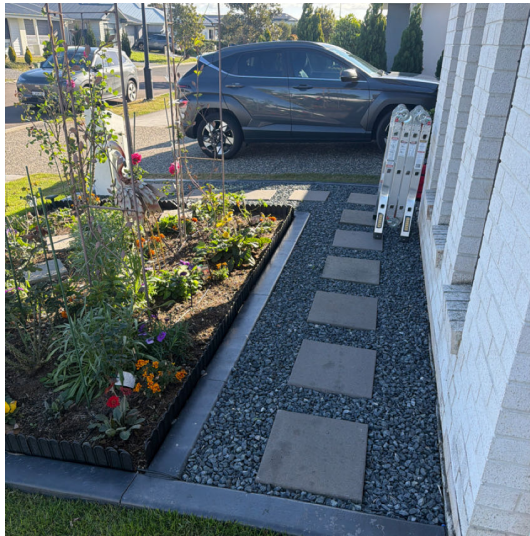
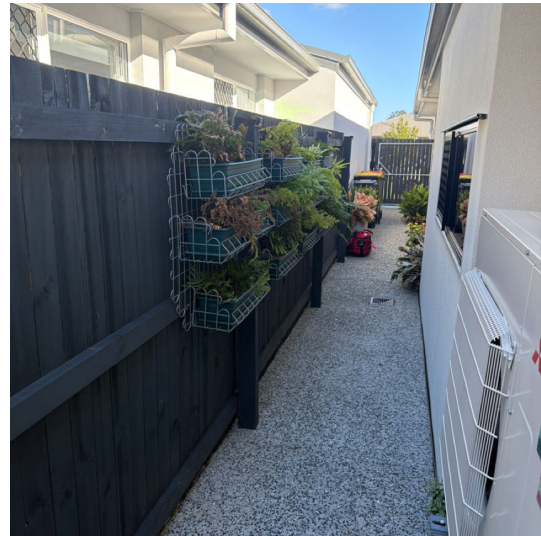
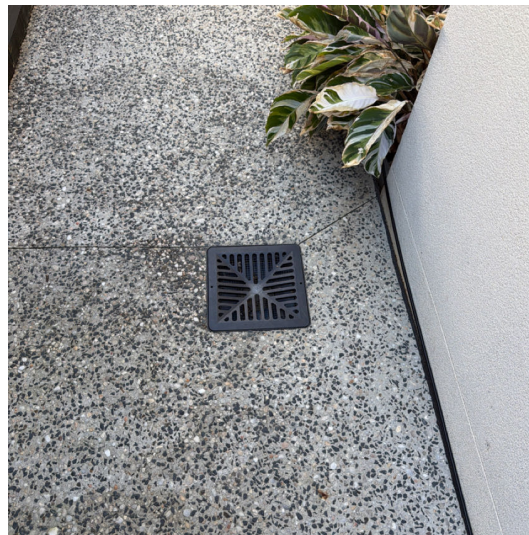
- It is important to redirect moisture away from the property to limit areas of excess moisture. Faulty gutters and downpipes in poor condition can cause water to seep into the foundations, causing conditions conducive to termites and fungal decay.
- Surface drainage conditions within 3 metres of the inspected structure appeared satisfactory.
- We recommend all storm water drains, pits and strip drains are cleaned on a regular basis in order to prevent blockages and possible flooding.

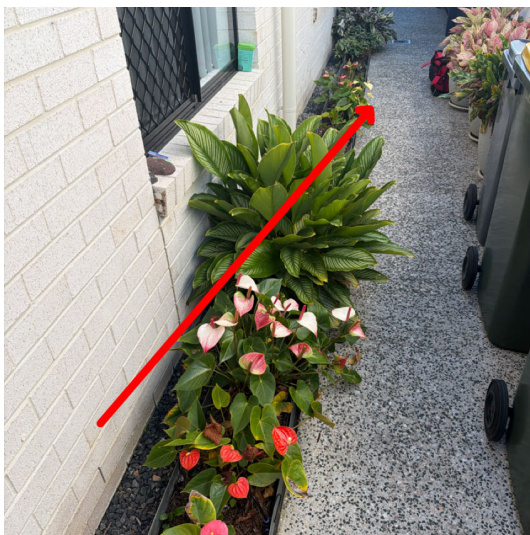
- Prune or remove any plants that are in contact or proximity to home to eliminate pathways of wood destroying insects.

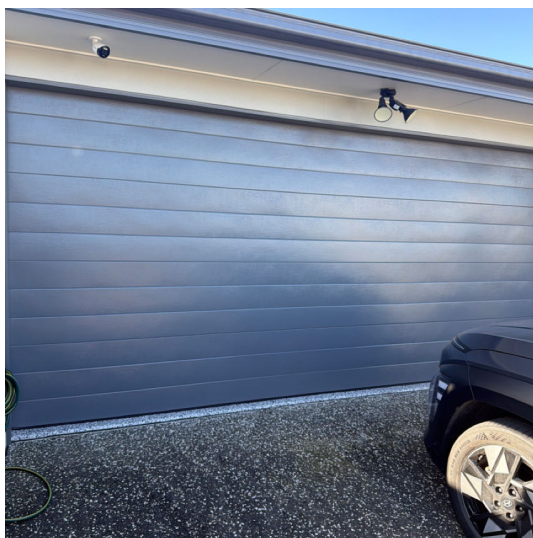
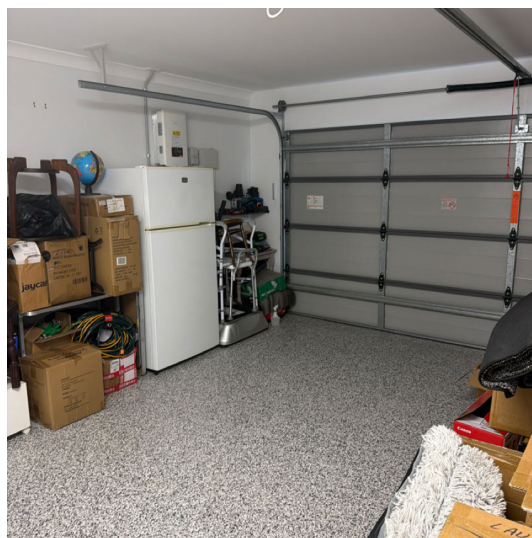
- Appeared satisfactory.

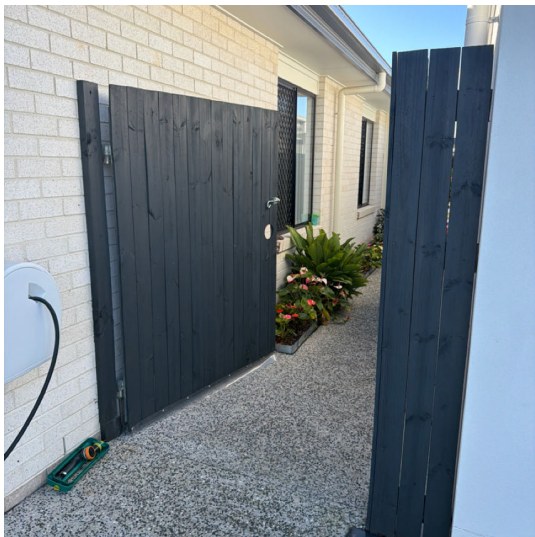
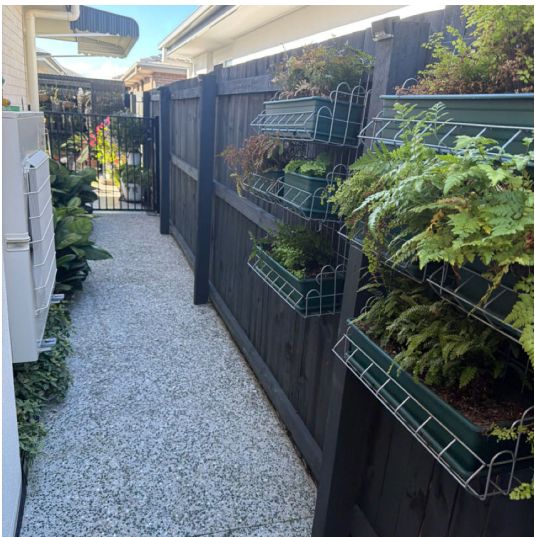
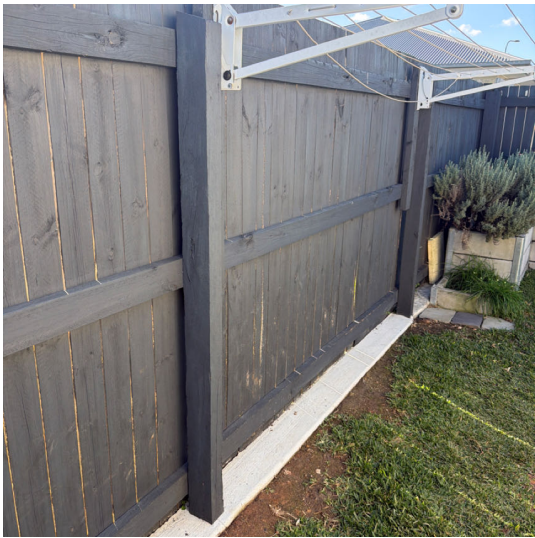
- Timber gate is in good condition.
- Timber fences are in good condition.

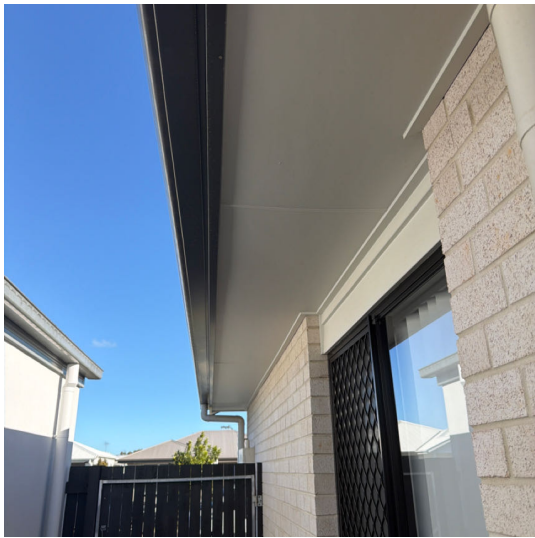
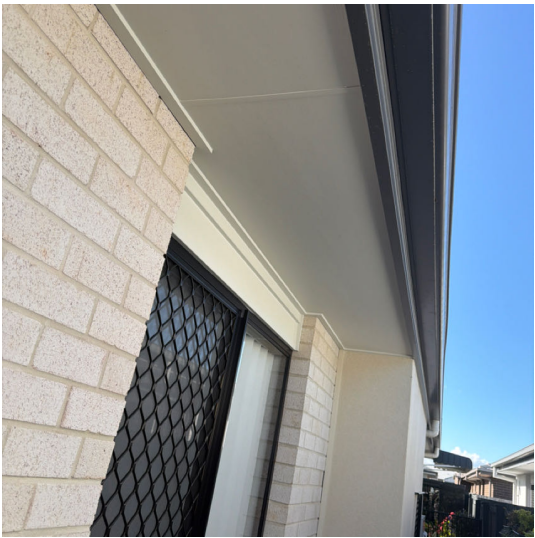
Comments:  
• The eaves are in satisfactory condition.
