## TIMBER PEST INSPECTION REPORT

Complies with Australian Standard AS 4349.3-2010

Inspection Date: 06/11/2025.

2 Keel Ln, Burpengary QLD 4505.

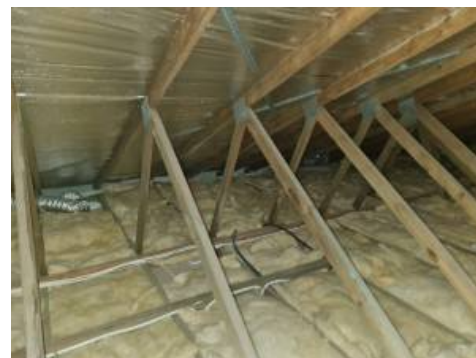
**Restrictions:** Insulation is present in the roof cavity. This restricted inspection to some roofing timbers. Removal of insulation is not within the scope of a standard visual inspection report. Sarking membrane covered roof battens restricting inspection.

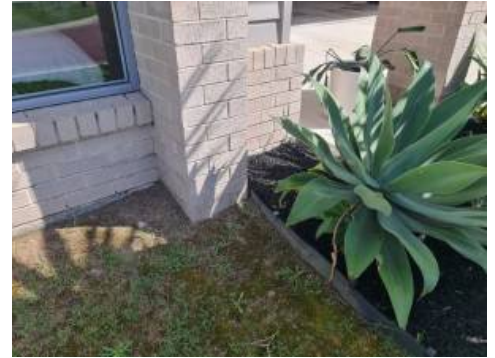
We recommend the removal of wood chip timbers/bark adjacent to external walls of the building. Timbers such as these are attractive to termite attack. Garden beds have been built up against the external walls. Garden beds should be removed or modified, so the gardens are not in contact with the building to prevent concealed pest attack.

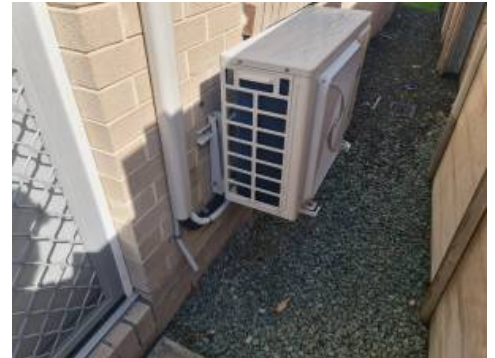
The potential presence of moisture in the form of, Air-conditioning unit(s) drain discharges moisture adjacent to the external walls. We recommend repair, or modification so that water is discharged over or into a drain, not causing damp conditions adjacent to building. These item(s) should be rectified as moist soil conditions are conducive to timber pest attack. Refer 9.0 The Presence of Excessive Moisture.

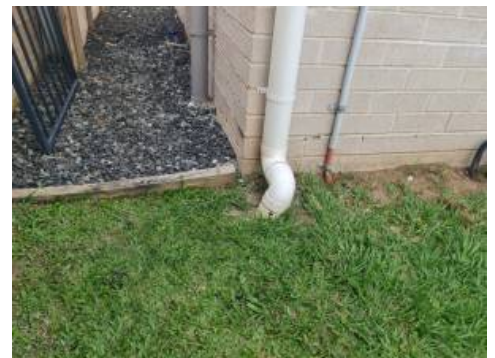
The potential presence of moisture in the form of, Some gutters and/or downpipes appear to discharge rainwater directly adjacent to the foundations of the structure. Due to damaged pipes or poor connections. We recommend repair, or modification so that water is discharged over or into a drain, not causing damp conditions adjacent to building. These item(s) should be rectified as moist soil conditions are conducive to timber pest attack. Refer 9.0 The Presence of Excessive Moisture.

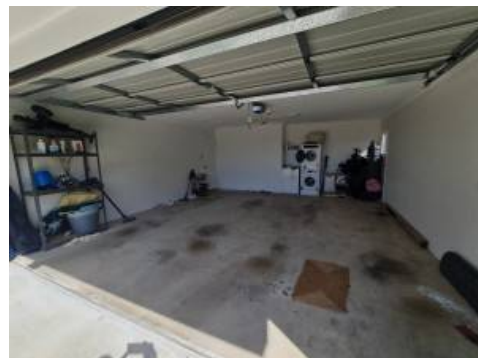
| <b>Restrictions:</b> | Stored items restricted inspection to the interior of this area. |

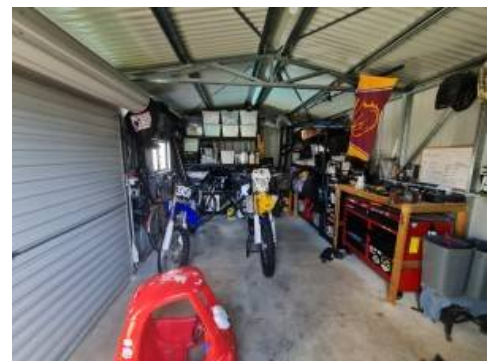
Inspection within some areas was restricted by stored items.

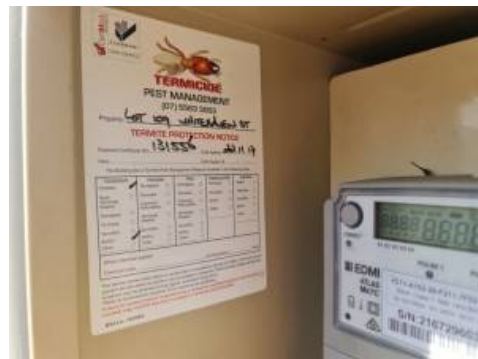
A notice indicates that the property has had a termite management system installed during construction in respect to protection against subterranean termite attack. The termite management system installed is known as a physical barrier system (Physical Barrier system), where collars have been installed to penetrations of floor/concrete slab, and termite resistant sheeting to perimeter wall cavities. This method relies on regular visual inspections of perimeter of the building. We recommend the client attempt to verify this information and obtain copies of all relevant documentation.
