# Pre sale building and pest report.

**610 Caboolture River Rd, Upper Caboolture, QUEENSLAND , 4510**

Report/Agreement #              030826052421261

Inspection Date:                  04 Aug 2026

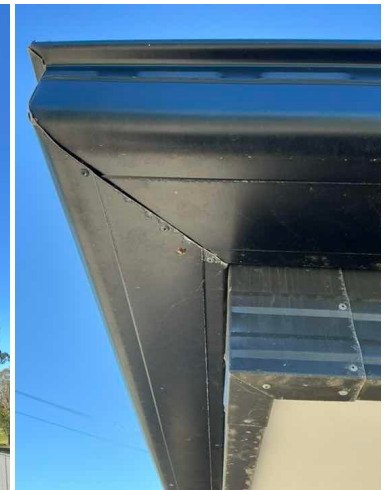
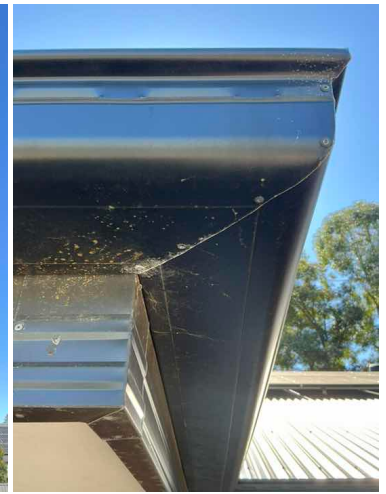
#1. Debris in gutter areas- this requires cleaning out to prevent blocking of downpipes and leaking into eaves and fascia. Have gutters cleaned and assessed by a plumber for adequate fall. Regularly clean to prevent ponding. Ponding water will contribute to rust.

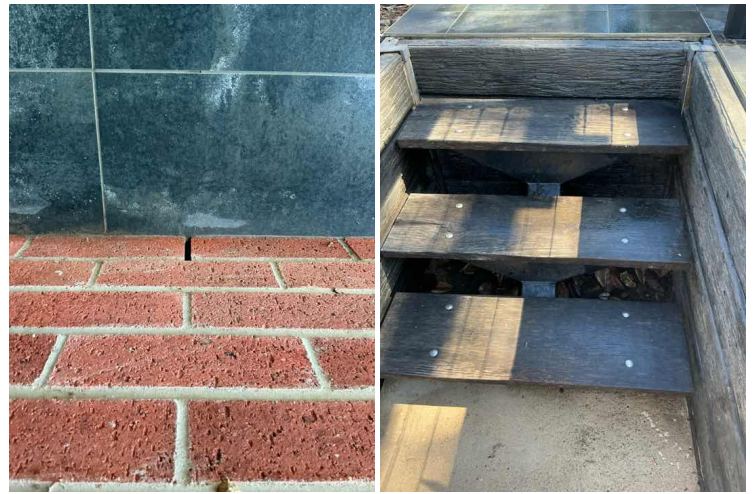
#2. Tile cracks evident. Engage a qualified tiling contractor to repair.

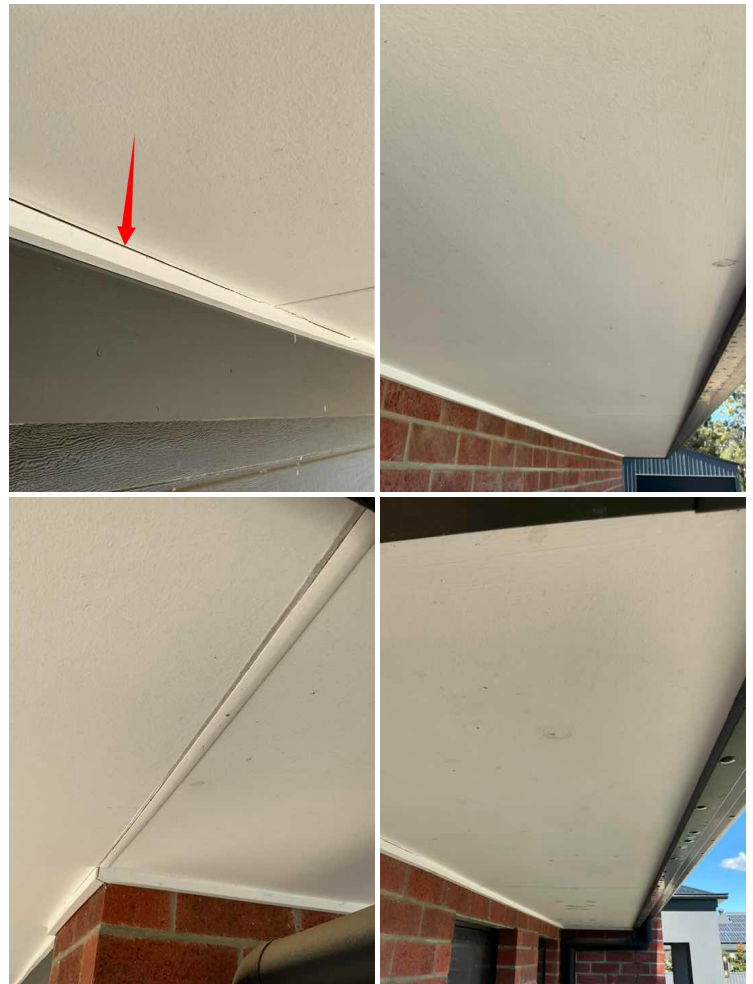
#3. Quad deteriorated or detached. Contact a licensed carpenter for repairs.

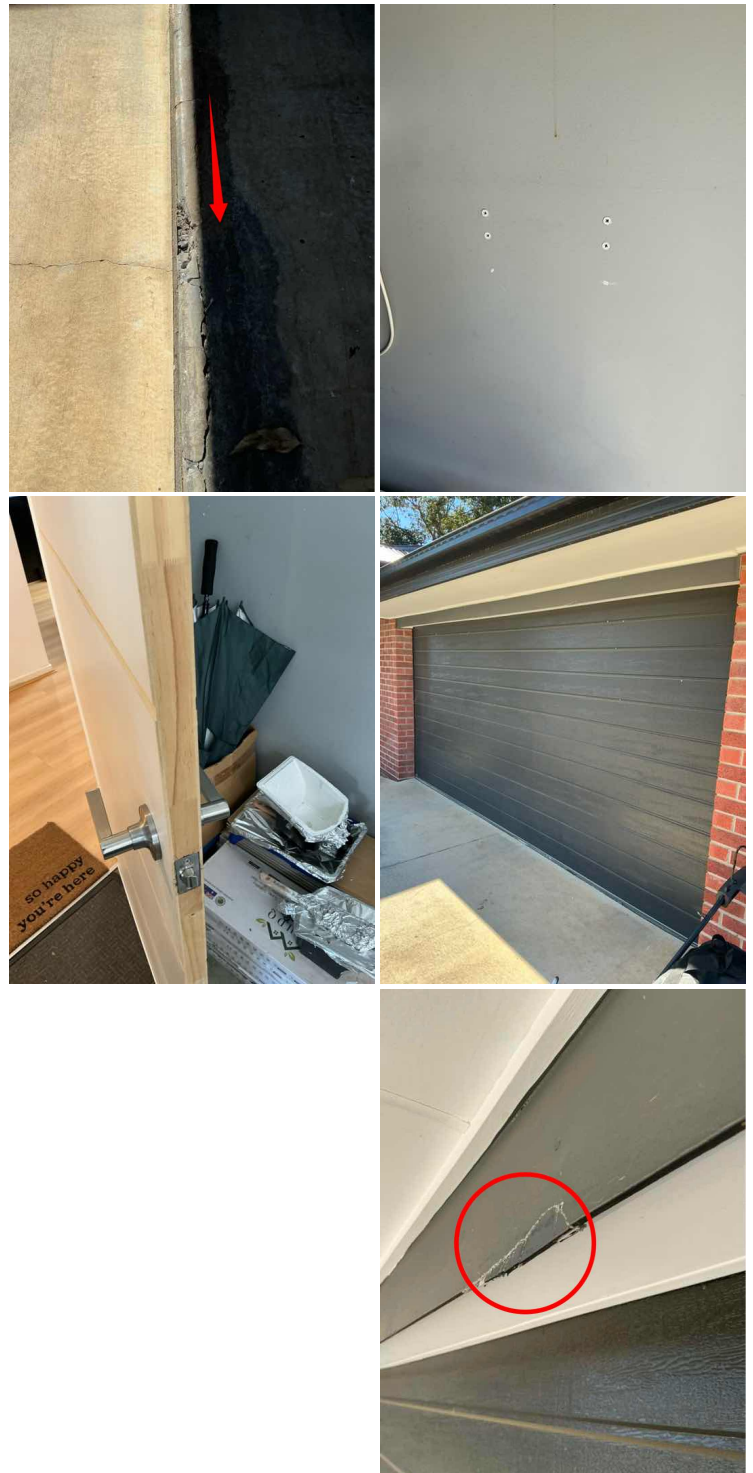
#4. Crack to cladding above door opening.

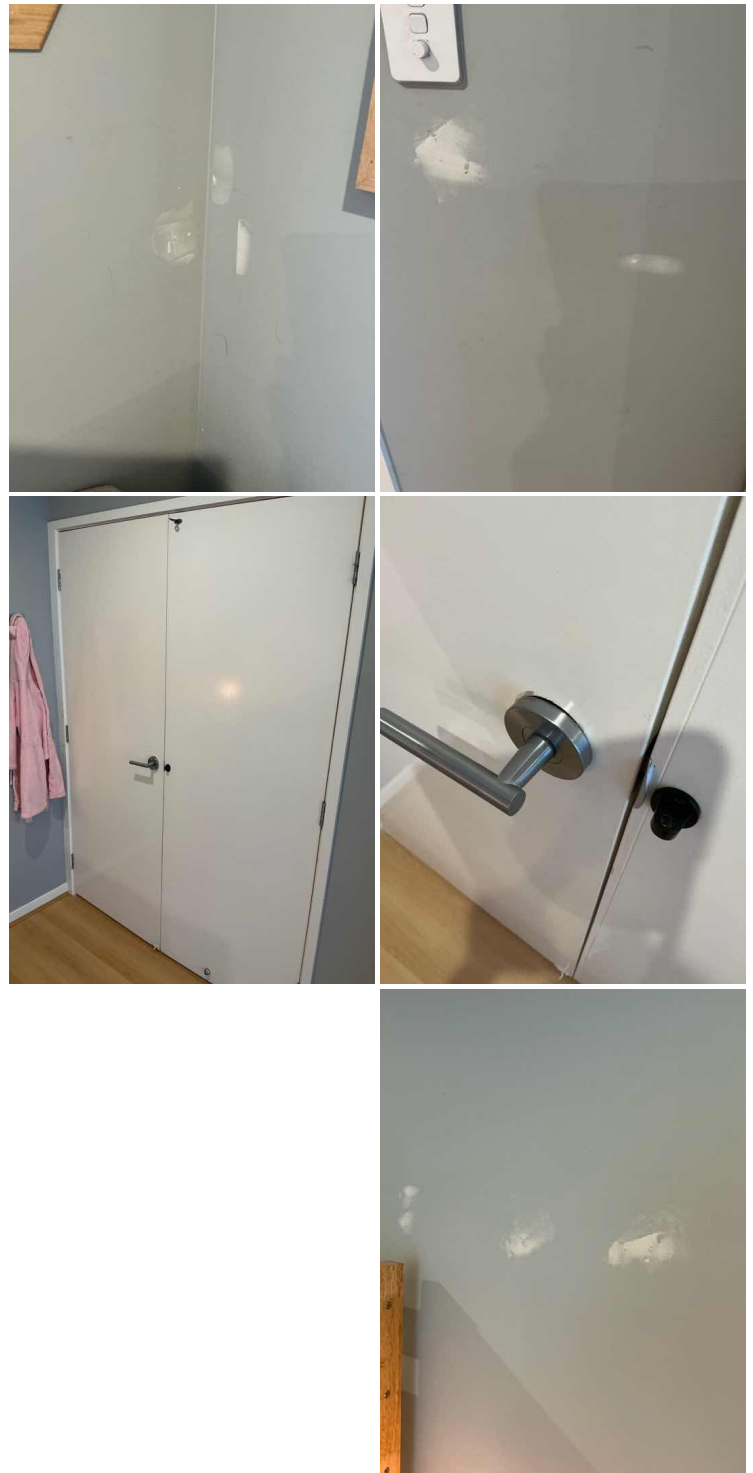
#9. Door lock hardware is loose possibly damaged. Maintenance as required.

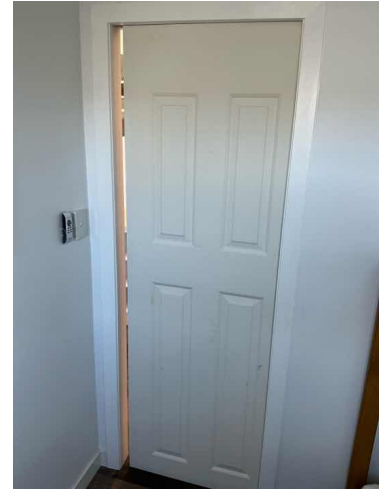
#12. Bedroom door painting incomplete.

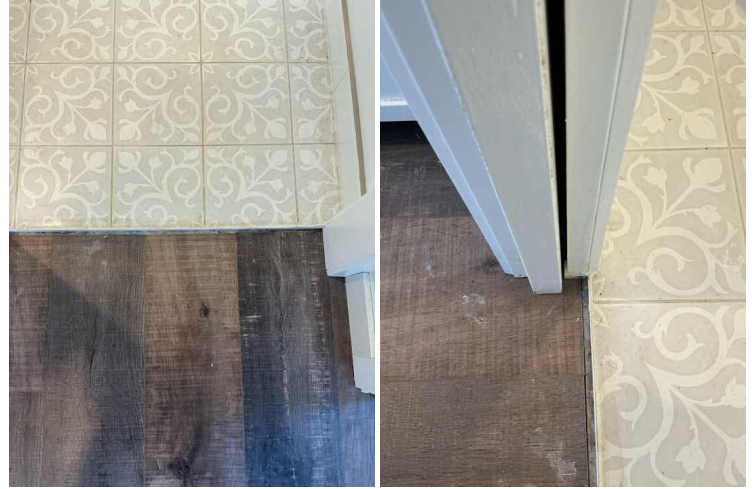
#16. Threshold trip to be installed.

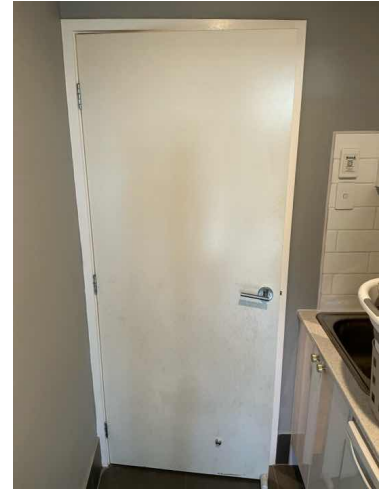
#17. Painting damaged. Sand and repaint.
