## BUILDING INSPECTION REPORT

Complies with Australian Standard AS 4349.1-2007

Inspection Date: 14/11/2025.

5 De Havilland Dr, Bray Park QLD 4500.

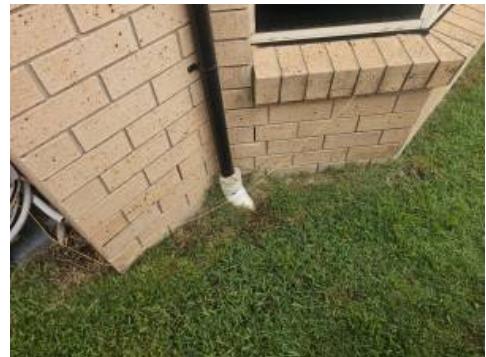
Down Pipe(s),  
Broken/disconnected at ground level. Some maintenance required. Dampness is conducive to movement and settlement of the building foundations. Right hand side elevation. Front elevation. A licensed plumbing contractor should be called to make further evaluation and repairs as needed.

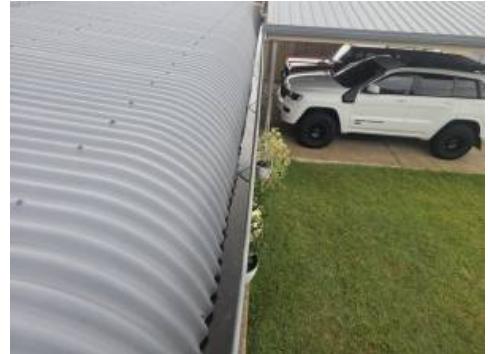
Guttering, Water is ponding in the gutters and they require realigning to allow ponding water to drain away adequately. Front elevation.

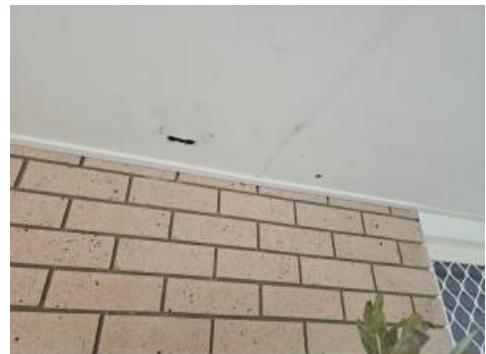
The overall condition of the eaves lining is fair. Some eaves linings have holes/ damaged areas and require, repair or replacing.

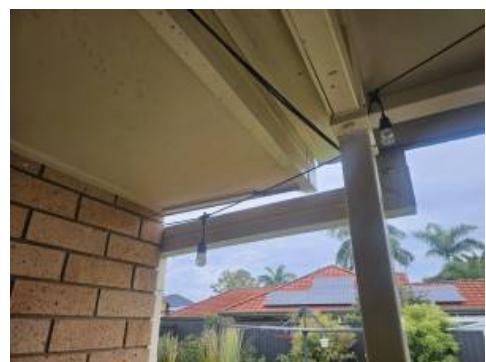
Moderate wood decay is present to timber mouldings of eaves. Maintenance is required.

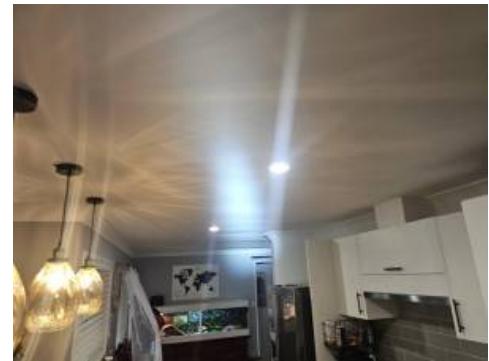
The condition of the ceilings is generally fair. Moderate undulations were noted to the ceiling lining. Some sections of refixing will be required. A second opinion from a plastering contractor to further investigate the extent of rectification works required, most appropriate method of rectification and the probable cost of rectification. Various areas.

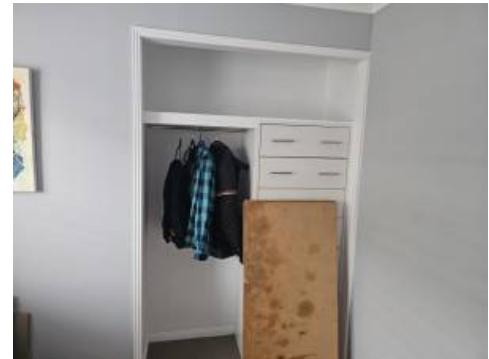
**Location/area** Bedrooms.

**Doors Condition:** Door(s) missing.

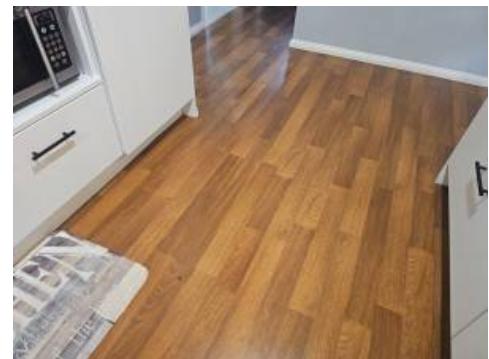
**Floors Condition:** Floors are concealed by floor coverings to various areas. Floor coverings are deteriorating/damaged in areas.

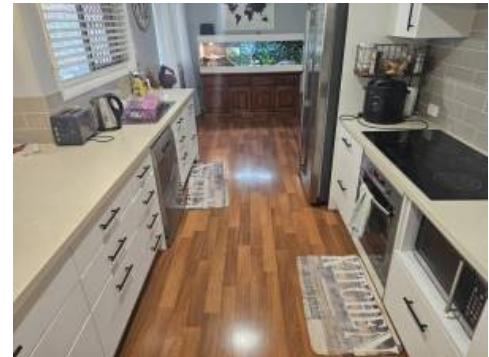
The condition of the fixtures is good. Chipped areas are present to the benchtops. General wear to cabinets due to age. The laminate is lifting/ separating in some areas. We have carried out a function test to the following item(s). Note: The testing was to validate whether the items tested are in a working order or non-working order. No specific tests other than running / turning on was carried out. No determination has been made as to the suitability or adequacy of the tested items. Refer Report Definition section within.

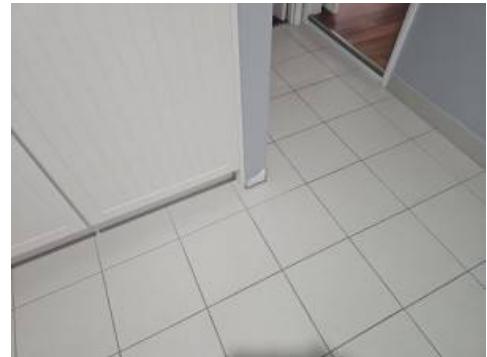
Various loose/missing tiles where present to skirtings. Rectifications are required.

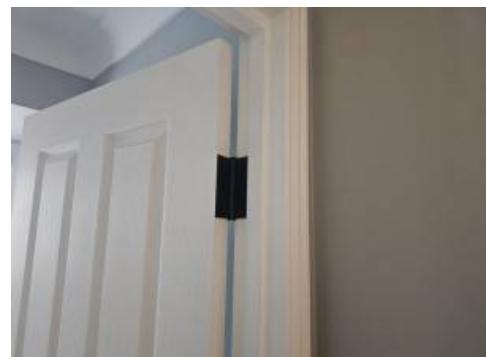
This area is generally in good condition. No lift off hinges to door. Consideration should be given to install lift off hinges for safety/ emergency reasons.

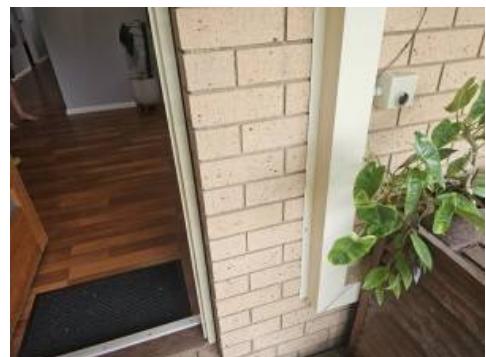
The condition of the walls is good. Some gaps/ holes are present to wall exterior. These gaps/holes should be sealed to prevent moisture and vermin entry to wall cavities. Front elevation.

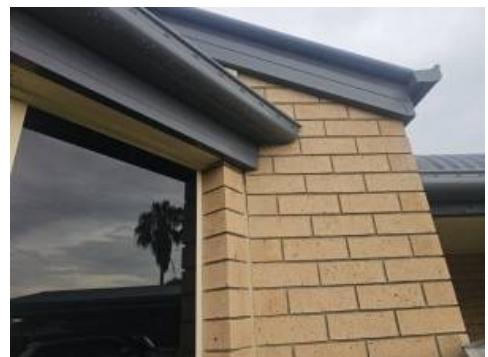
Appearance cracking is noted to areas of external walls indicates that settlement/movement to structure has occurred. The area(s) where cracking was noted is listed below. Refer 4.7 Cracking of building elements note.

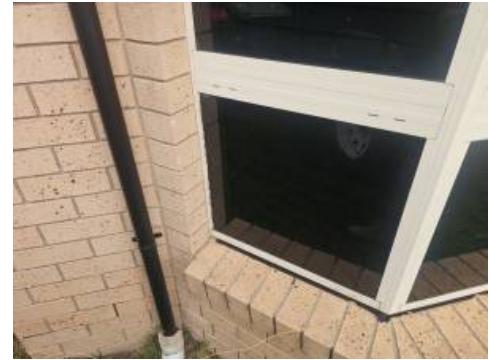
The condition of the exterior of the windows/doors is generally fair. Damage noted to aluminium frame. Front elevation.

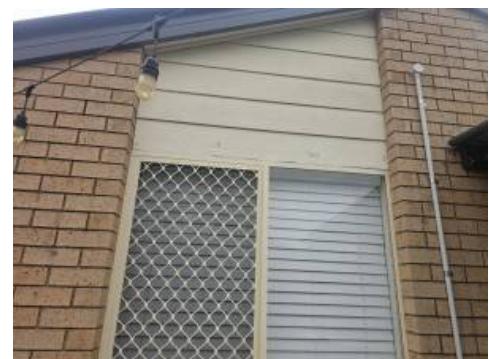
Flashings are not present to top of openings (windows and doors, etc). It is good building practice flashings be fitted to ensure water does not penetrate through this area. Rear elevation.

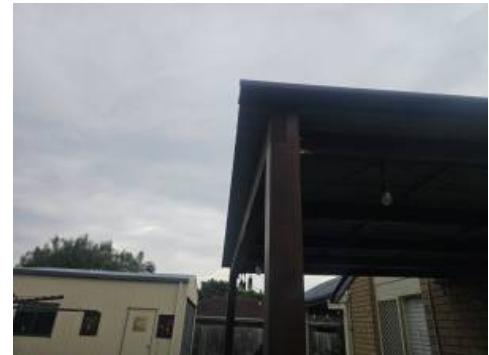
The fall/pitch of the roof appears to be inadequate for type of roofing material. This may allow wind driven rain penetration or water ponding. As the area is considered a shade area, the roof appears fit for its intended use.

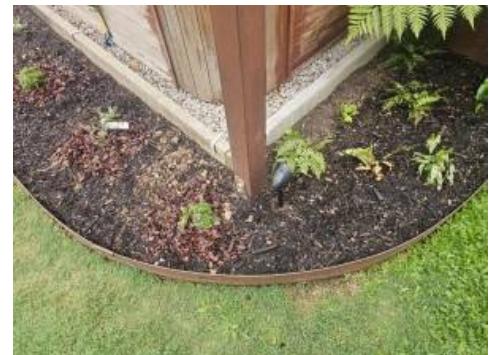
Recommend Timber posts be at least 75mm above finished ground levels to prevent wood decay and possible termite entry.

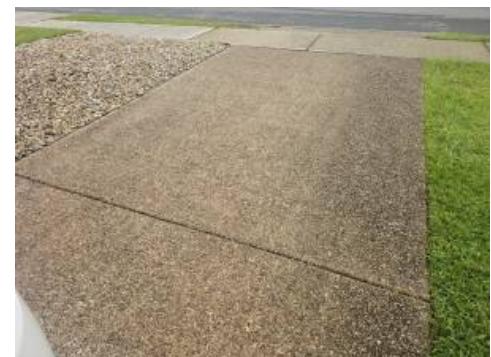
The concrete driveway stands in good condition. Common cracks and settlement were observed to the driveway.

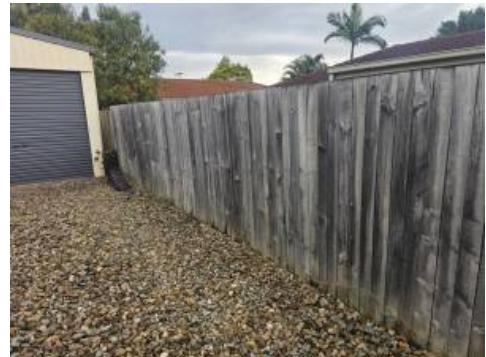
Only one side of dividing fences was accessible at time of inspection. The fences are generally in fair condition. The fences are mainly constructed from timber. Minor wood decay was noted. Repair when necessary.

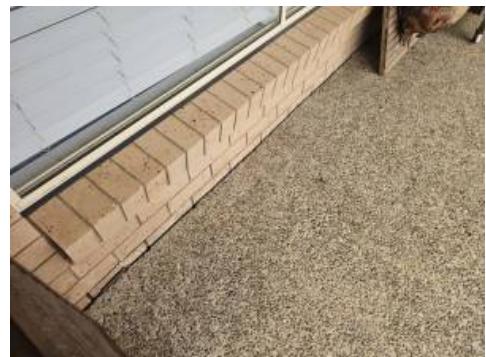
The concrete paths built against the building have moved away from building in sections, appears consistent with climatic conditions soils suffer. This is considered a serviceable defect. Services to building in this area eg, downpipe connections at ground level, inspection points to both sewer/septic and stormwater pipes, main water supply, conduits for electrical or phone services should be checked by appropriate trades person.

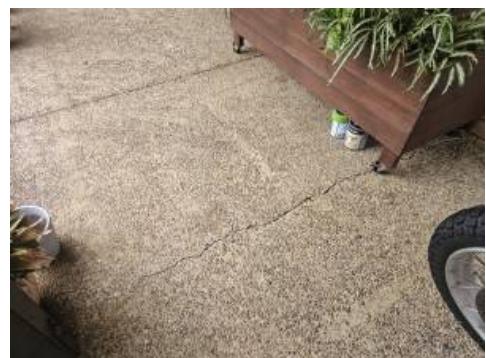
Front section.

Noticeable cracks are evident to concrete. Visible cracking is considered to be a larger than expected. Refer 4.7 Cracking of building elements note.

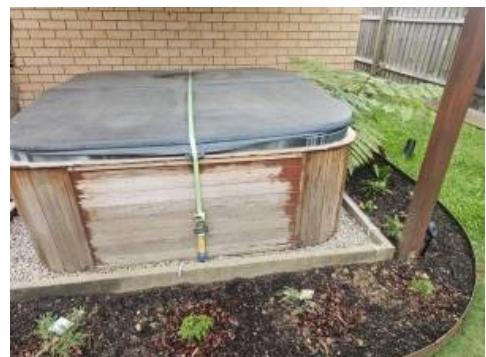
As defined in the limitations of this inspection all swimming pools /spa pools and associated filtration equipment is excluded from the inspection. An inspection should be sought from a specialist pool inspector to determine the condition of the pool and associated equipment. All pool fencing is required to be compliant for safety reasons, the pool fencing will need to be certified by a building certifier if the correct documentation cannot be obtained.

A pool is present but there is no pool fence present. A fence must be installed.

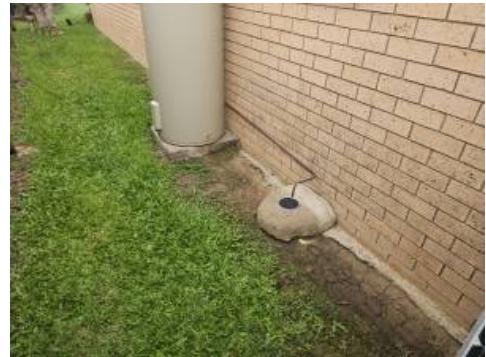
The drainage at the left side of the property appears inadequate. Drains should be installed at the left side to divert seepage and surface runoff water away from the house. The drains should be connected to the existing stormwater drainage system. A licensed plumber should be called to make further evaluation and repairs as needed.
