Building and Pest Report

Property Address:
1 Sylvania St, Kallangur

BUILDING & TIMBER PEST INSPECTION REPORT TO AS4349.1 2007 & AS4349.3 2010

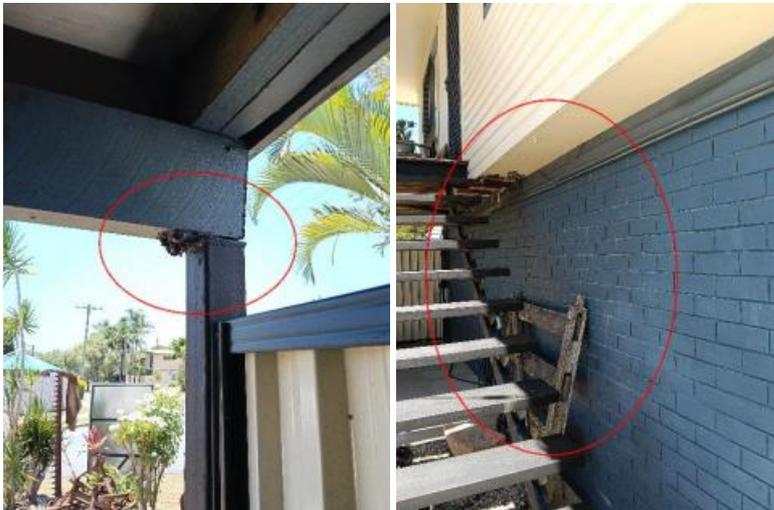
The front verandah requires amendments and repairs. The handrails and balustrades do not appear to comply with the current BCA Standards for height and spacing. Although this report does not generally comment on items of compliance, this issue may become a safety issue and therefore was included in this report. Recommend you further investigate this matter and upgrade if necessary. The metal is rusting and treatment is required.

A licensed builder should be called to make a further evaluation and repairs or rectification as needed.

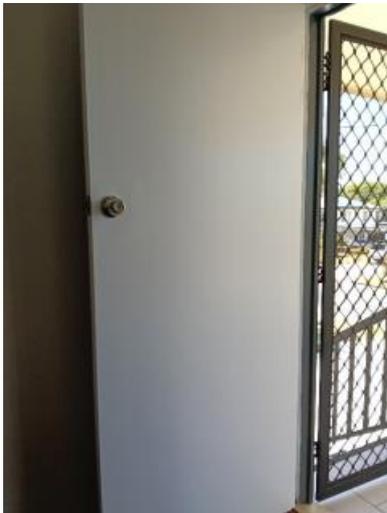
The front door is an internal door, amendments recommended.

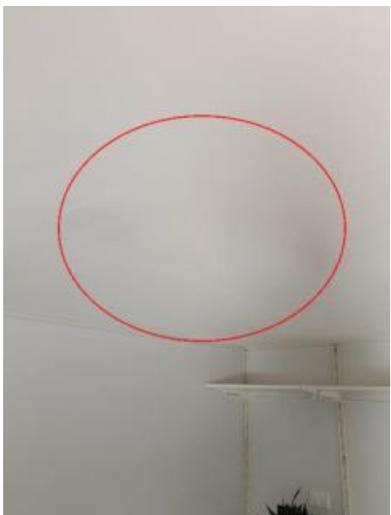
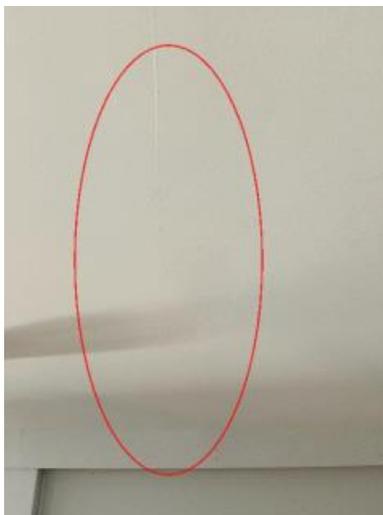
Minor settlement cracks were noted and these are typical of this type of material. Periodic maintenance may be required. Moderate undulations were noted to the ceiling lining. This is to be expected in a house of this age. Periodic maintenance will be required.

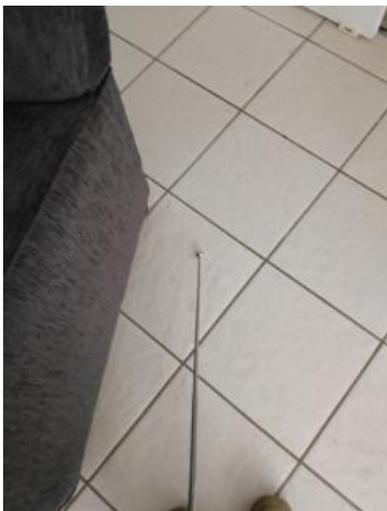
Some drummy tiles were noted. Drummy tiles may require relaying if they become loose over time.

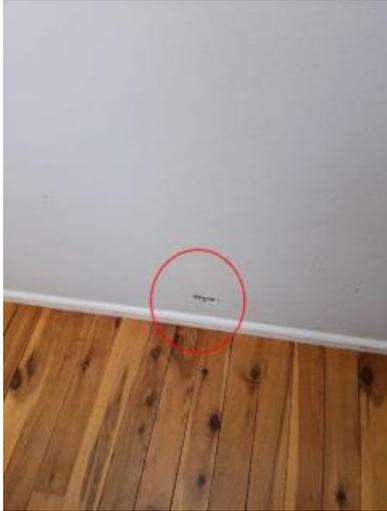
Impact damage was noted to some wall surfaces and repairs will be required.

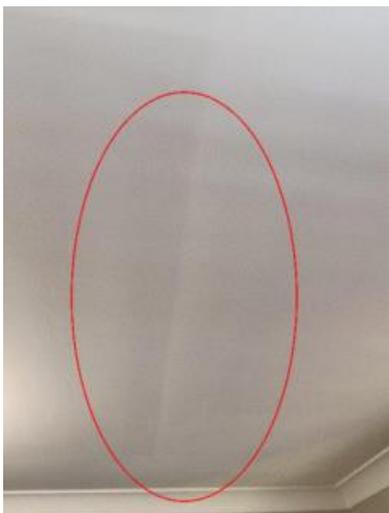
Minor undulations were noted to the ceiling lining. This is to be expected in a house of this age. Periodic maintenance may be required.

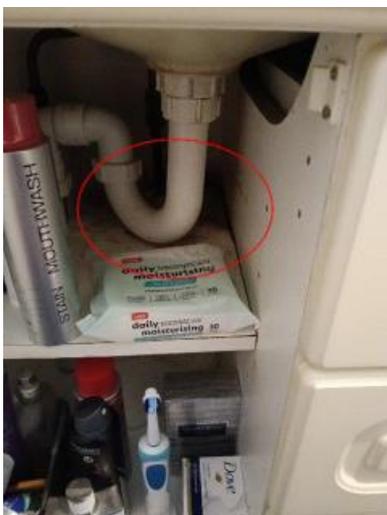
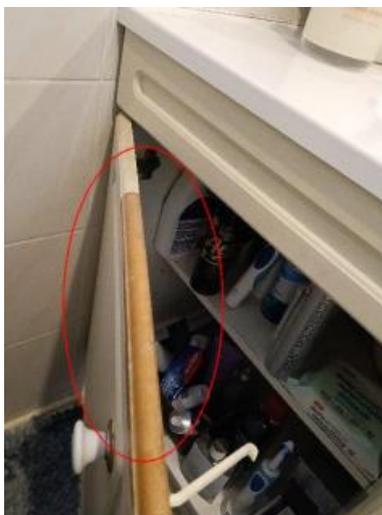
The basin & taps appear serviceable. However, a leak has appeared to have taken place at some stage.

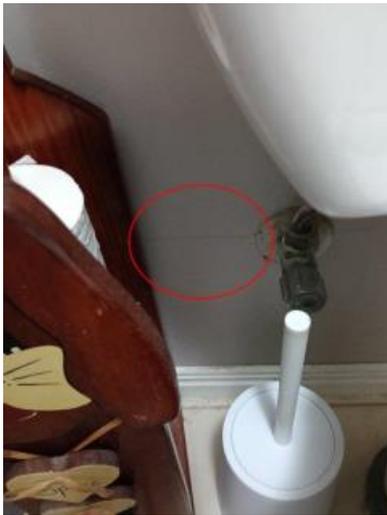
Moderate cracking is evident to wall linings. Periodic maintenance may be required.

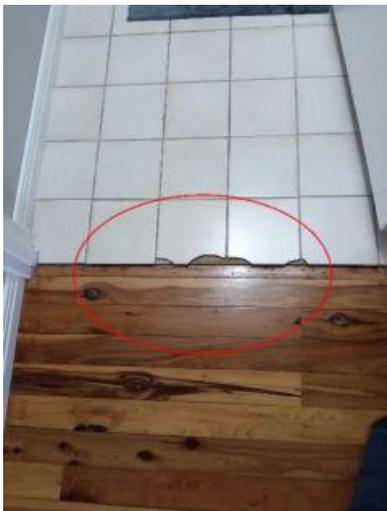
Some drummy, loose or cracked tiles were noted in this area. Maintenance will be required if this area continues to deteriorate.

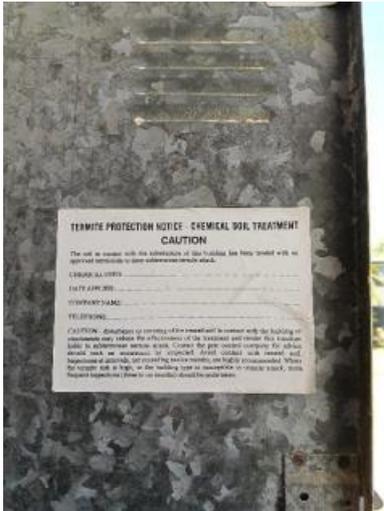
A treatment notice appears to be present however, we are unable to determine the type of treatment carried out as the notice was unreadable.
