# Building and Pest Report

Property Address:  
108 Burgundy Dr, Morayfield

# BAYSIDE BUILDING & PEST INSPECTIONS

# **BUILDING & TIMBER PEST INSPECTION REPORT TO AS4349.1 2007 & AS4349.3 2010**

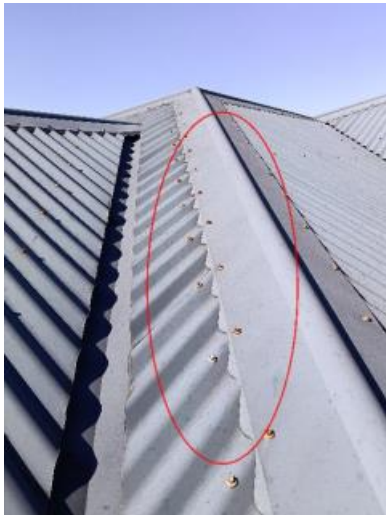
#### ROOFING SCREWS / NAILS

Some roofing screws show signs of rust and require replacement.

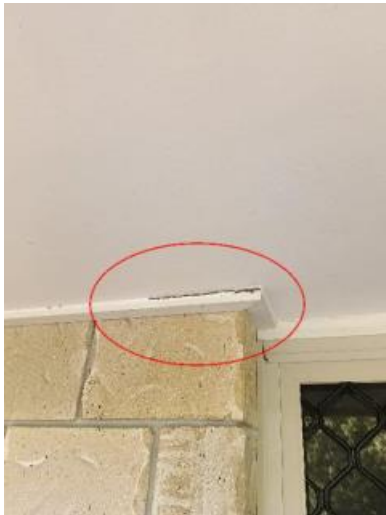
## EAVES / FASCIAS / BARGES

Minor gap noted.

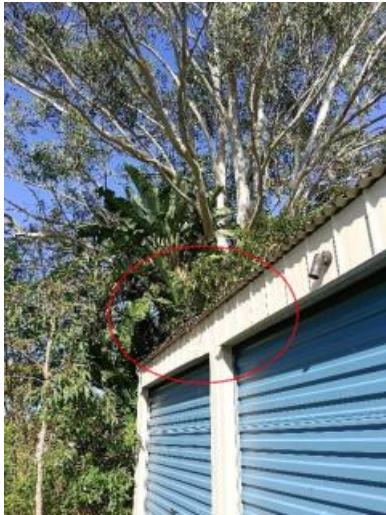
#### Condition:

Satisfactory, however, Gutter recommended.

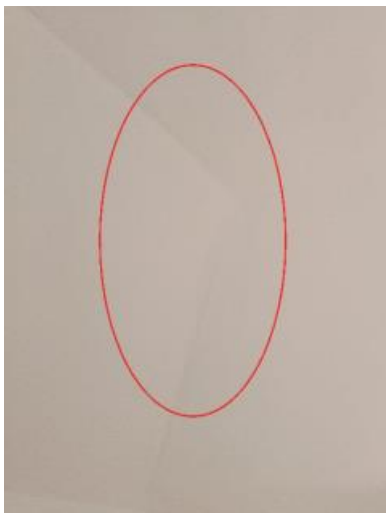
### Ceiling Condition:

Minor settlement cracks were noted and these are typical of this type of material. Periodic maintenance may be required.

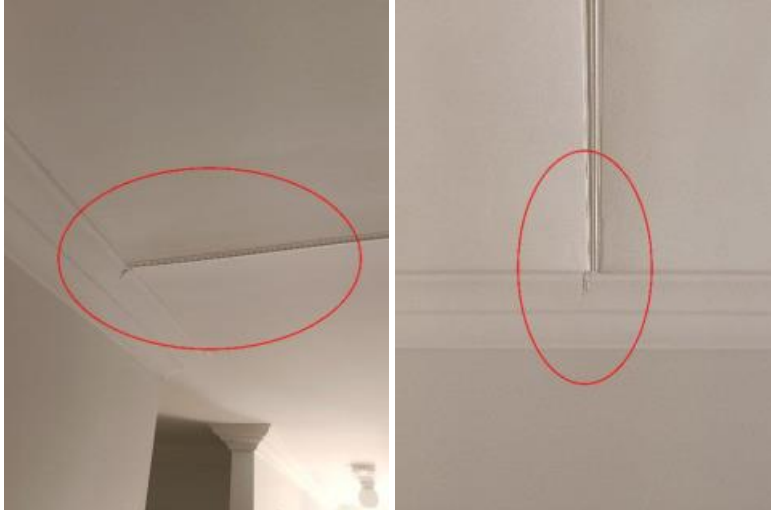
### Ceiling Condition:

Minor settlement cracks were noted and these are typical of this type of material. Periodic maintenance may be required.

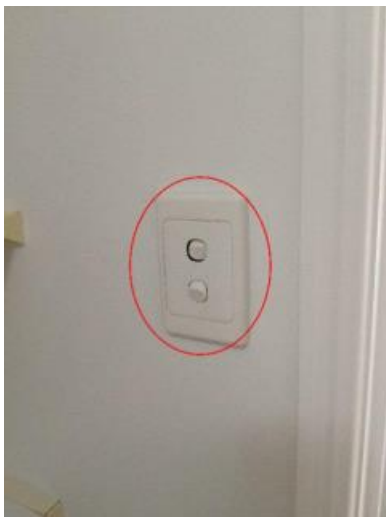
**Internal Walls Condition:**

Maintenance to light switch required.

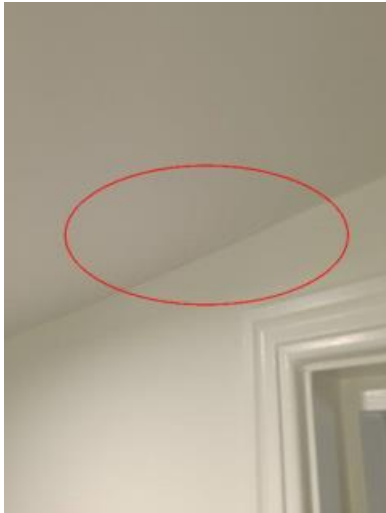
**Ceiling Condition:**

Slight bubbling noted to square set.

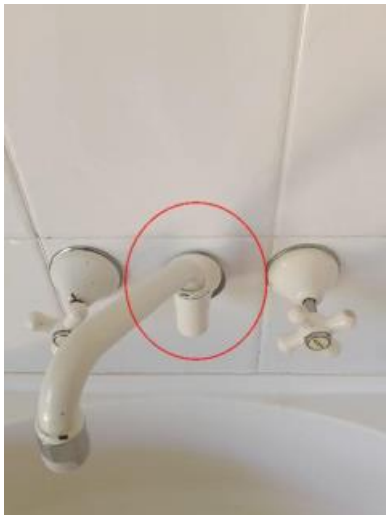
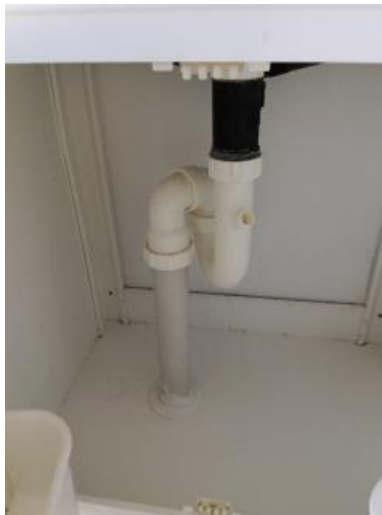
### Basin & Taps:

Minor adjustment to sink tap required.

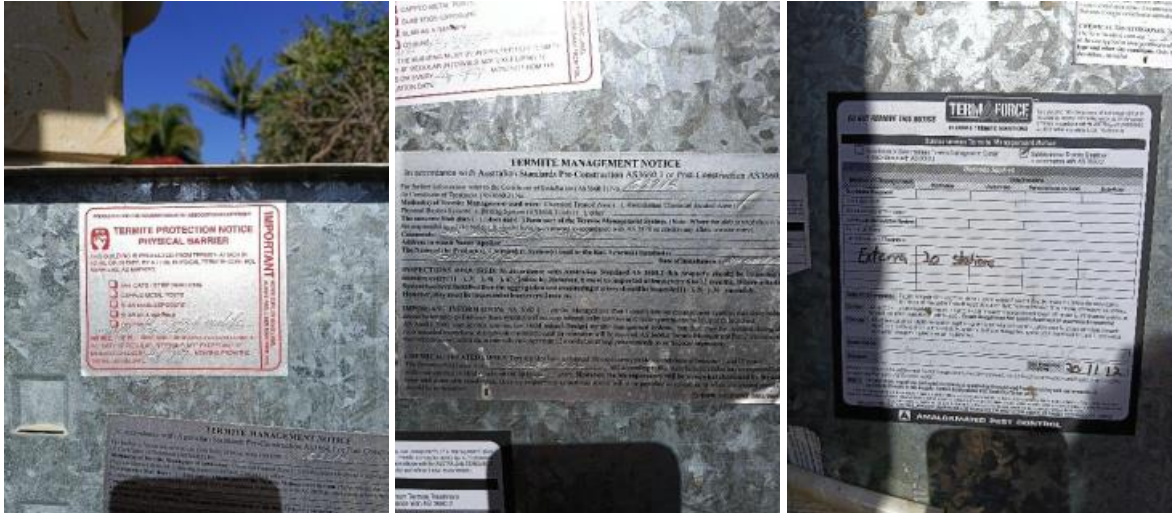
Yes, there is evidence of a previous termite treatment.

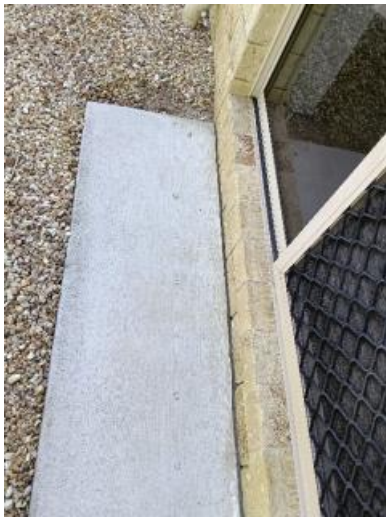
### Physical Evidence

Evidence of drill holes were noted to concrete areas. Drill holes are an indicator that the area or areas may have been treated by chemical injection in respect to termite control or protection. We strongly recommend any prospective purchaser attempt to verify this information and obtain copies of all relevant documentation.
