## TIMBER PEST INSPECTION REPORT

Inspection Date: 14/11/2025.

5 De Havilland Dr, Bray Park QLD 4500.

# VISUAL TIMBER PEST INSPECTION REPORT

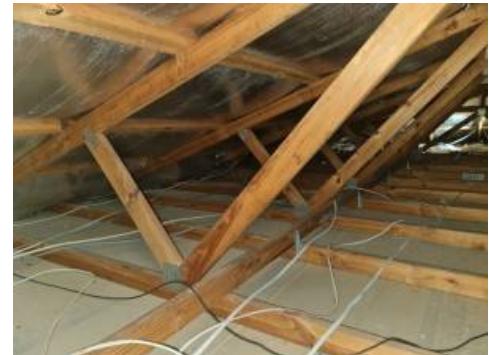
Inspection over the eaves was restricted due to the low pitch and construction allowing only a limited visual inspection.

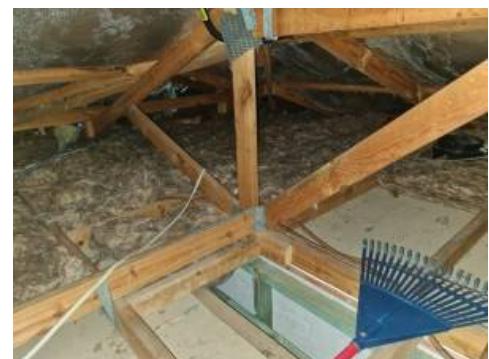
Partial Insulation is present in the roof cavity. This restricted inspection to some roofing timbers. Removal of insulation is not within the scope of a standard visual inspection report.

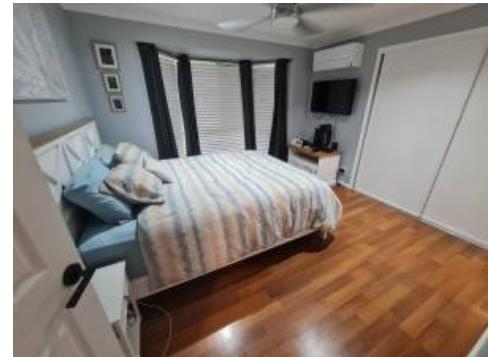
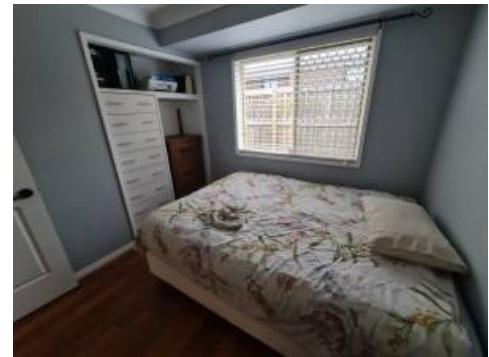
Floor coverings were present and restricted inspection to the upperside of floor structure. Furniture and window furnishings was present and restricted inspection within this area.

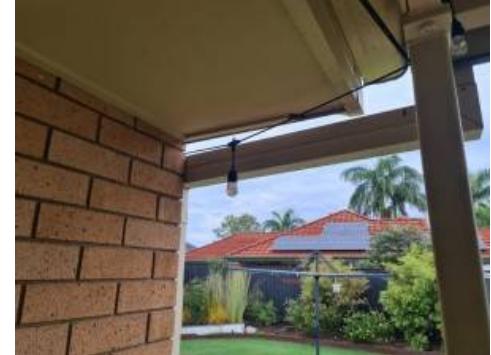
**Description** Yes - Wood decay damage was noted to the following timbers/areas.

**Affected external timbers** Eaves moulding timbers.

**Severity** Visible timber damage appears minor however, this opinion is based on a visual inspection. A special purpose report can offer a more detailed description. Refer to the definitions section of this report.

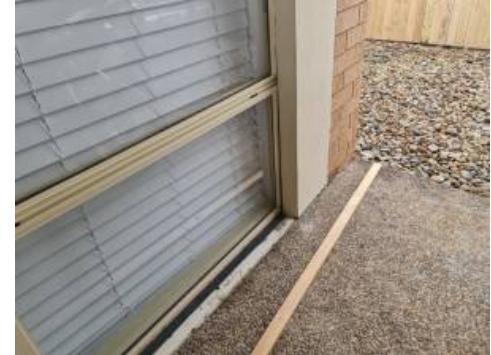
**Description** External cladding is in contact with the ground. This can allow concealed termite entry and we recommend modifications be made so that ground is not in contact with cladding.

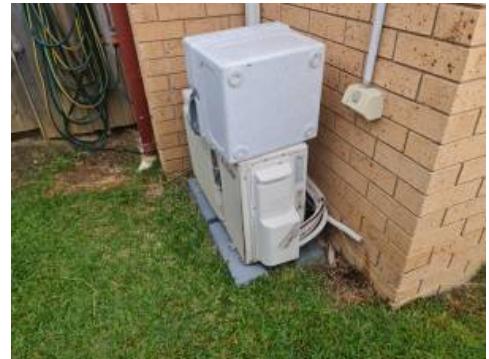
The potential presence of moisture in the form of, Air-conditioning unit(s) drain discharges moisture adjacent to the external walls. We recommend repair, or modification so that water is discharged over or into a drain, not causing damp conditions adjacent to building. These item(s) should be rectified as moist soil conditions are conducive to timber pest attack. Refer 9.0 The Presence of Excessive Moisture.

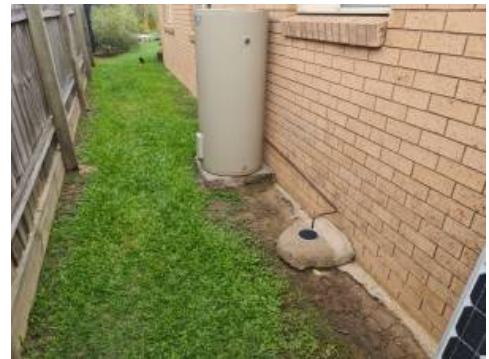
The potential presence of moisture in the form of, Evidence that water may pond to areas adjacent to the building structure. This may be due to a drainage problem or some other factor. We recommend repair, or modification so that water is discharged over or into a drain, not causing damp conditions adjacent to building. These item(s) should be rectified as moist soil conditions are conducive to timber pest attack. Refer 9.0 The Presence of Excessive Moisture.

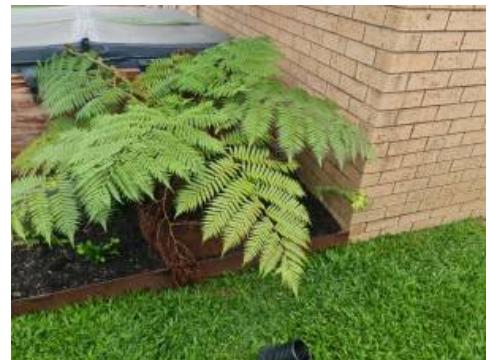
Garden beds have been built up against the external walls. Garden beds should be removed or modified, so the gardens are not in contact with the building to prevent concealed pest attack.

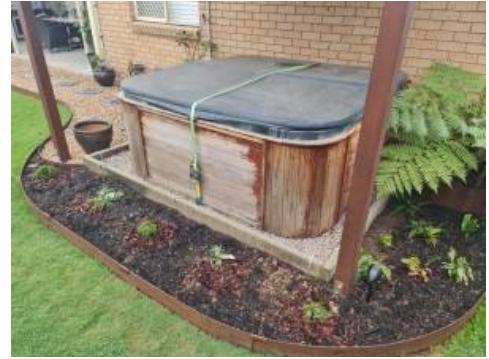
Some external timbers are in contact with the ground. These should be modified so that timber to ground contact does not occur. Noted items such as these can allow concealed termite attack. Pergola/ patio support timbers are either in contact with or in close proximity to ground.

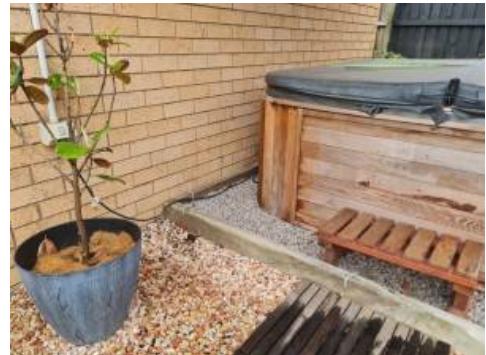
The landscape timbers in areas are in direct contact with the building structure. This situation can allow termites to enter the structure and we recommend that suitable modifications be made so that timbers are not in direct contact with the structure.

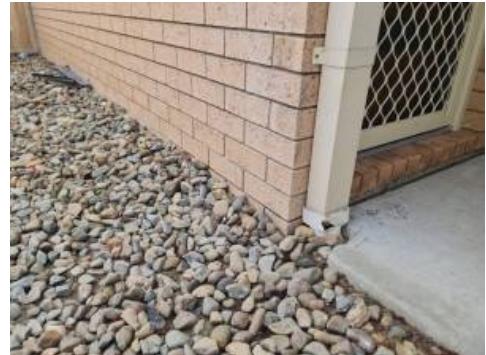
The potential presence of moisture in the form of, Some gutters and/or downpipes appear to discharge rainwater directly adjacent to the foundations of the structure. Due to damaged pipes or poor connections. We recommend repair, or modification so that water is discharged over or into a drain, not causing damp conditions adjacent to building. These item(s) should be rectified as moist soil conditions are conducive to timber pest attack. Refer 9.0 The Presence of Excessive Moisture.

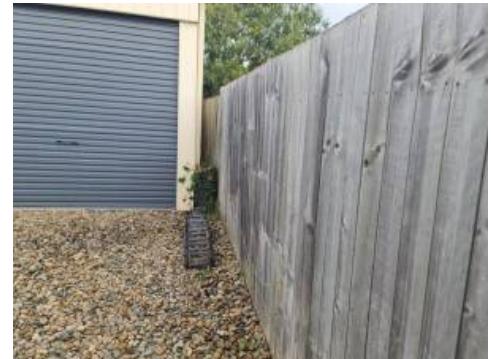
Yes - Wood decay damage was noted to the following timbers/areas.

Various fencing timbers:

Visible timber damage appears minor however, this opinion is based on a visual inspection. A special purpose report can offer a more detailed description. Refer to the definitions section of this report.

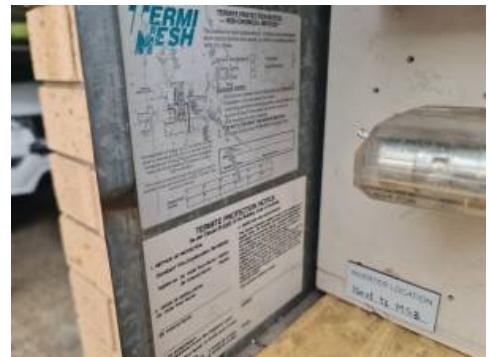
A notice indicates that the property has had a termite management system installed during construction in respect to protection against subterranean termite attack. The termite management system installed is where collars (Termimesh Barrier system) have been installed to penetrations of floor/concrete slab, and a chemical soil barrier to the perimeter of the building. Chemical Barriers have life spans up to 10 years. We recommend the client attempt to verify this information and obtain copies of all relevant documentation.

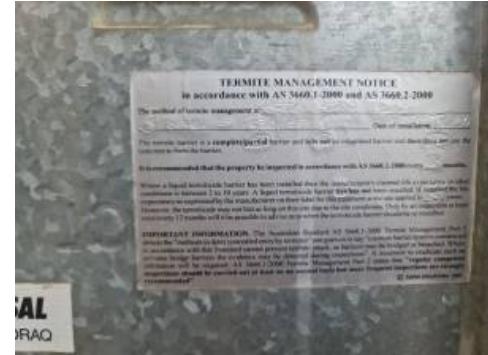
A notice is present indicating that a reticulation system is present. Termite reticulation systems installed during or after construction to assist in the protection of the structure against subterranean termite attack. Chemical Barriers have life spans up to 10 years. We recommend the client attempt to verify these findings and obtain all relevant documentation in relation to this system.
