# Building and Pest Report

Property Address:  
14 Chestnut St, Caboolture South

# BAYSIDE BUILDING & PEST INSPECTIONS

# **BUILDING & TIMBER PEST INSPECTION REPORT TO AS4349.1 2007 & AS4349.3 2010**

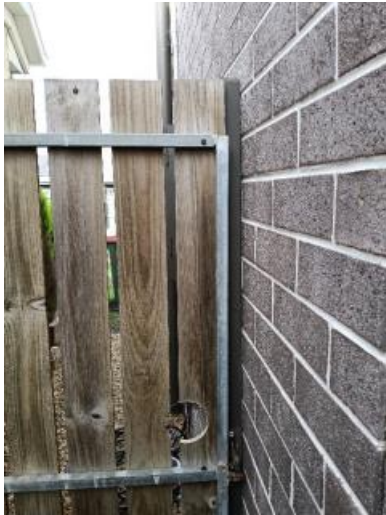
#### FENCING

Some gates require adjustment / refixing

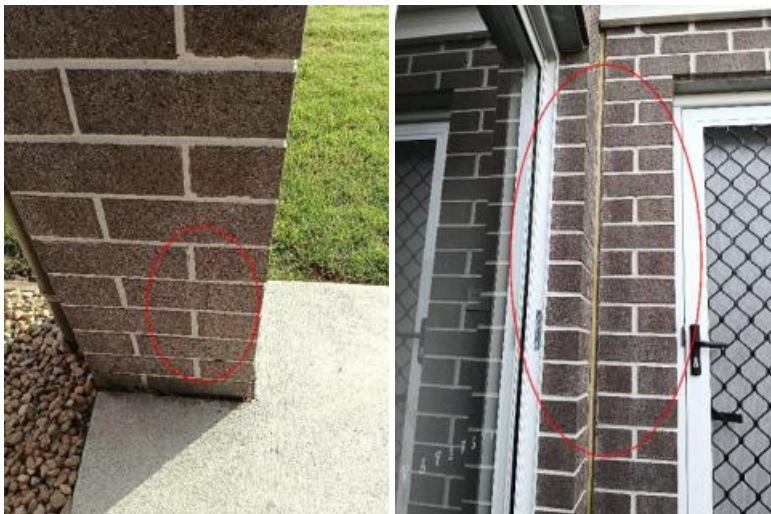
#### Cracking (to AS 2870)

Cracks to brickwork at Cracks to the brickwork indicate that some settlement or subsidence / soil heave has taken place. We strongly recommend that the evident cracks be monitored and that appropriate action be taken if they increase in size.

Cracks to brickwork at Cracks to the brickwork indicate that some settlement or subsidence / soil heave has taken place. We recommend that this settlement / subsidence be referred to an appropriately qualified Structural / Geotechnical Engineer for investigation. If you decide not to employ the services of an engineer, we recommend that the evident cracks be monitored and appropriate action be taken if they increase in size.

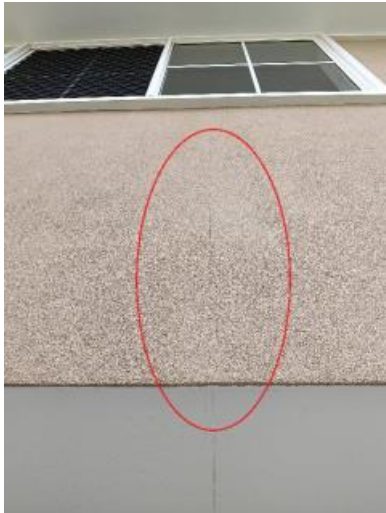
### EXTERNAL CLADDING

Some fibrous cement sheet joins require resealing with a suitable sealant.

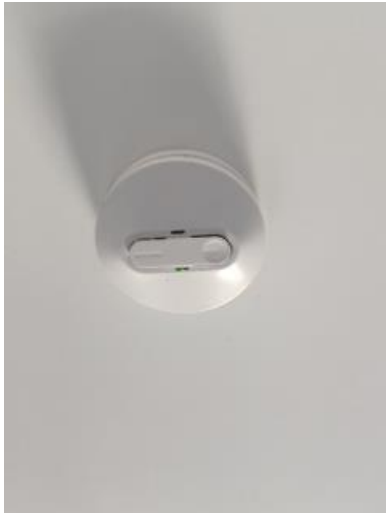
## Smoke Detectors / Alarms

AS 3786 - Advises that Smoke Detectors / Alarms are required for all buildings where people sleep. It is

recommended that an electrician be consulted to advise on those installed or install new detectors / alarms.

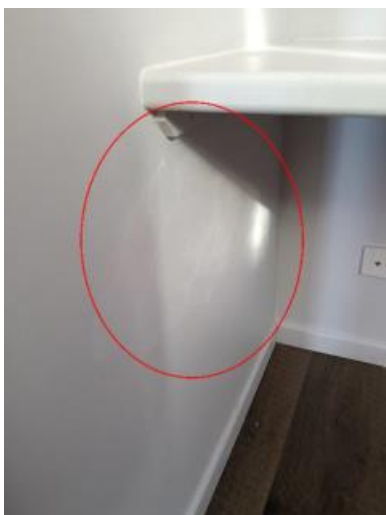
### Internal Walls Condition:

Defective or poor surfaces were noted to wall materials and will need repair prior to next painting.

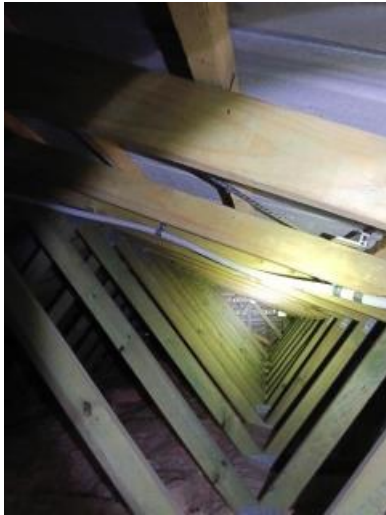
### Restrictions to Inspection

Insulation is present in the roof cavity. This restricted inspection to some roofing members. Removal of insulation is not within the scope of a standard building inspection report.

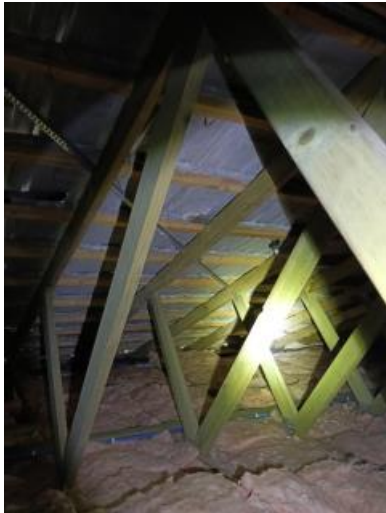
### Roof Space & Framing - Condition

Satisfactory Some roof framing timbers show signs of deflection. Monitoring or repair highly recommended.

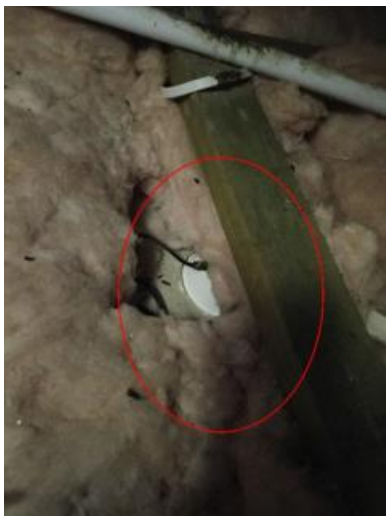
### Insulation

The loose insulation in the roof void is close to / in contact with the back of the recessed light fixtures. Insulation must be kept clear of the backs of recessed lights by at least 200mm or a cowl (available from all electrical supply stores) should be placed around such lights to prevent insulation from contacting lights. Insulation covering recessed light fixtures is a fire hazard.

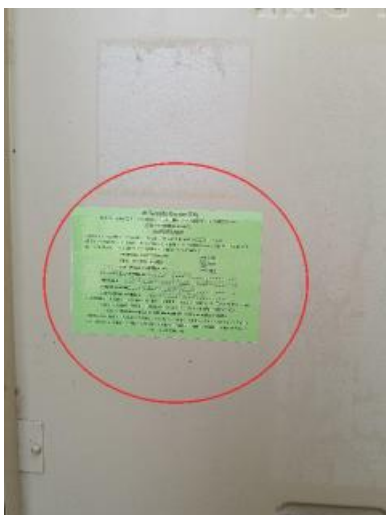
#### **Description:**

Yes, there is evidence of a previous termite treatment.
