Pre sale building and pest report.

All Building Inspections Pty Ltd

1/4 Cyan Court, Morayfield, QLD

Report/Agreement # 160226084809139
 Inspection Date: 18 Feb 2026
 Inspection Time: 10:00 am

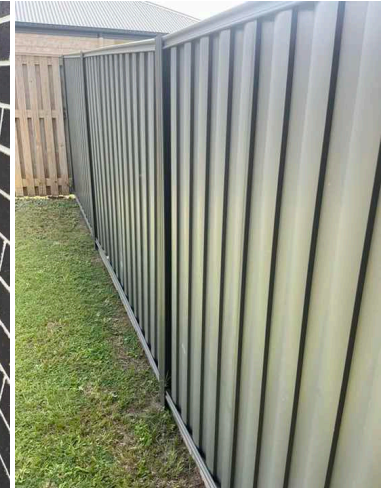
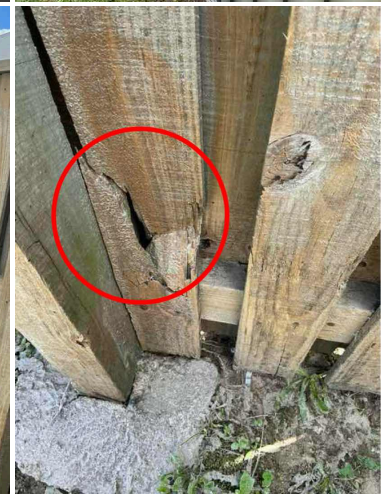
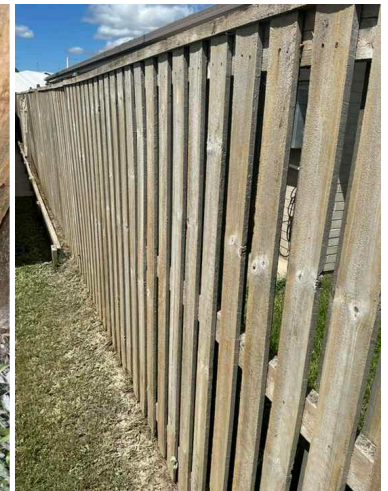
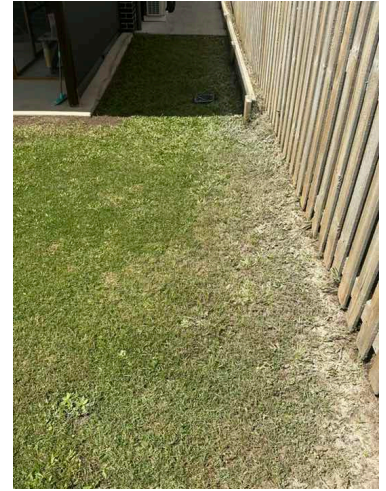
#1. Damage was noted to the timber fence slat. Contact a fencing contractor for repairs.

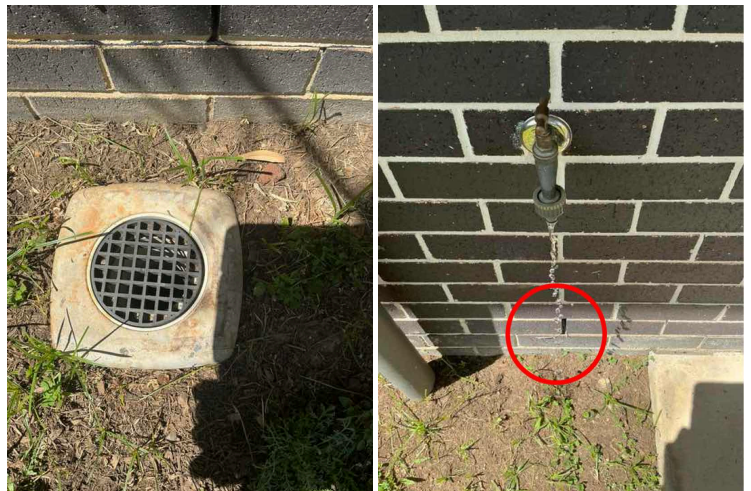
No evidence of slow or blocked drains at the time of inspections.
Recommend installing a drainage point under the tap to assist with drainage.

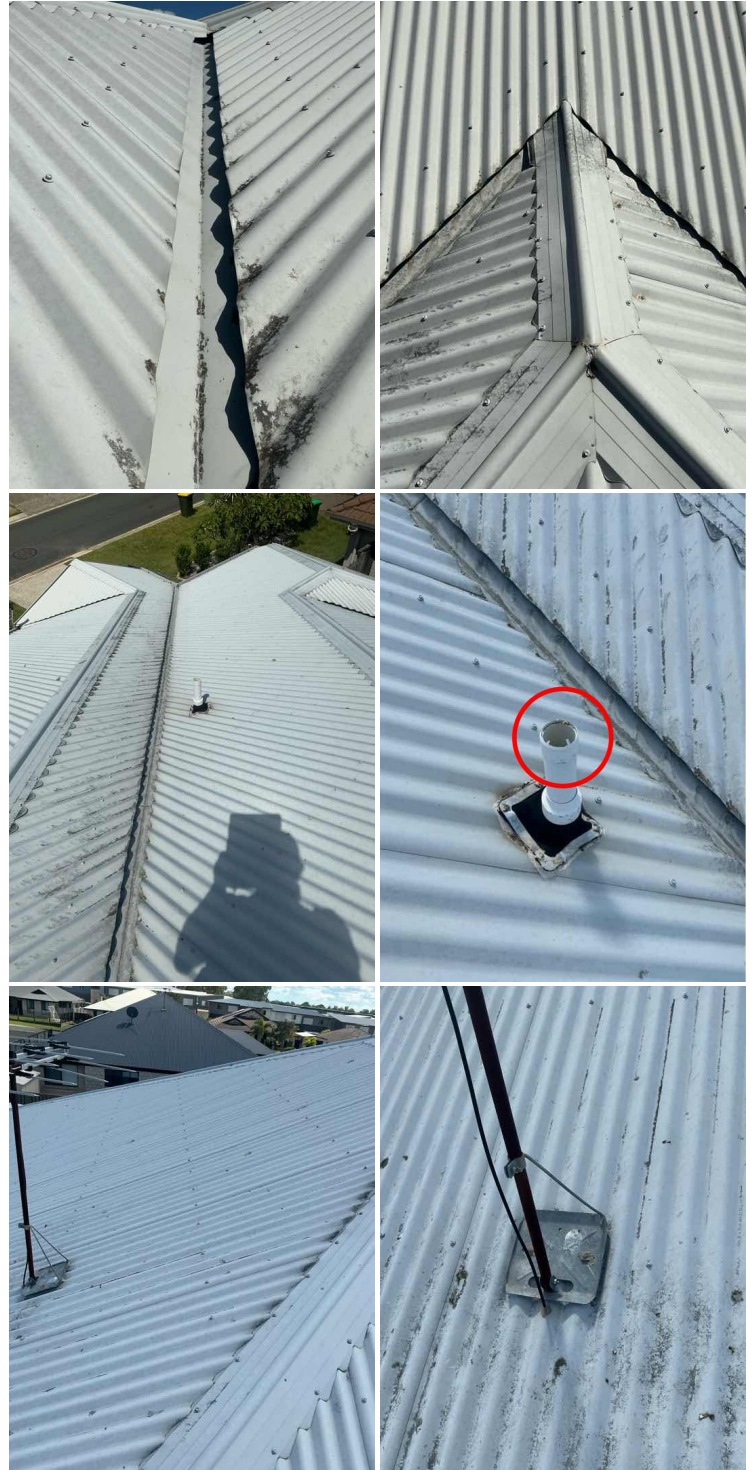
#2. On inspection, defects were noted that may require further assessment and recommendations by licensed roofer.

1. Vent pipe cap to be replaced.

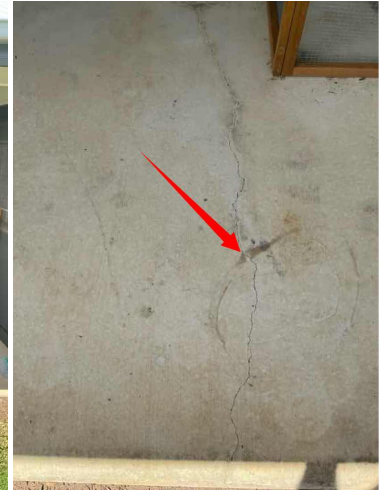
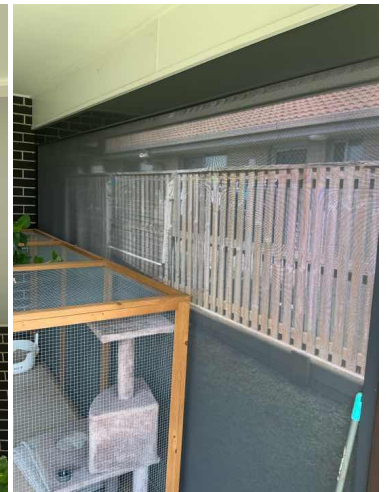
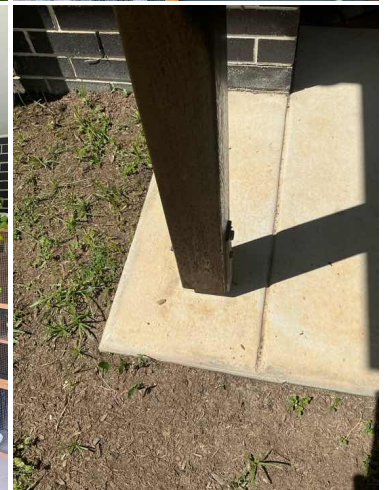
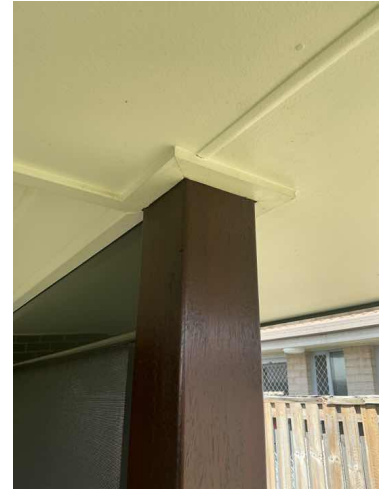
Typical concrete cracks evident. These are typical for the age.

Please note: Whilst these cracks appeared to be minor and typical at the time of inspection, we recommend you monitor these cracks and if worsening occurs contact a qualified concreter for repairs.

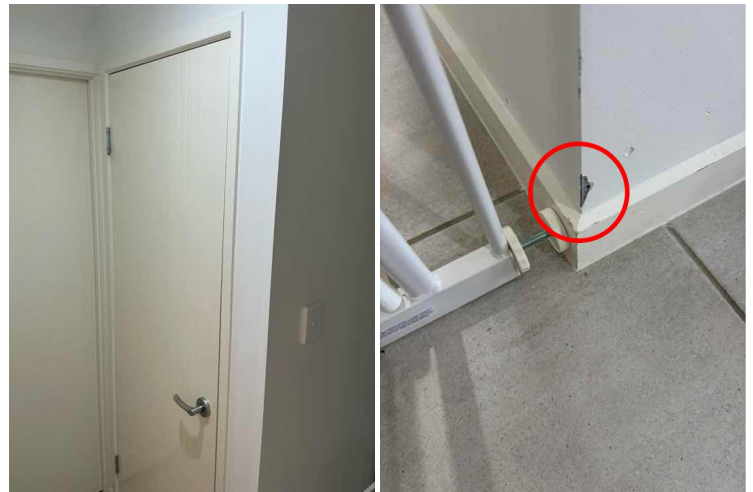
#3. Impact damage noted. Contact a qualified painter for repairs.

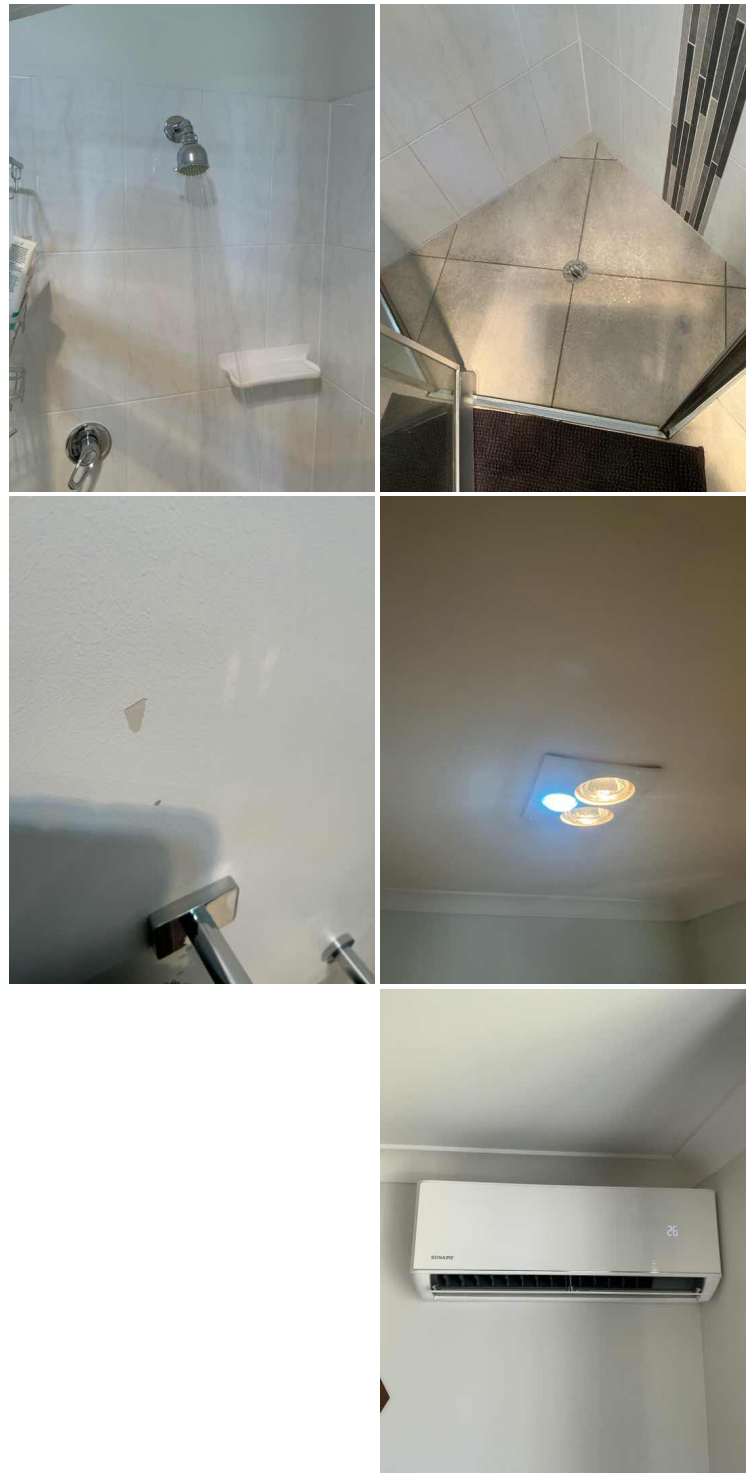
#4. On inspection, defects were present that will require further assessing and recommendations by licensed and qualified trades persons, please read below for details.

1. Cistern flush button to be repaired.

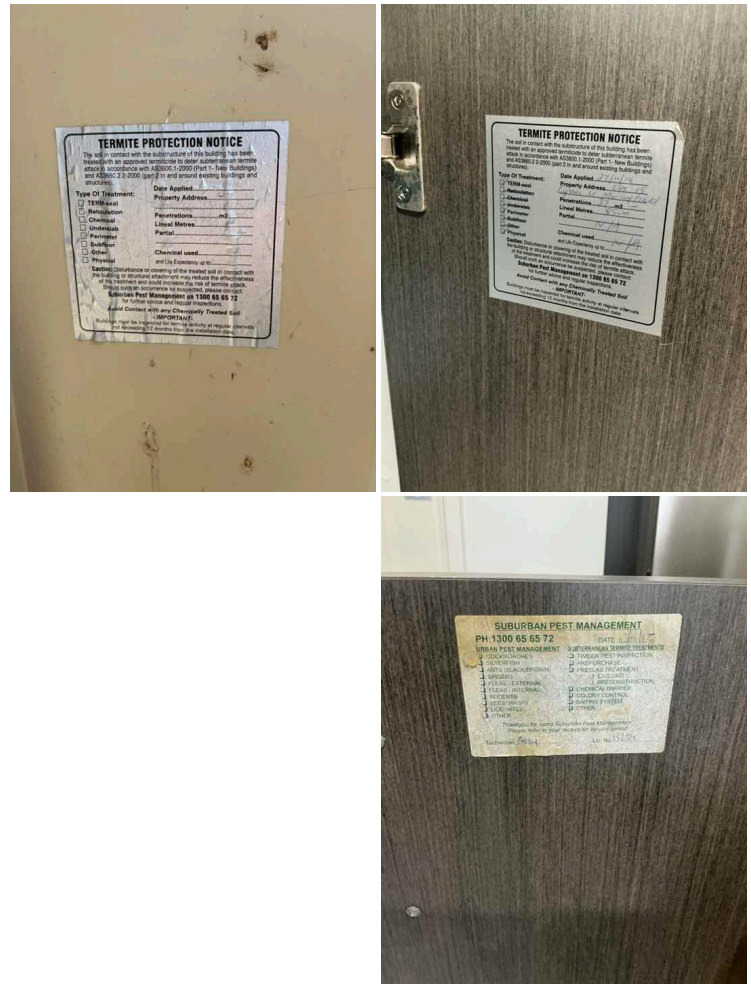
Yes, a durable notice was found in the meter-box during the inspection.
