## BUILDING INSPECTION REPORT

Complies with Australian Standard AS 4349.1-2007  
Inspection of Buildings Part 1: Pre-Purchase Inspections - Residential Buildings - Appendix "C"

Inspection Date: 06/11/2025.

2 Keel Ln, Burpengary QLD 4505.

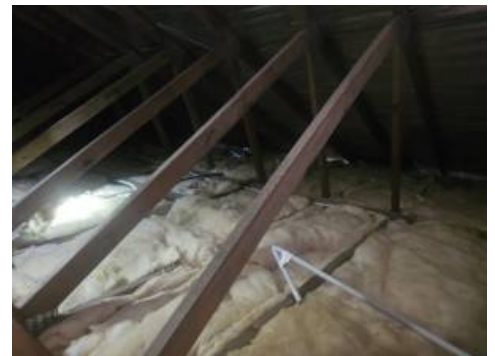
Inspection over the eaves was restricted due to the low pitch and construction allowing only a limited visual inspection. Insulation is present in the roof cavity. This restricted inspection to some of the buildings framework. Removal of insulation is not within the scope of a standard visual inspection report. Sarking membrane covered roof battens restricting inspection.

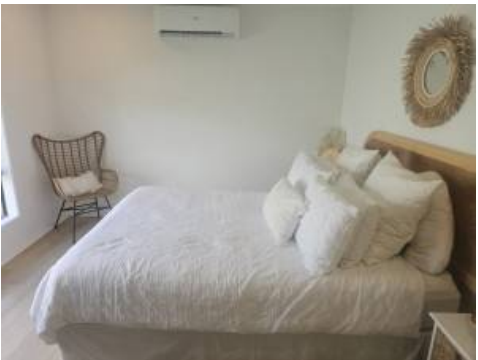
Floor coverings were present and restricted inspection to the upperside of floor structure. Furniture and window furnishings was present and restricted inspection within this area.

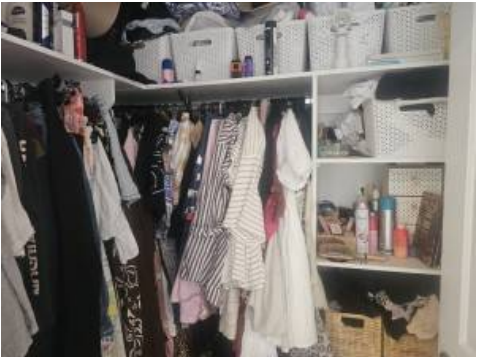
Some stored goods were present to the area(s) listed below which restricted the inspection. Stored items should be removed to allow a more complete inspection to be carried out. Inspection within various cupboards was restricted by stored items.

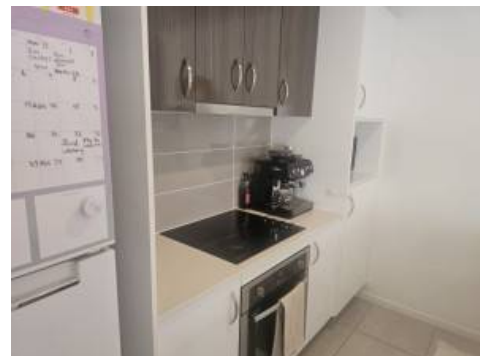
The condition of the fixtures is good. General wear to cabinets due to age. We have carried out a function test to the following item(s). Note: The testing was to validate whether the items tested are in a working order or non-working order. No specific tests other than running / turning on was carried out. No determination has been made as to the suitability or adequacy of the tested items. Refer Report Definition section within.

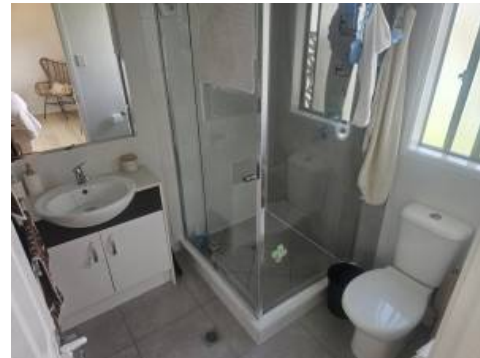
Shower appears to be in a serviceable condition. Gaps noted to internal corners of shower base.

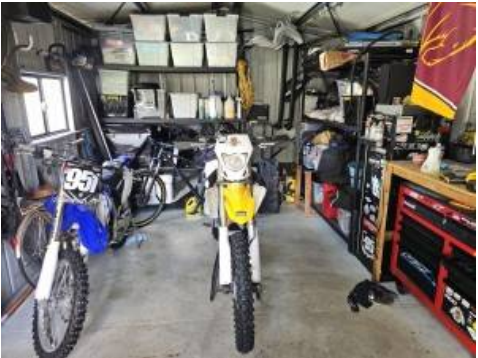
Inspection within some areas was restricted by stored items.

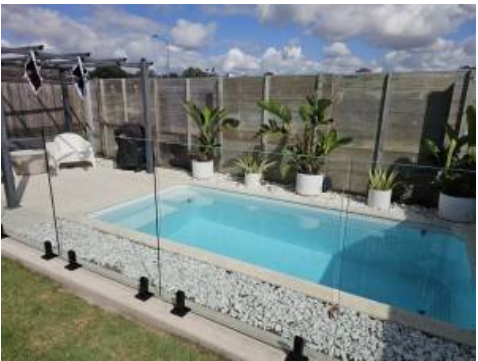
As defined in the limitations of this inspection all swimming pools /spa pools and associated filtration equipment is excluded from the inspection.  
An inspection should be sort from by a specialist pool inspector to determine the condition of the pool and associated equipment. All pool fencing is required to be compliant for safety reasons, the pool fencing will need to be certified by a building certifier if the correct documentation cannot be obtained.

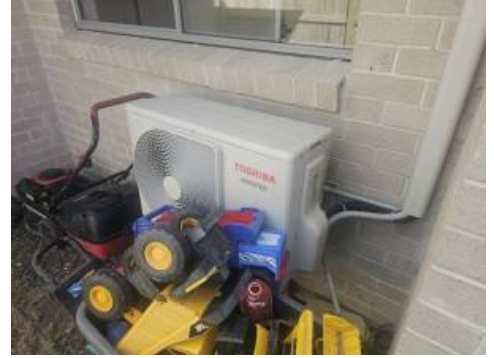
Air-conditioning is installed in the premises. The air conditioning unit(s) appears to be in working condition. No specific tests other than running / turning on was carried out. No determination has been made as to the suitability or adequacy of the air conditioning system. The air conditioning overflow should be redirected to a drain, see Timber Pest Report.

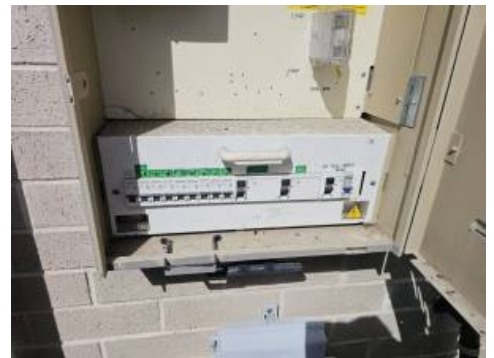
Safety switches were found to be installed. Note: only a licensed electrician can verify if safety switch is connected to appropriate circuits.

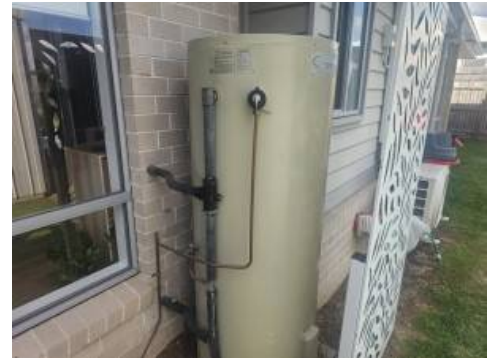
Mains electric hot water system:  
Located externally: The hot water system appears to be in working condition. No specific tests other than running the hot water from a tap was carried out. No determination has been made as to the suitability or adequacy of the hot water system in relation to capacity or otherwise.
