## TIMBER PEST INSPECTION REPORT

Complies with Australian Standard AS 4349.3-2010

Inspection Date: 06/11/2025.

2 Keel Ln, Burpengary QLD 4505.

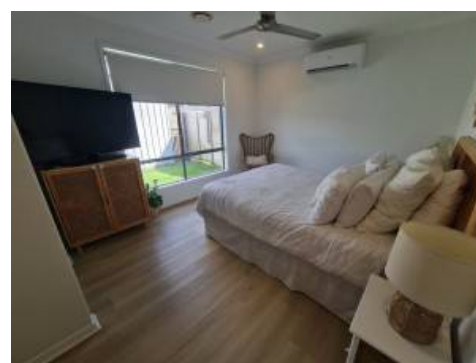
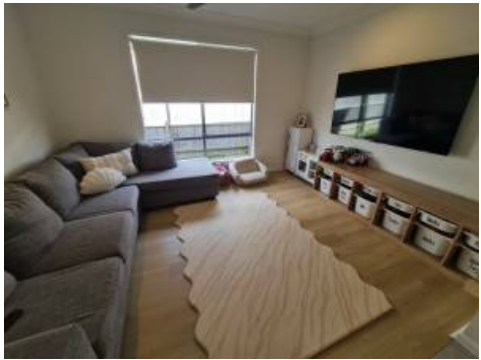
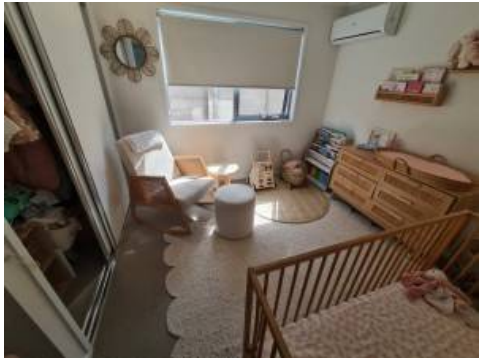
**Restrictions:** Floor coverings were present and restricted inspection to the upperside of floor structure. Furniture and window furnishings were present and restricted inspection within this area.

Active termites or other timber damaging pests may be present and not detected in areas where inspection was limited, obstructed or access was not gained. We strongly recommend that access be gained to all inaccessible areas. See Section - Reasonable Access.

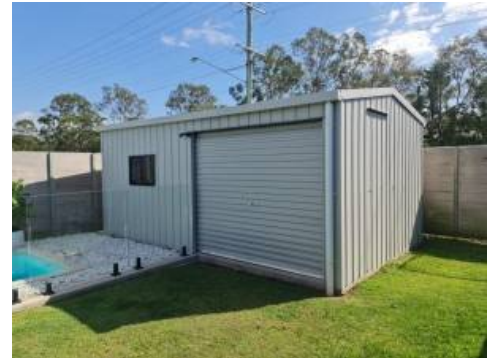
#### List of outbuildings

A shed.
