# Pre sale building and pest report.

**610 Caboolture River Rd, Upper Caboolture, QUEENSLAND , 4510**

Report/Agreement #              030826052421261

Inspection Date:                  04 Aug 2026

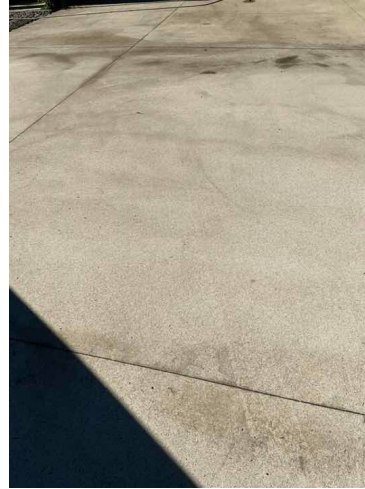
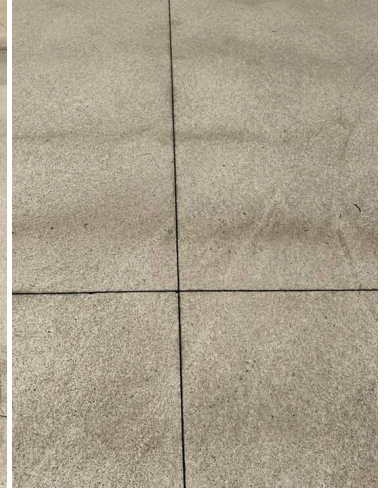
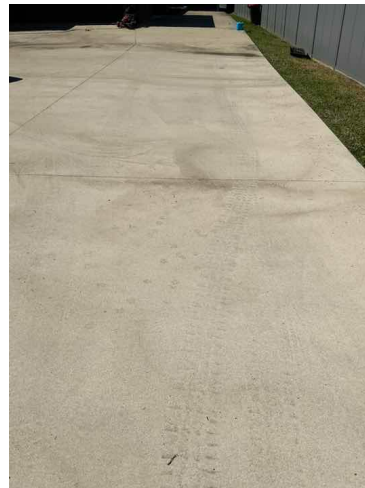
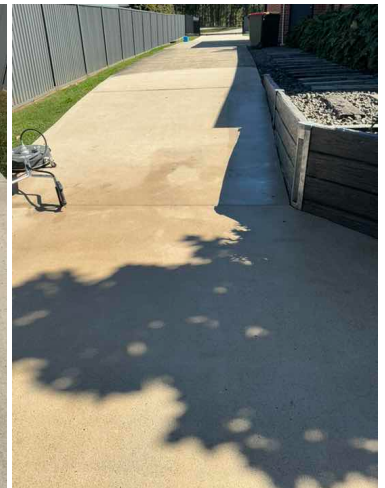
#### Driveway Condition

On visual inspection, the general condition of the driveway is serviceable. Construction joints are visible and in good order.

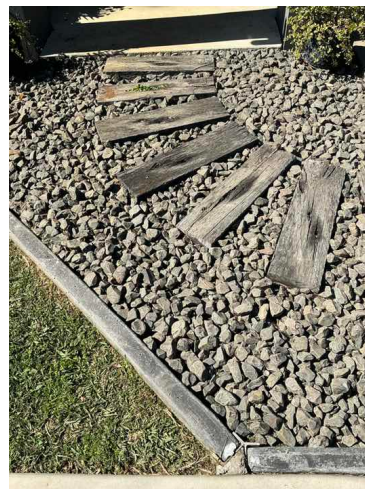
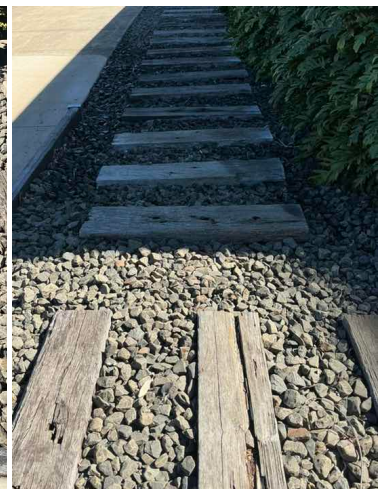
#### Pathways Condition

The paths around the home are in a serviceable condition for the age of this building with no major defects visible.

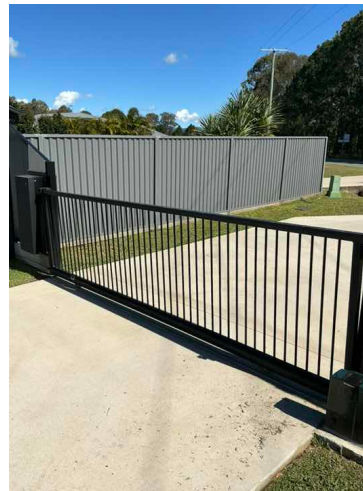
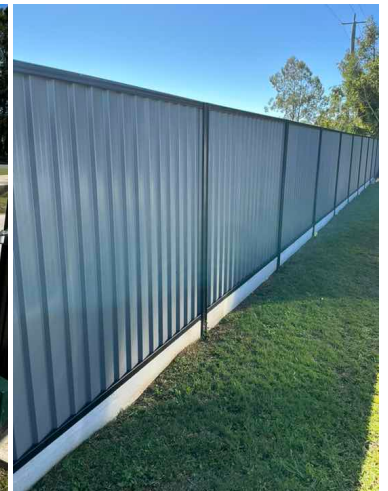
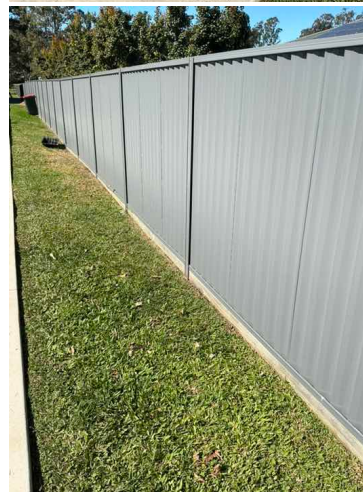
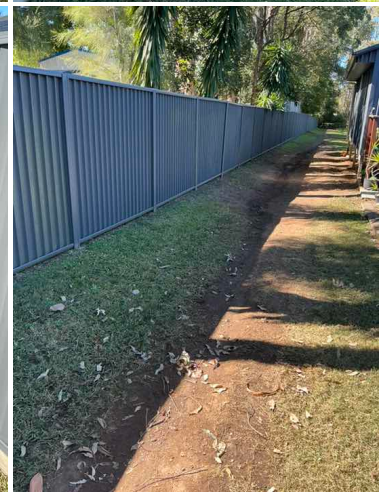
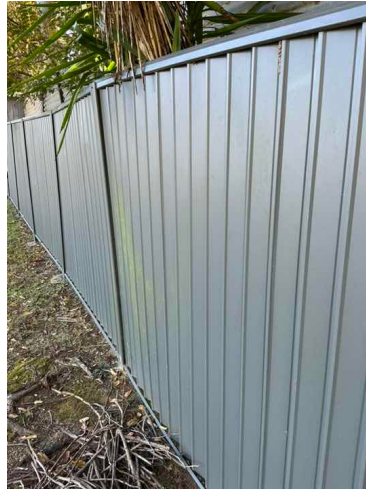
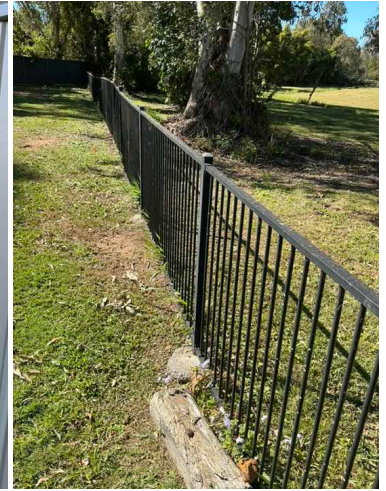
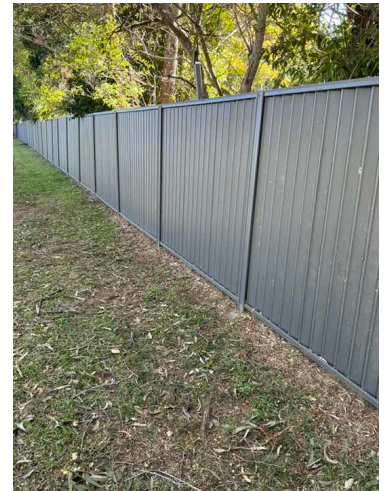
### **Overall Condition**

Of the visible areas, the general condition of the fences and gates is serviceable for the age of building.

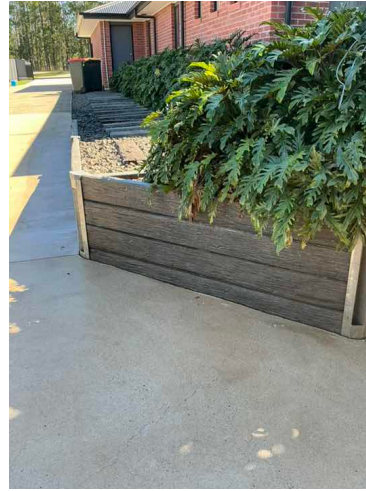
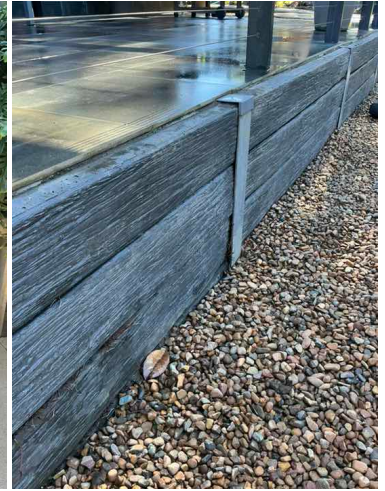
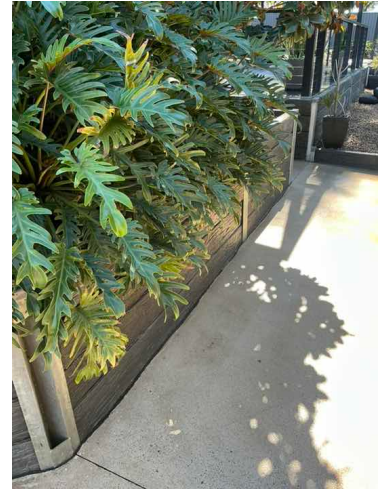
### **Overall Condition**

Of the visible areas, the general condition is serviceable or in reasonable condition for age of dwelling.

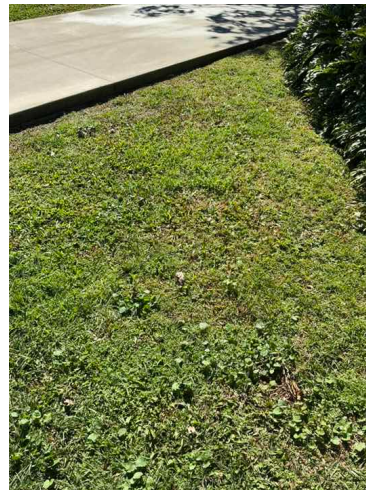
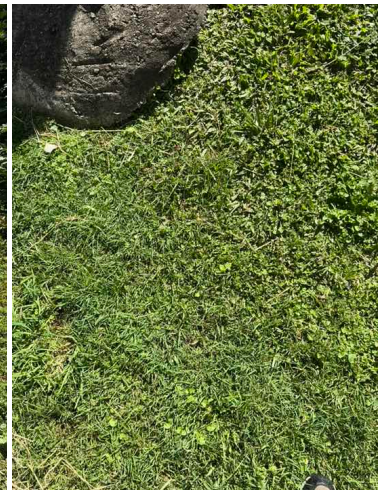
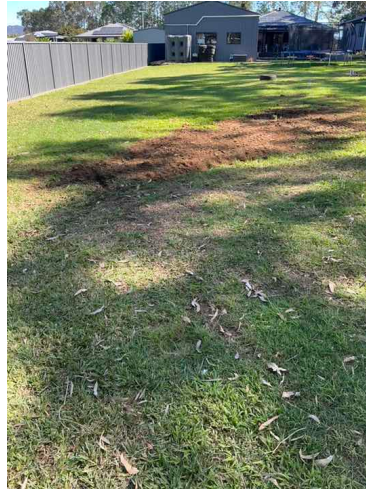
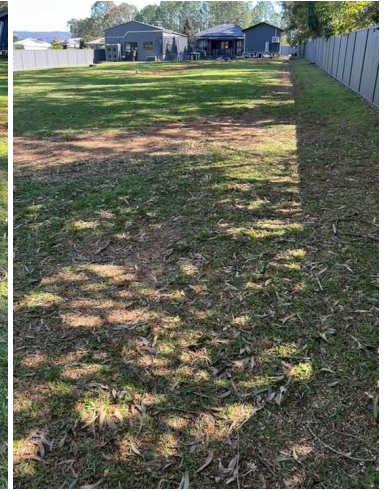
### **Drainage Findings**

There was no visible evidence of excess ponding or fall towards the property walls at the time of the inspection. Regardless, it is difficult to ascertain in dry conditions and it is therefore recommended that you assess same after a rainfall period to be able to sufficiently ascertain if any problems exist in this regard. If water is ponding around the perimeter walls and paths or appears to be flowing into the footings/foundations you should have the area assessed by a qualified plumber or landscaper.

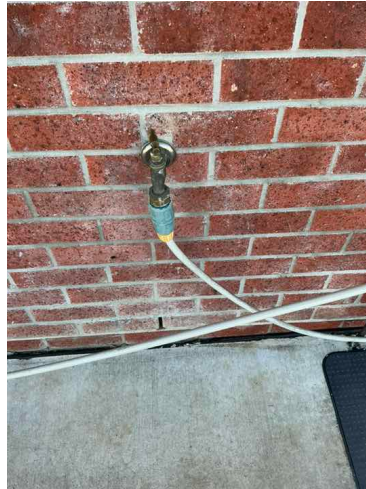
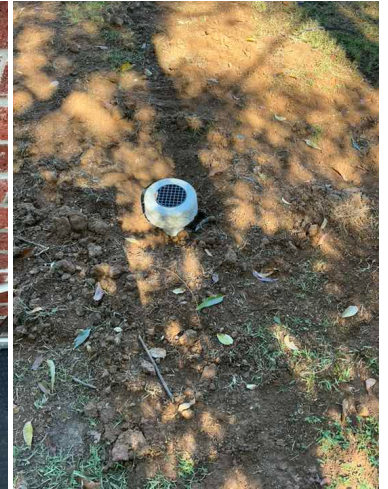
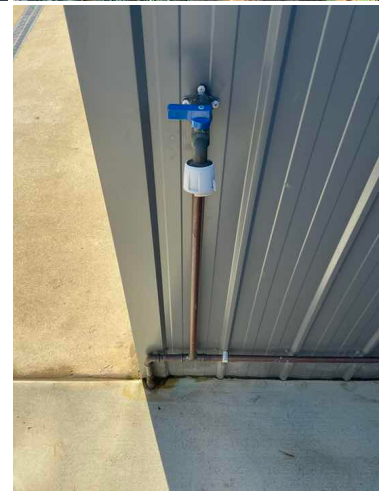
## Drains

No evidence of slow or blocked drains at the time of inspections.

Recommend installing a drainage point under the tap to assist with drainage.

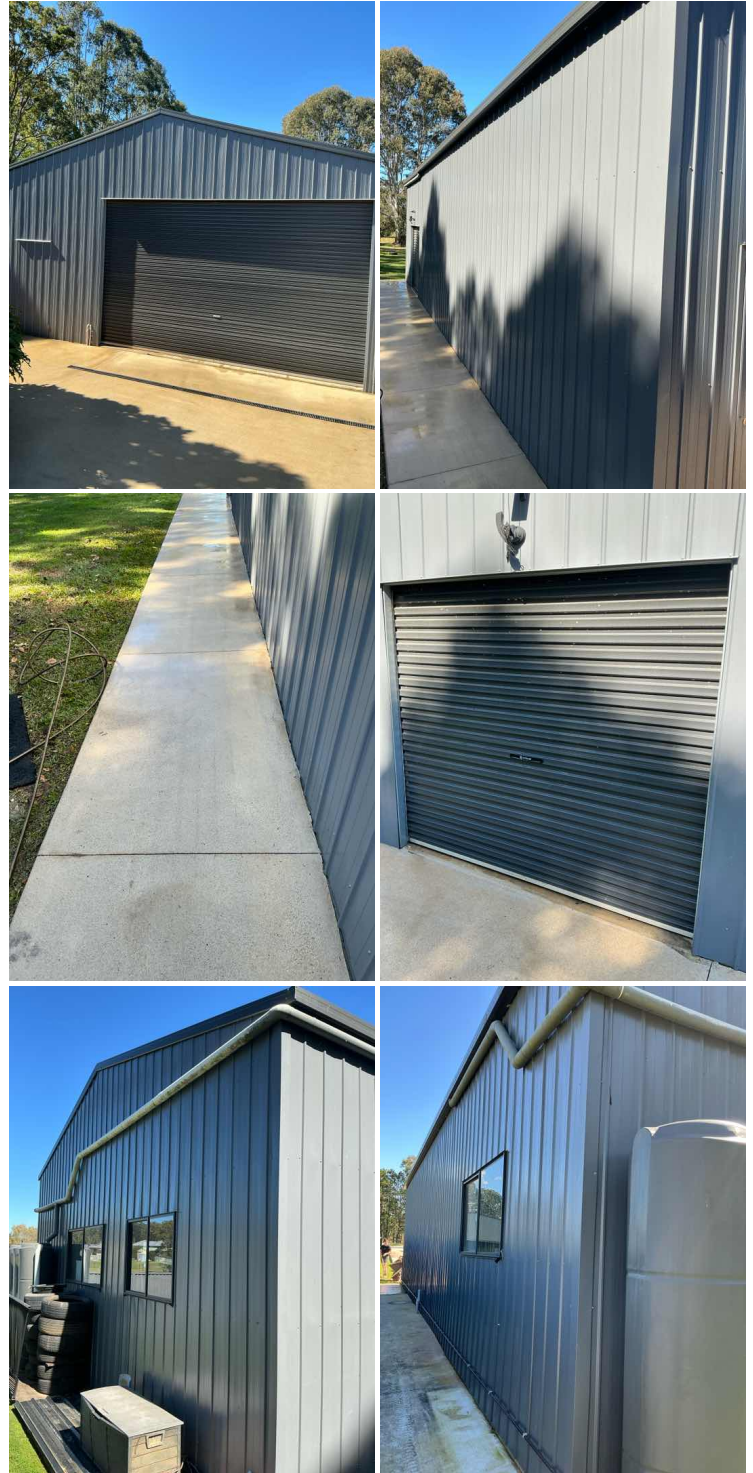
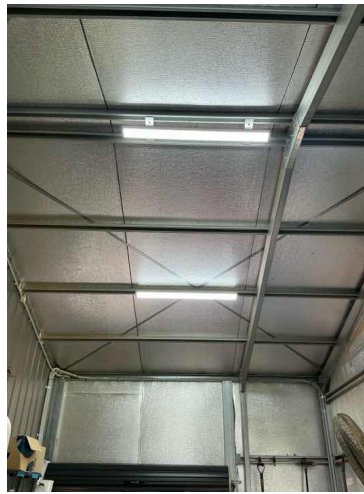
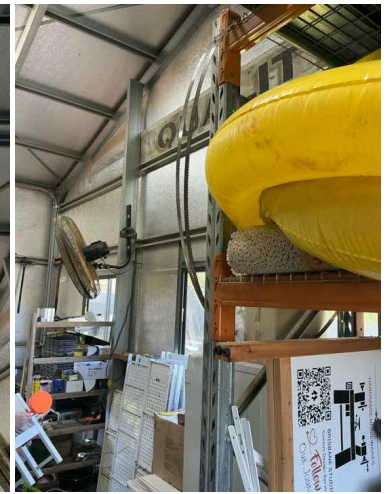
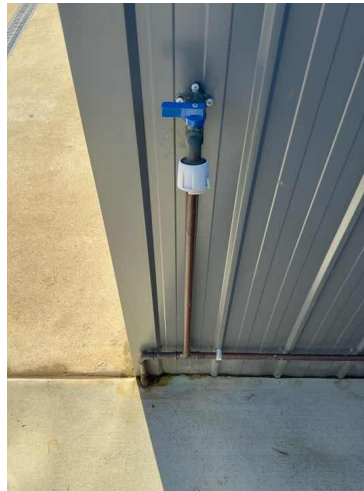
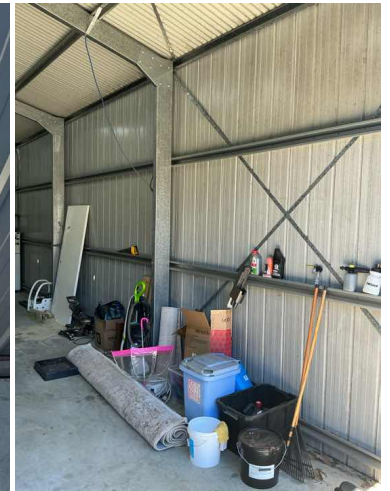
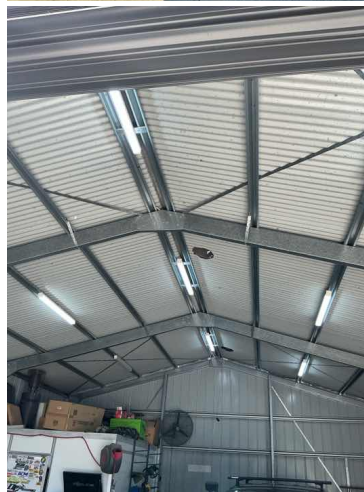
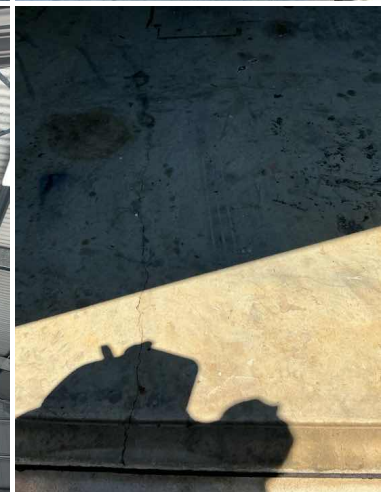
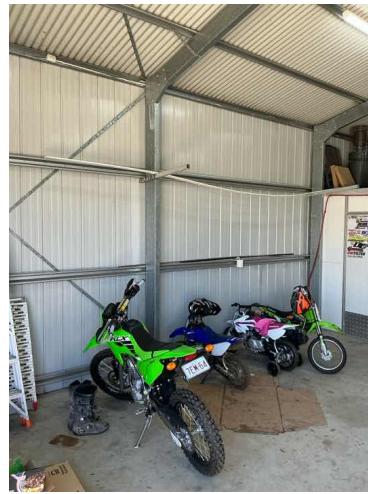
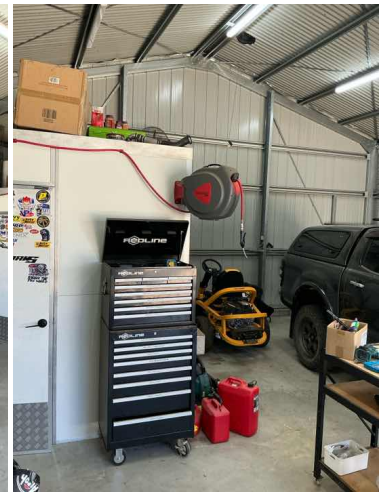
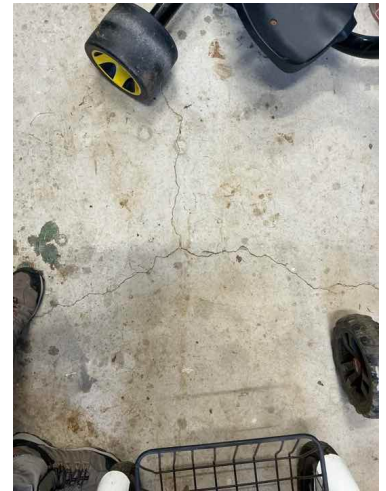
### Shed Condition

The shed appears to be in fair usable condition.

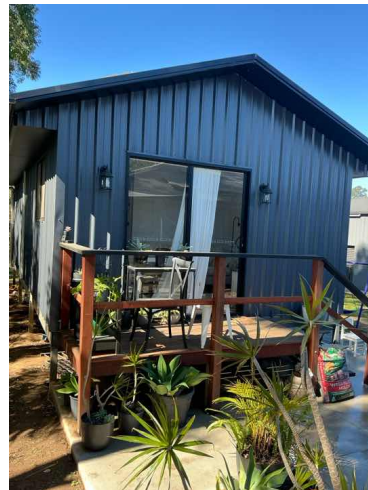
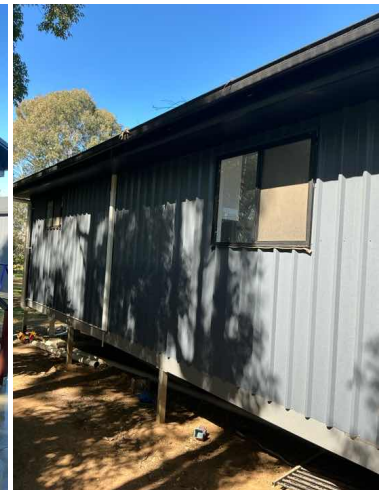
### **Cottage Condition**

The shed appears to be in fair usable condition.

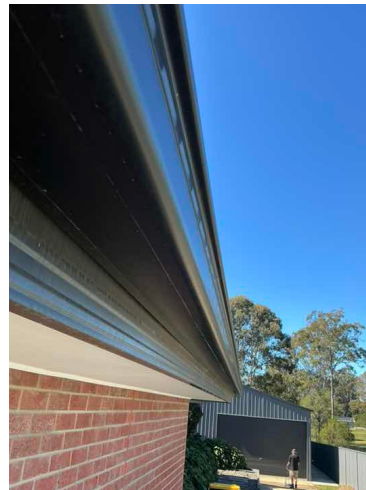
#1. Debris in gutter areas- this requires cleaning out to prevent blocking of downpipes and leaking into eaves and fascia. Have gutters cleaned and assessed by a plumber for adequate fall. Regularly clean to prevent ponding. Ponding water will contribute to rust.

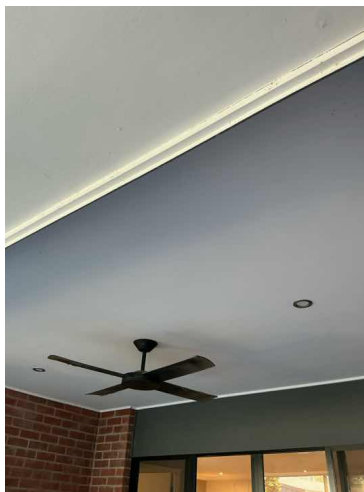
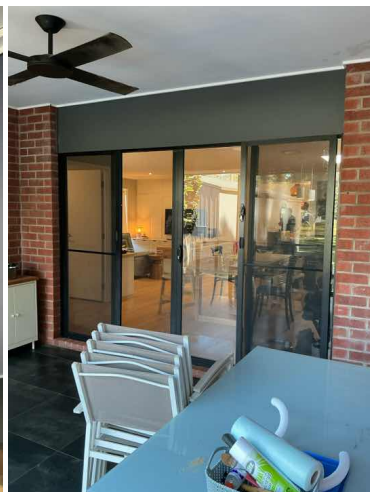
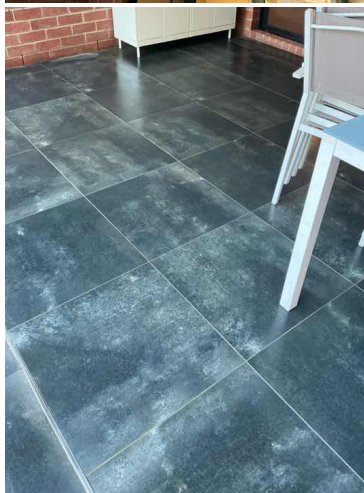
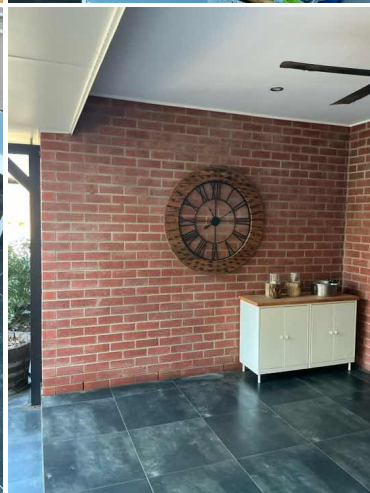
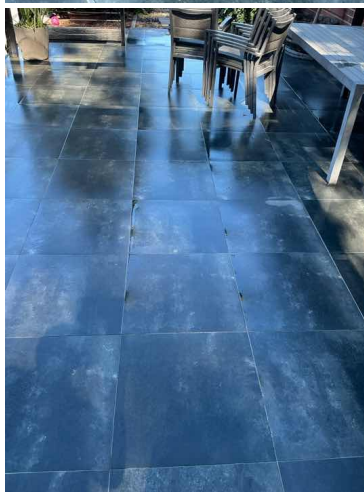
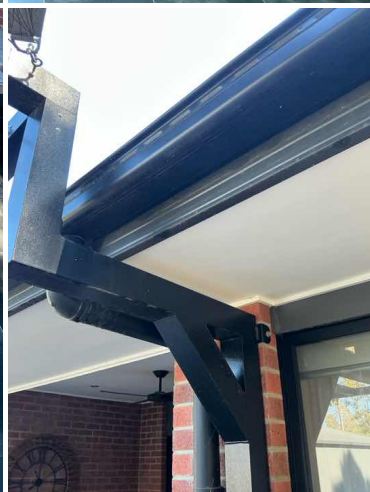
#2. Tile cracks evident. Engage a qualified tiling contractor to repair.

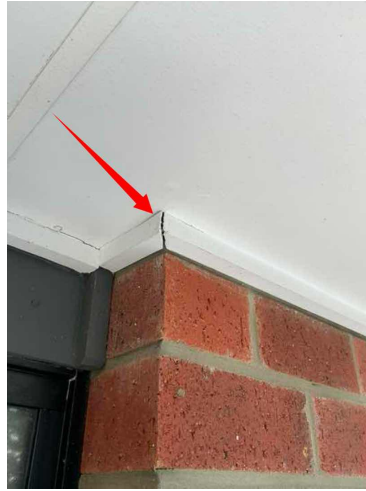
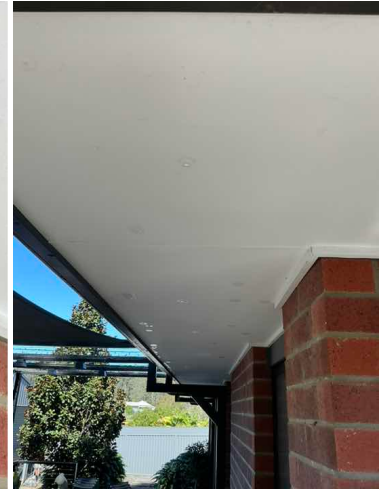
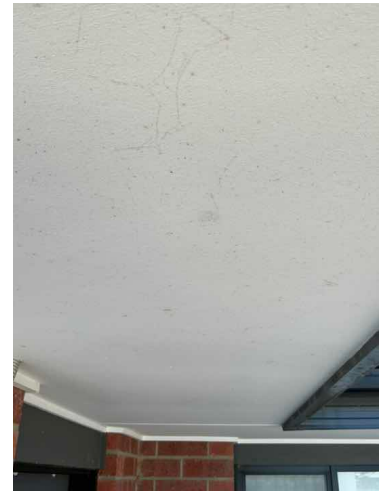
#3. Quad deteriorated or detached. Contact a licensed carpenter for repairs.

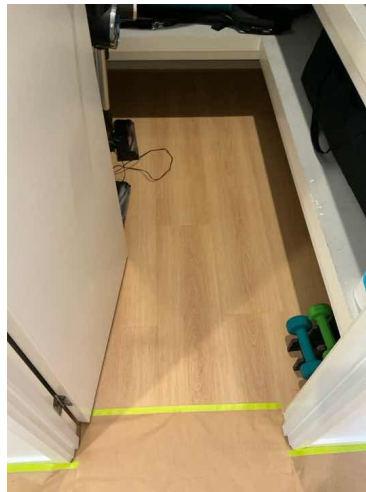
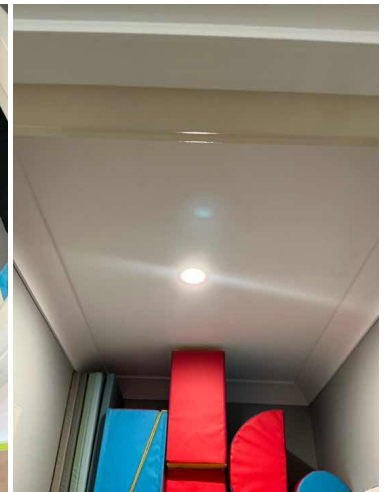
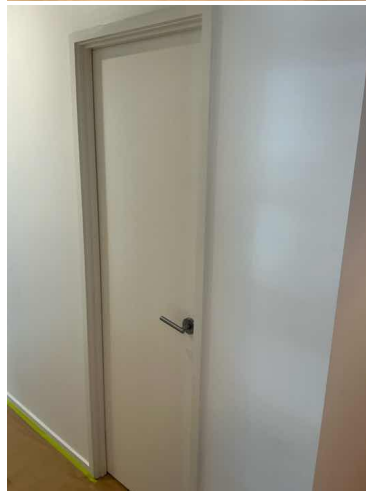
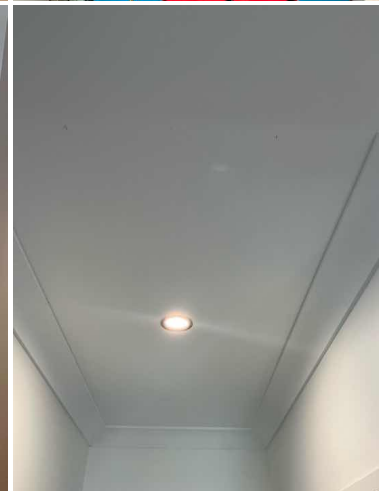
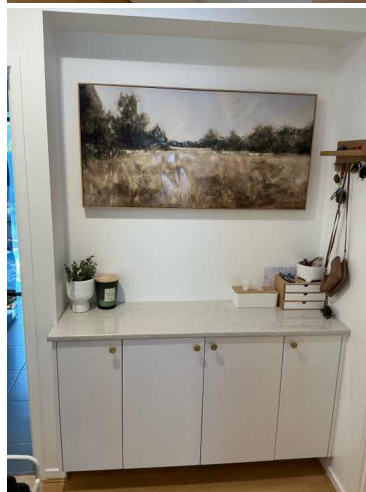
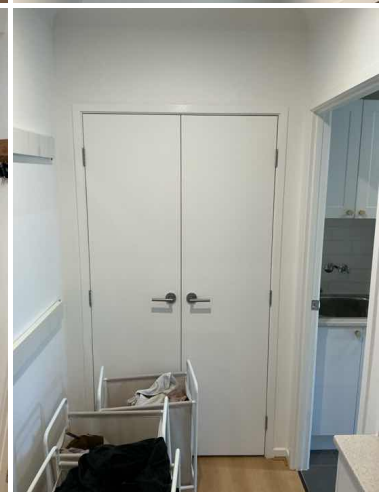
#9. Door lock hardware is loose possibly damaged. Maintenance as required.

#10. Incomplete Patch/Paint repairs noted. I recommend you contact a qualified painter for repairs.

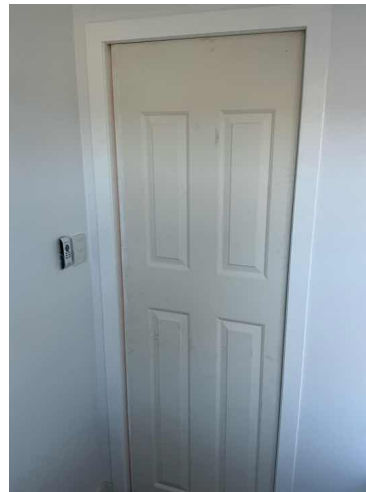
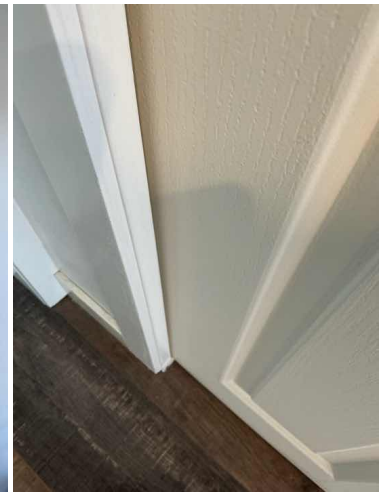
#11. Bedroom door painting incomplete. Door binding needs adjustment..

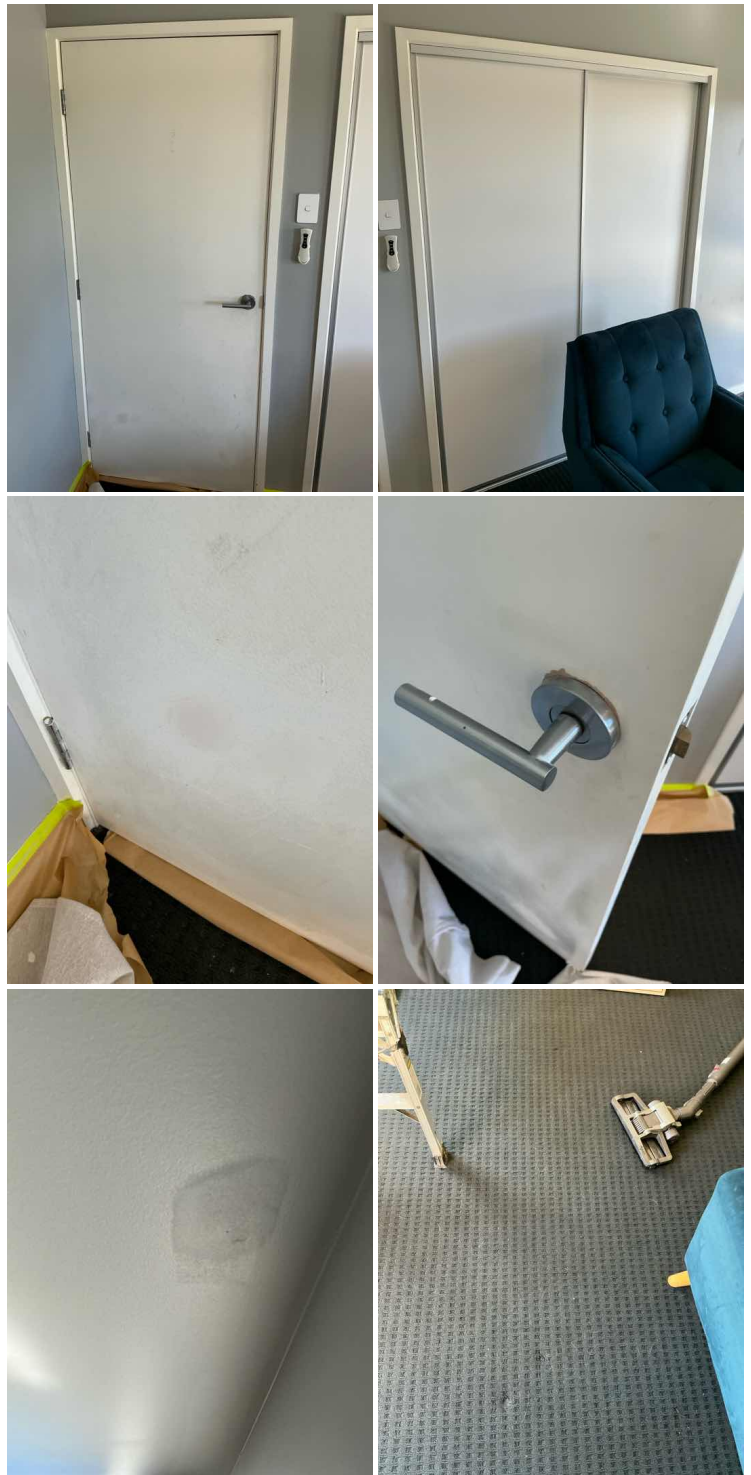
#13. Door lock hardware is loose possibly damaged. Maintenance as required.

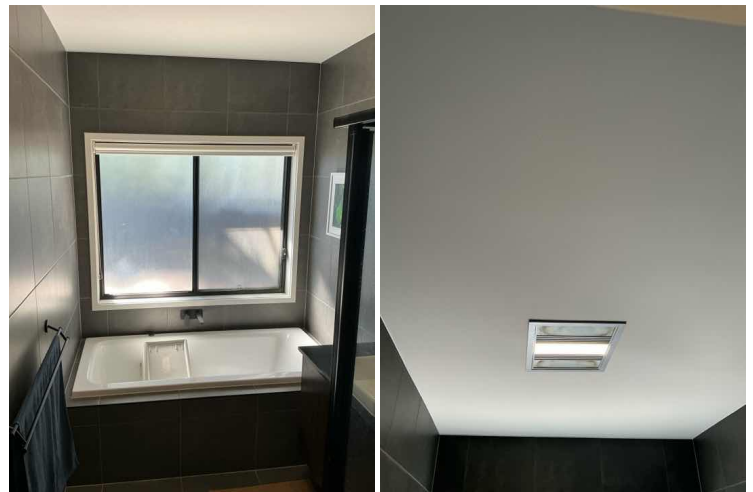
#15. Painting incomplete.

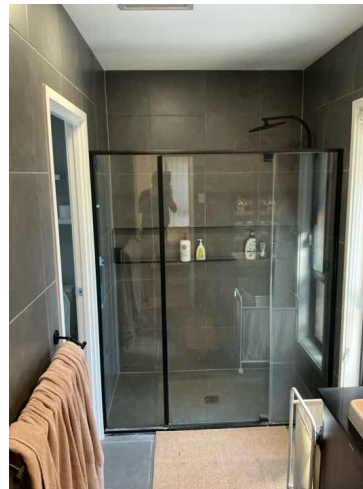
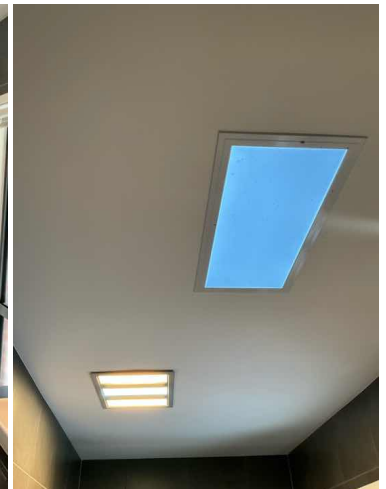
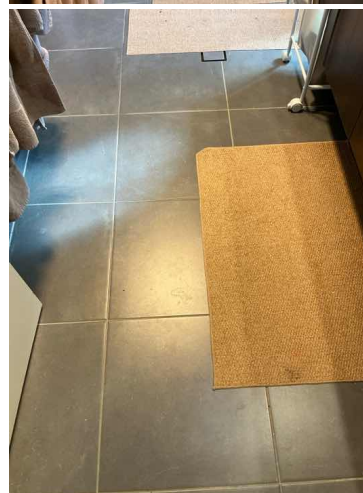
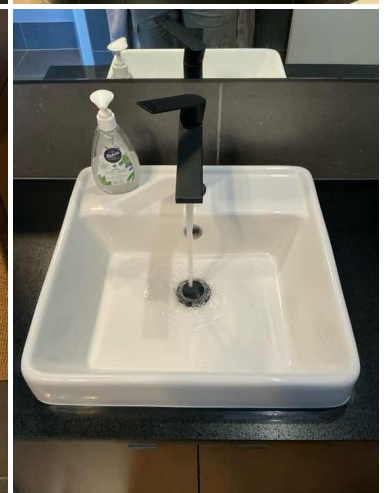
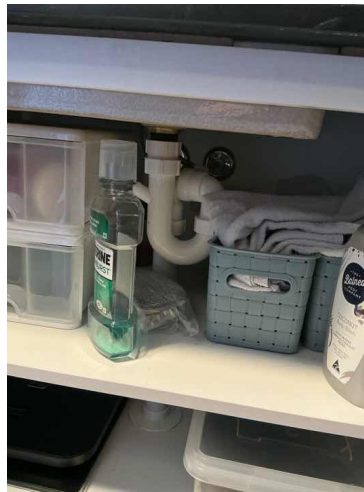
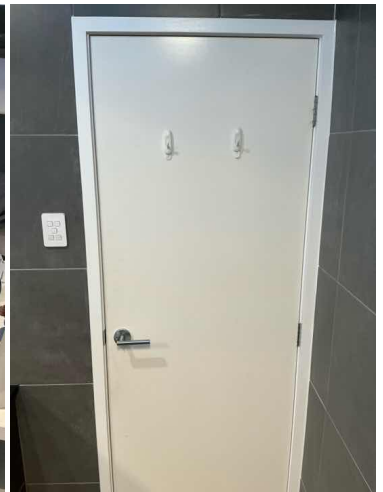
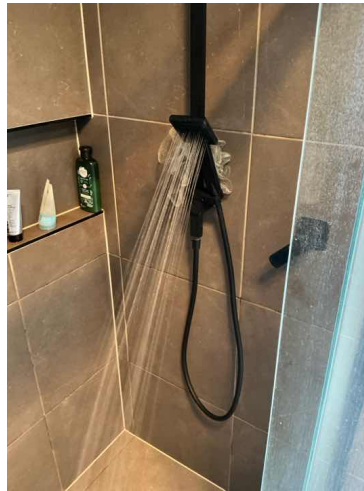
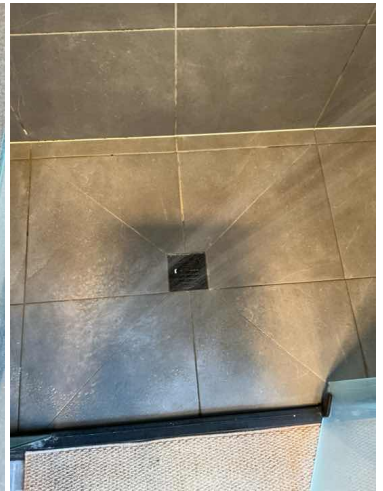
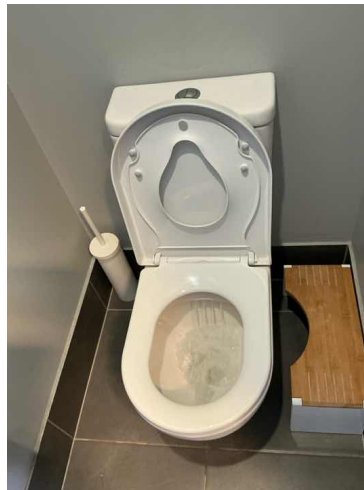
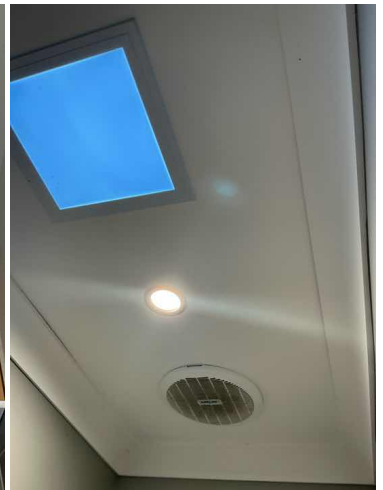
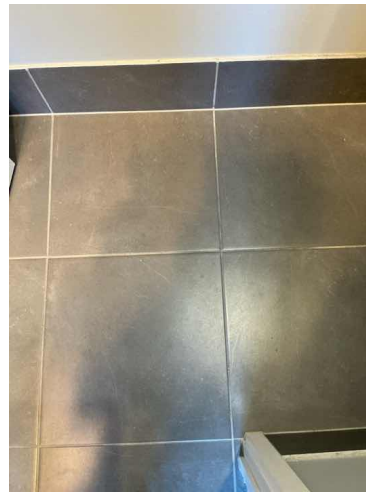
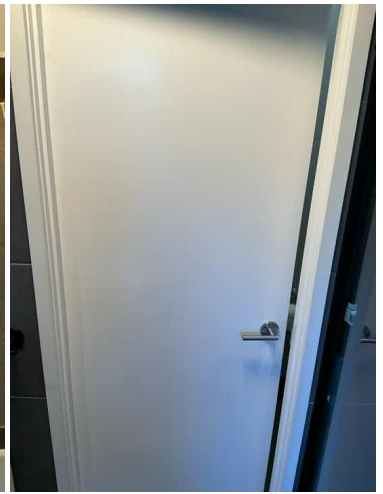
## **Bathroom 3**

Of the visible areas, the general condition of this bathroom is serviceable or in reasonable condition for age of dwelling.

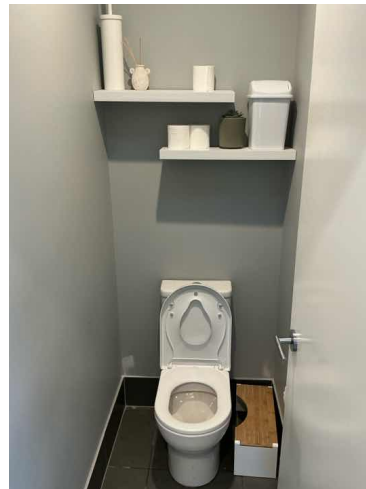
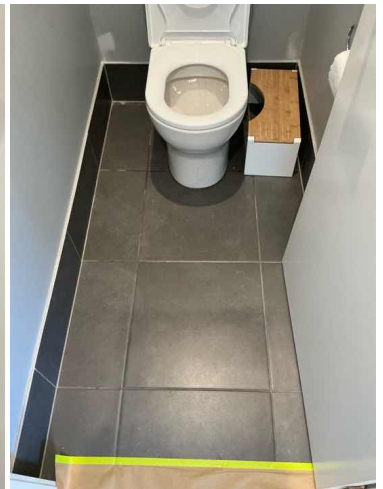
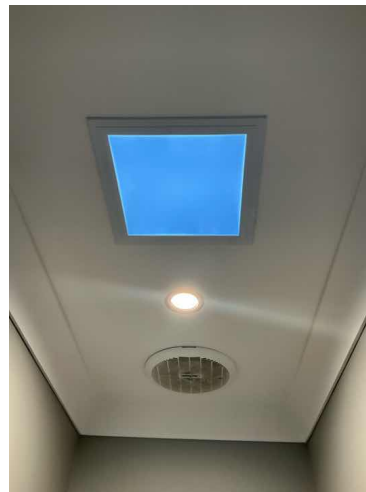
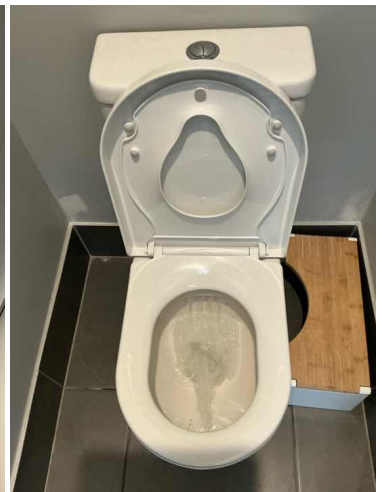
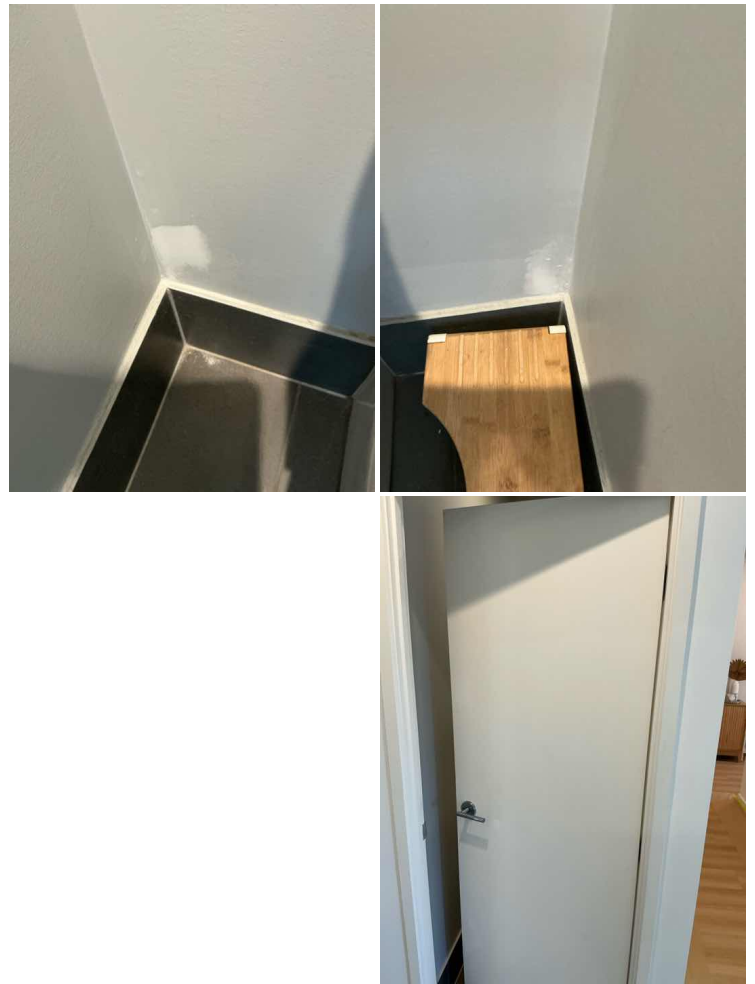
## **Toilet**

Of the visible areas, the general condition of this bathroom is serviceable or in reasonable condition for age of dwelling.

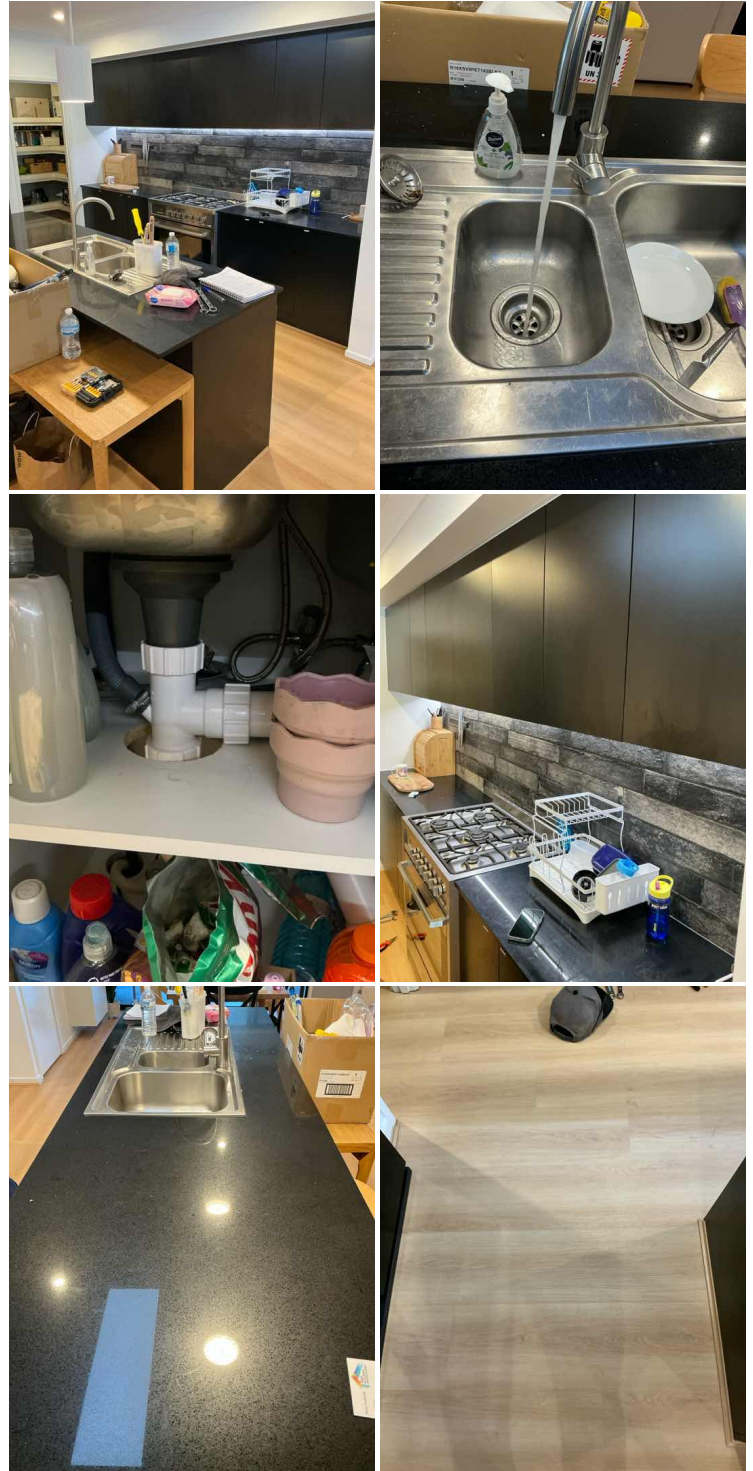
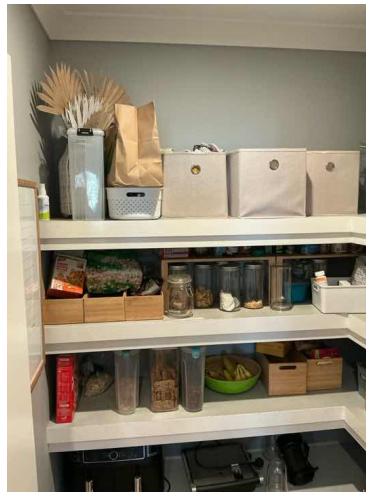
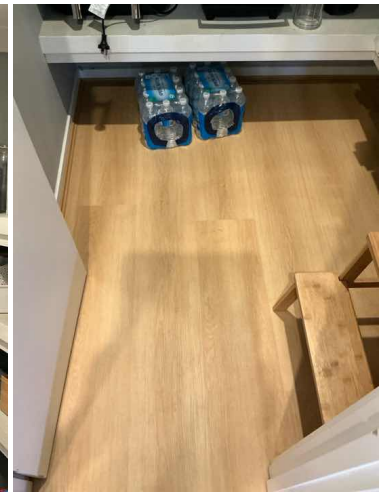
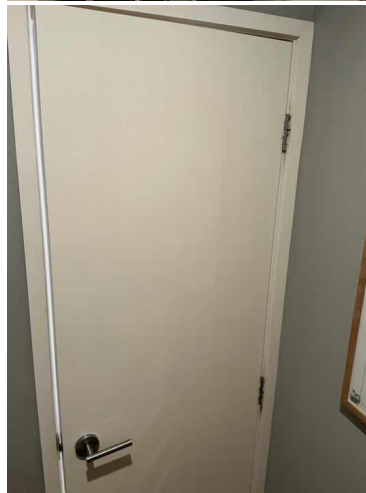
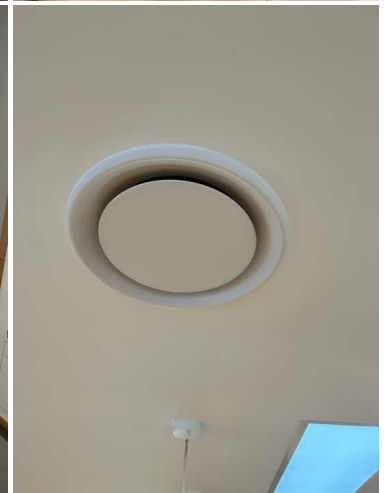
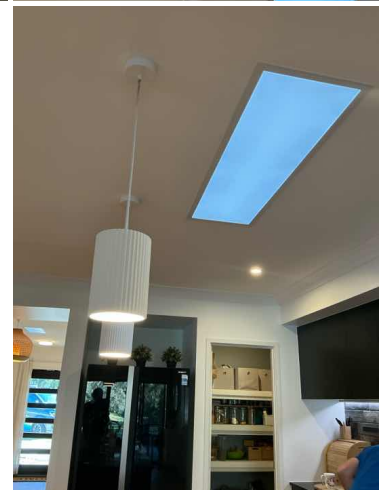
## KITCHEN & LAUNDRY

Of the visible areas, the general condition of the kitchen and pantry appears to be in serviceable condition for the age of the premises.

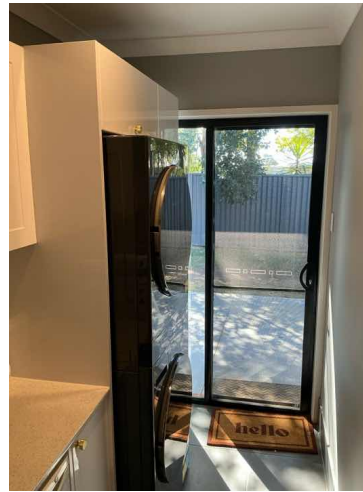
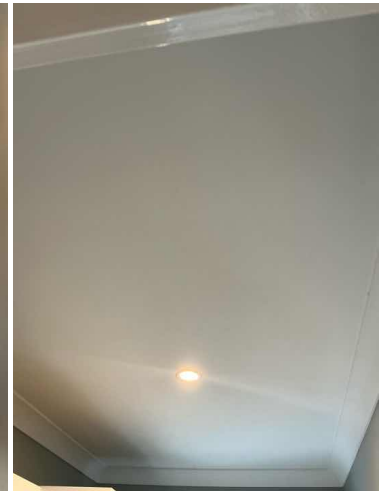
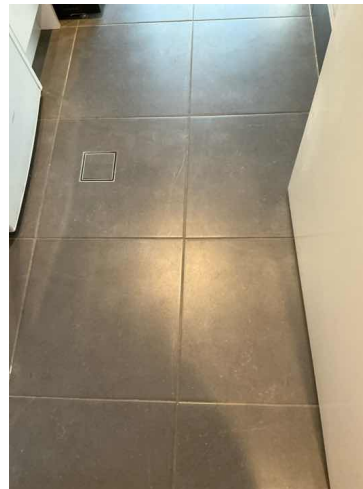
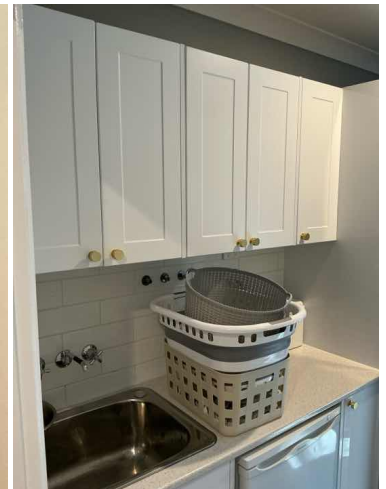
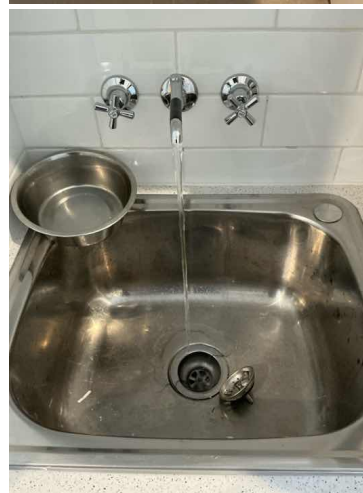
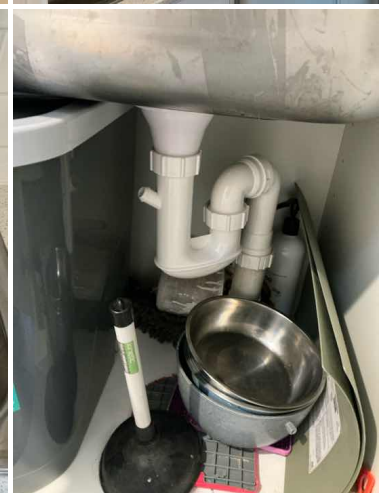
## Laundry

Of the visible areas, the general condition of the laundry appears to be in reasonable condition for the age of the premises.

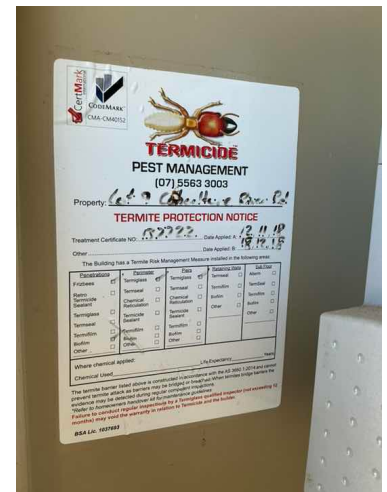
Yes, a durable notice was found in the meter-box during the inspection.

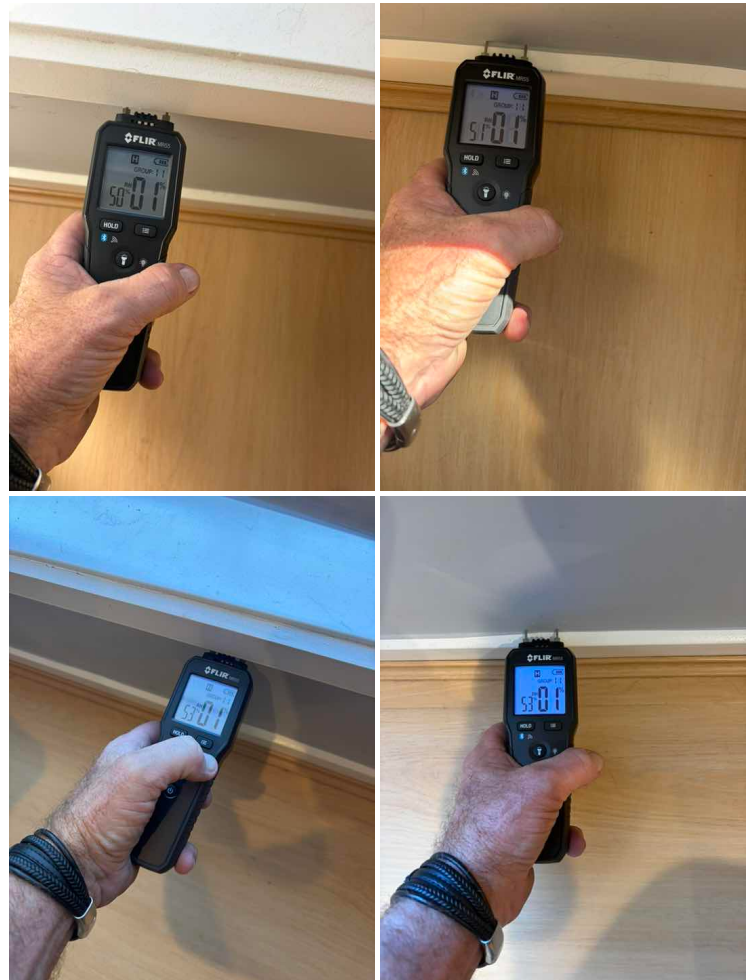
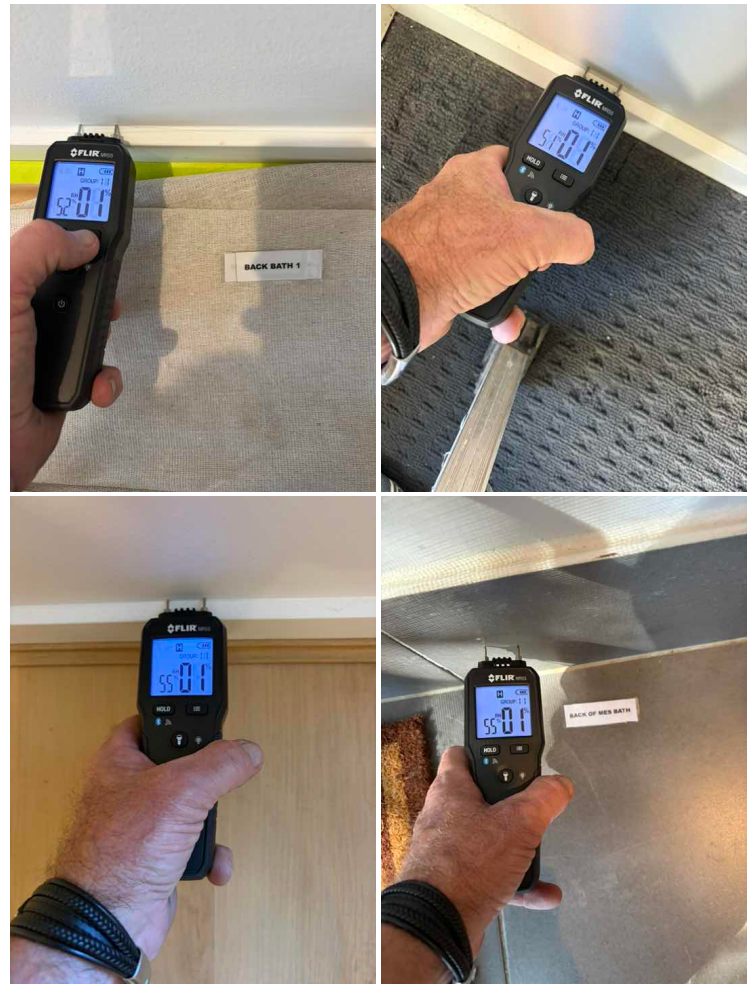
At the time of the inspection, our electronic moisture meter readings were normal.

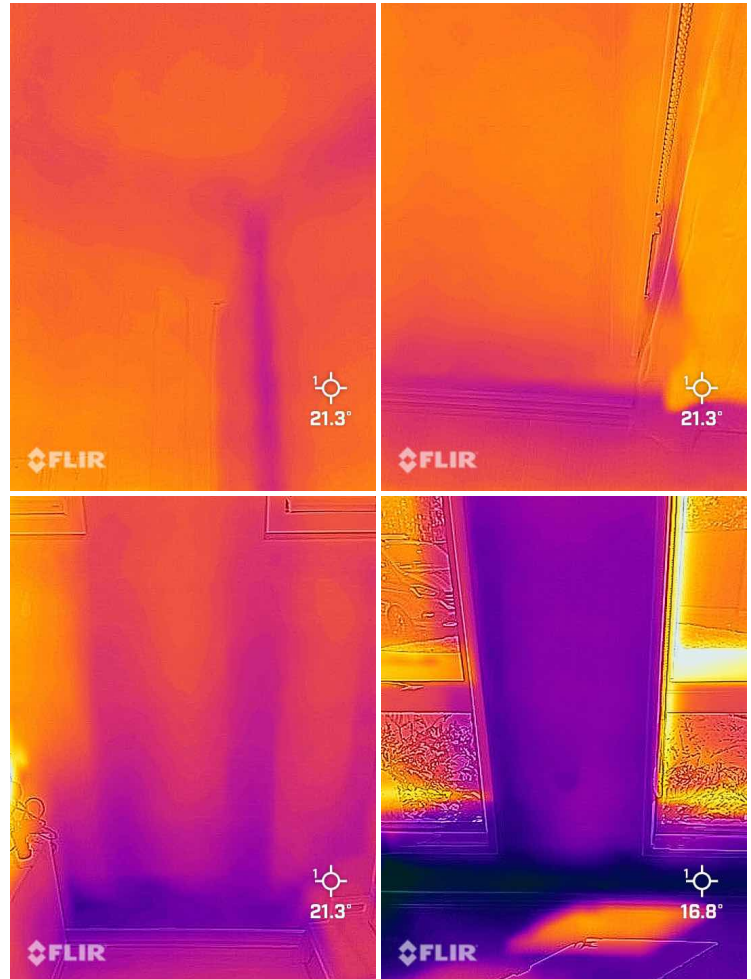
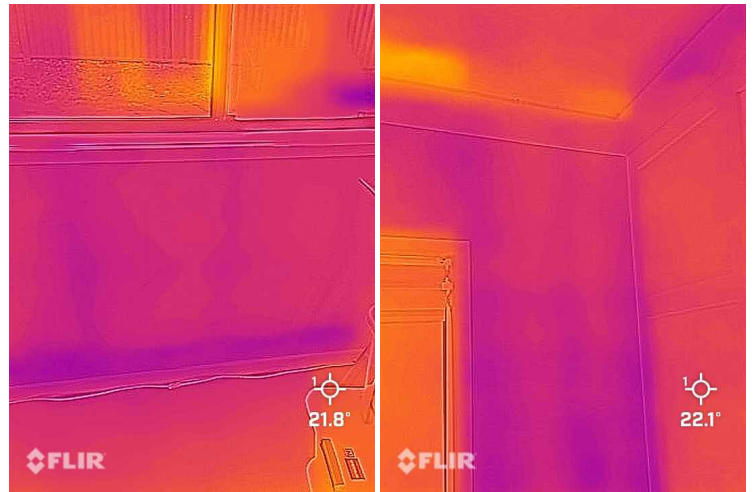
An infrared thermal imager was utilised during the inspection. No thermal anomalies were detected during this inspection, however various factors must be taken into effect which may hamper or impede the reading obtainable by the imager. These factors include obstructions, ambient temperature, wall material and thickness etc. If any surface is restricted visually or otherwise, a proper thermal reading is not possible and is not within the scope of this inspection. Any findings or otherwise is reported on at the time of the inspection only.
