## BUILDING INSPECTION REPORT

Complies with Australian Standard AS 4349.1-2007

Inspection Date: 14/11/2025.

5 De Havilland Dr, Bray Park QLD 4500.

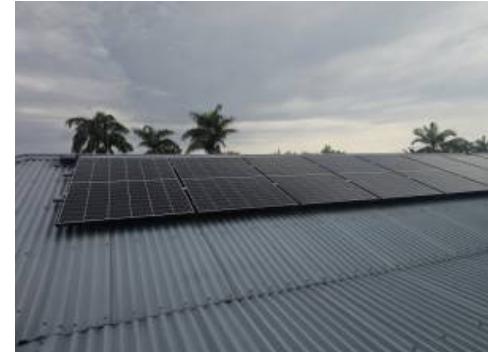
There are solar panels installed to a section of roof surface, this conceals part of the roof. No inspection/assessment can be offered where visual is not obtained.

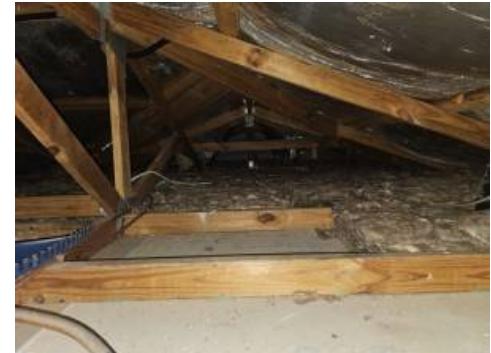
Inspection over the eaves was restricted due to the low pitch and construction allowing only a limited visual inspection. Partial Insulation is present in the roof cavity. This restricted inspection to some of the buildings framework. Removal of insulation is not within the scope of a standard visual inspection report.

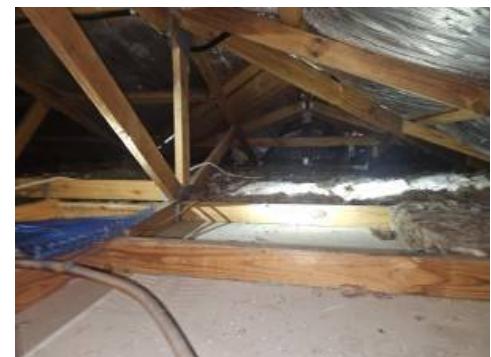
Sarking paper and insulation is present in the roof cavity (Anticon Type). Partial Insulation is present to roof cavity.

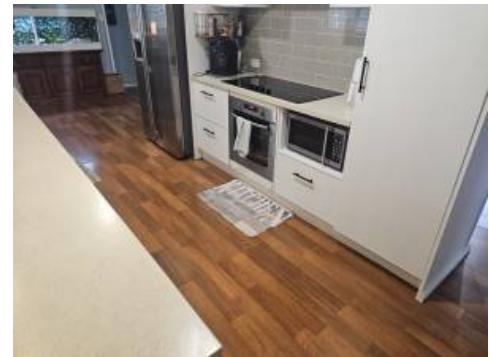
The condition of the fixtures is good. Chipped areas are present to the benchtops. General wear to cabinets due to age. The laminate is lifting/ separating in some areas. We have carried out a function test to the following item(s). Note: The testing was to validate whether the items tested are in a working order or non-working order. No specific tests other than running / turning on was carried out. No determination has been made as to the suitability or adequacy of the tested items. Refer Report Definition section within.

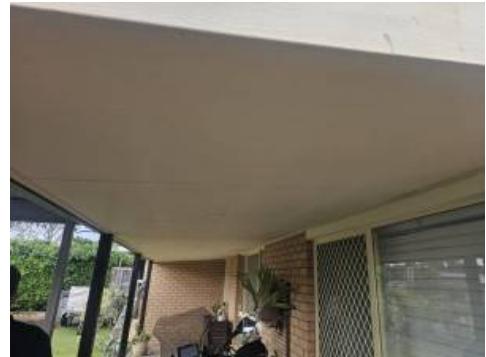
Patio is lined underneath and therefore concealing various timbers, limiting visual assessment.

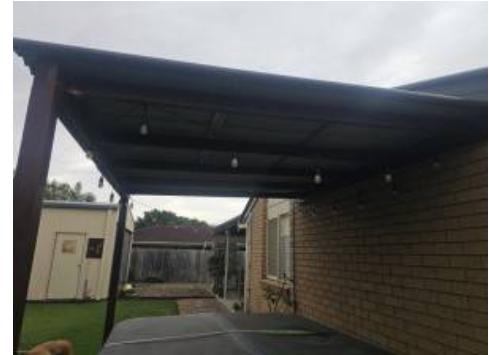
Constructed from timber and metal. The general condition of this structure is fair.

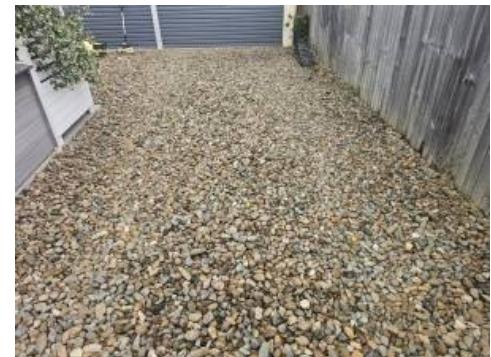
The gravel driveway stands in fair condition.

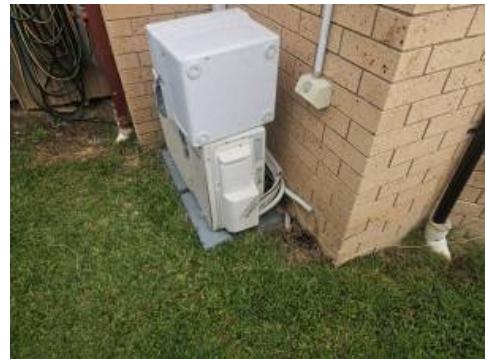
Air-conditioning is installed in the premises. The air conditioning unit(s) appears to be in working condition. No specific tests other than running / turning on was carried out. No determination has been made as to the suitability or adequacy of the air conditioning system. The air conditioning overflow should be redirected to a drain, see Timber Pest Report.
