Pre sale building and pest report.

All Building Inspections Pty Ltd

1/4 Cyan Court, Morayfield, QLD

Report/Agreement # 160226084809139
 Inspection Date: 18 Feb 2026
 Inspection Time: 10:00 am

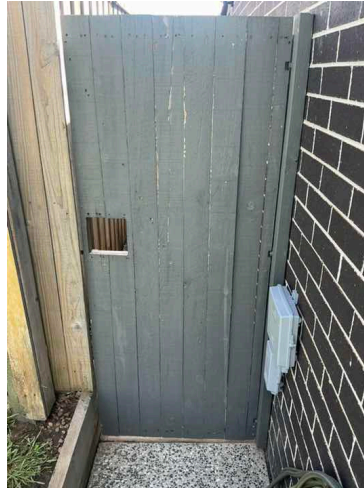
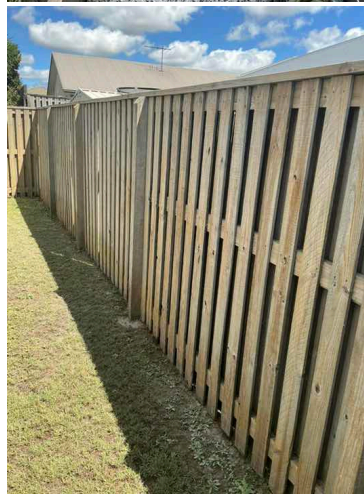
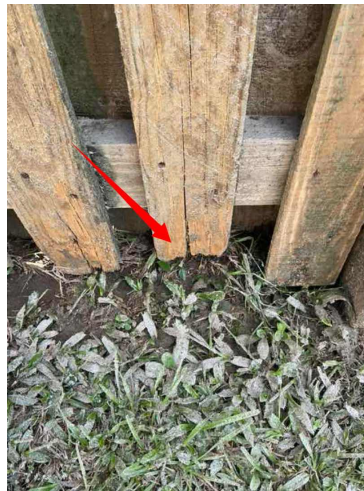
#1. Damage was noted to the timber fence slat. Contact a fencing contractor for repairs.

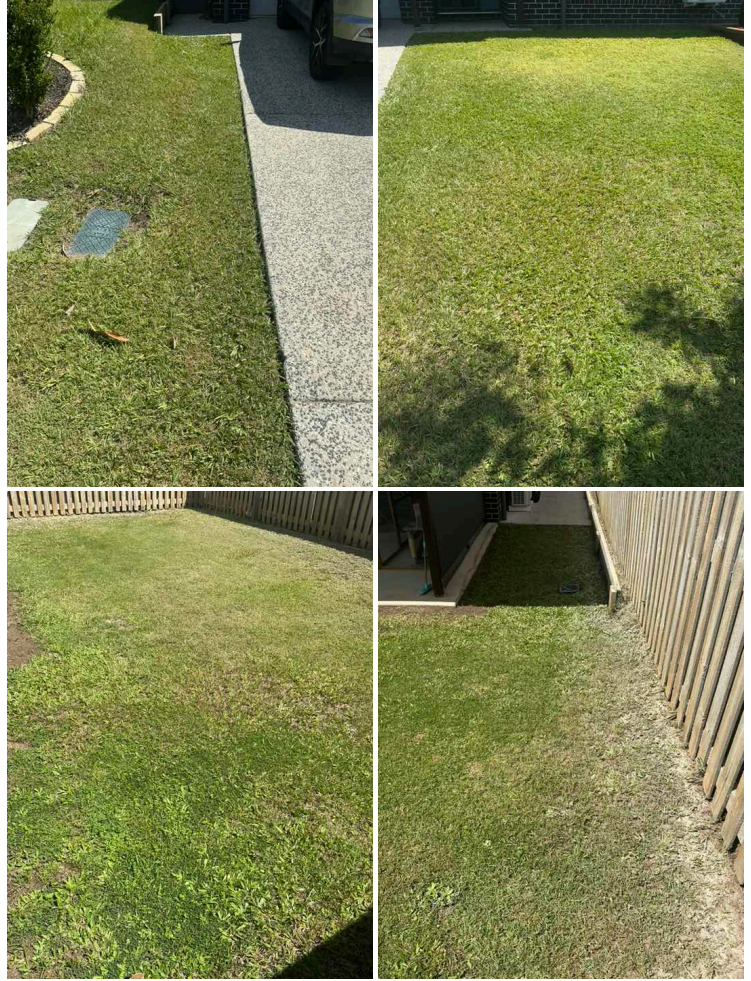
There was no visible evidence of excess ponding or fall towards the property walls at the time of the inspection. Regardless, it is difficult to ascertain in dry conditions and it is therefore recommended that you assess same after a rainfall period to be able to sufficiently ascertain if any problems exist in this regard. If water is ponding around the perimeter walls and paths or appears to be flowing into the footings/foundations you should have the area assessed by a qualified plumber or landscaper.

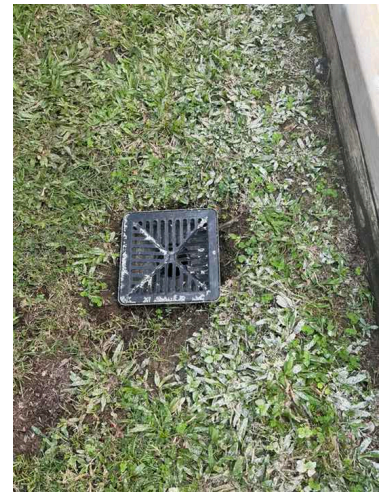
No evidence of slow or blocked drains at the time of inspections.
Recommend installing a drainage point under the tap to assist with drainage.

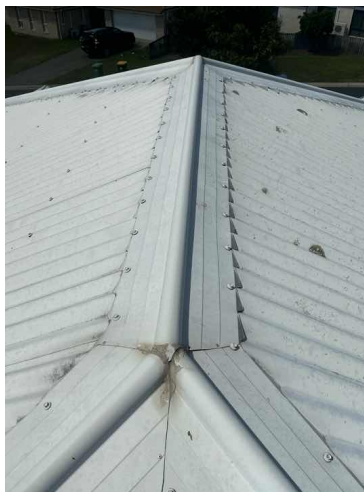
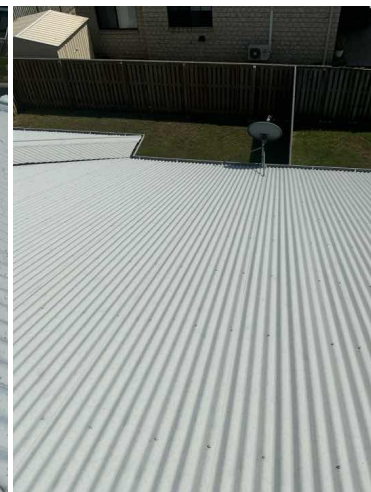
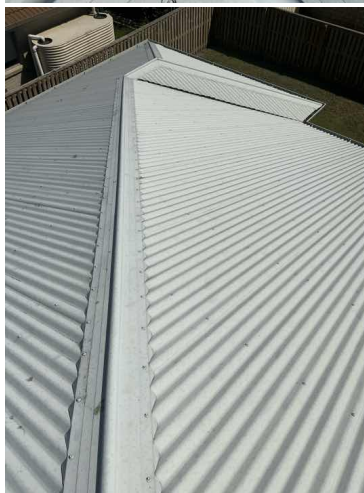
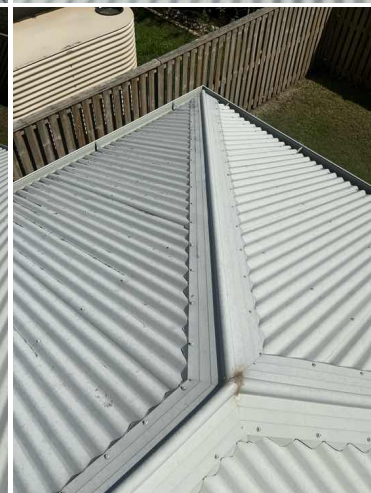
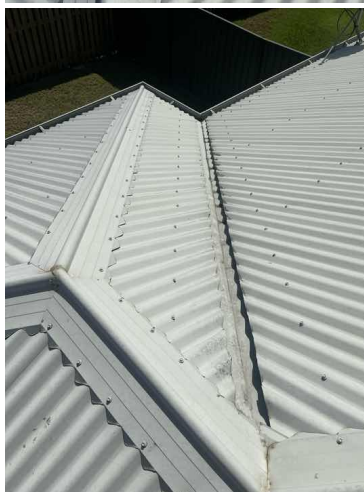
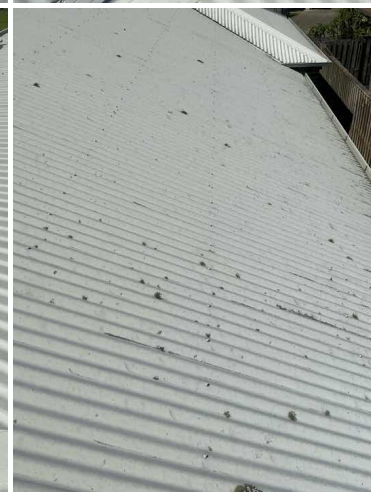
#2. On inspection, defects were noted that may require further assessment and recommendations by licensed roofer.

1. Vent pipe cap to be replaced.

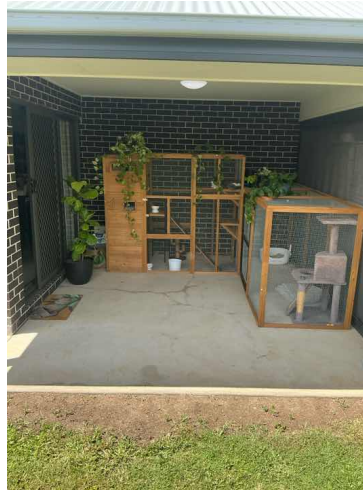
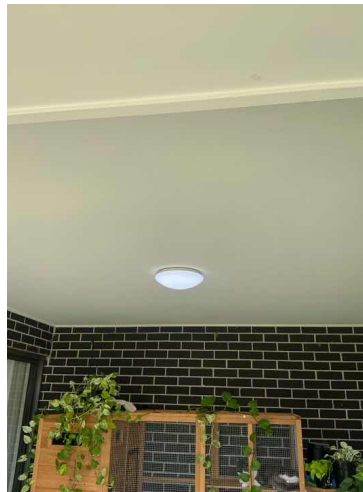
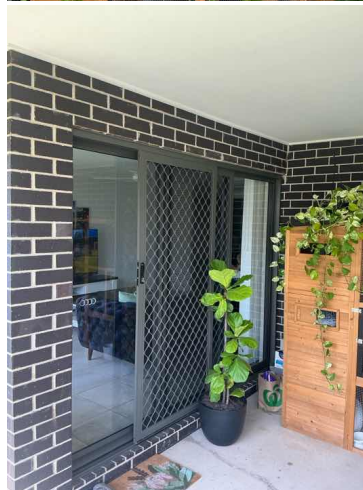
Visible sections of the Alfresco area are serviceable or in reasonable condition for the age of this dwelling.

Typical concrete cracks evident. These are typical for the age.

Please note: Whilst these cracks appeared to be minor and typical at the time of inspection, we recommend you monitor these cracks and if worsening occurs contact a qualified concreter for repairs.

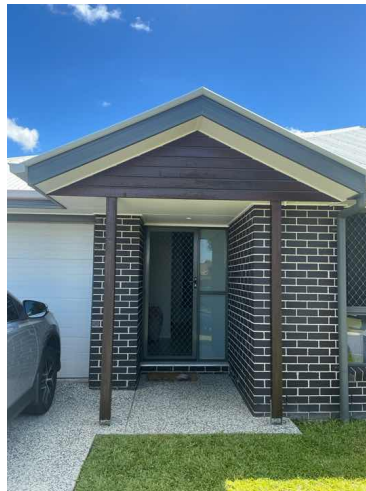
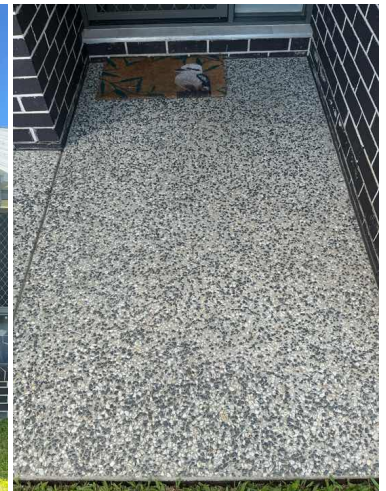
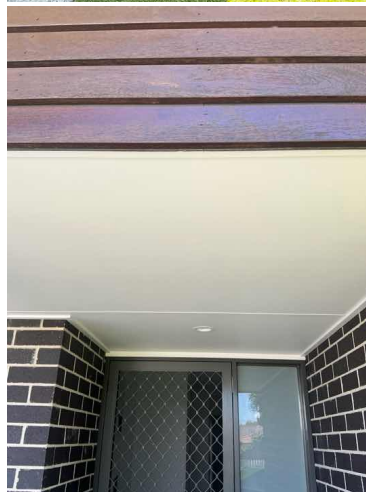
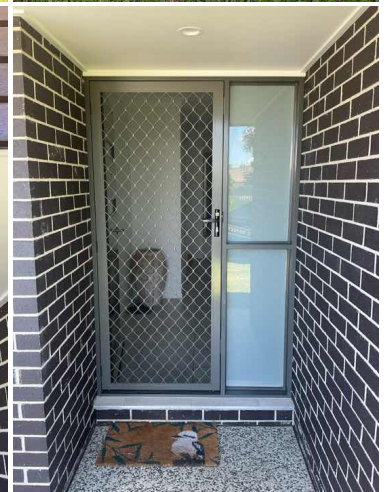
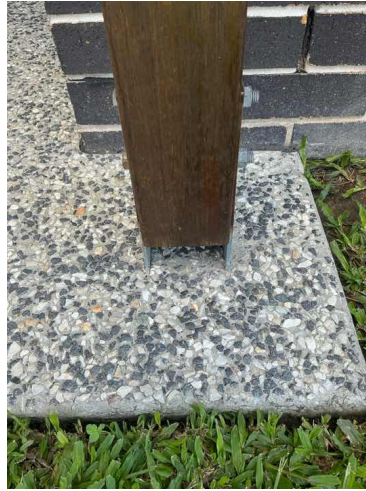
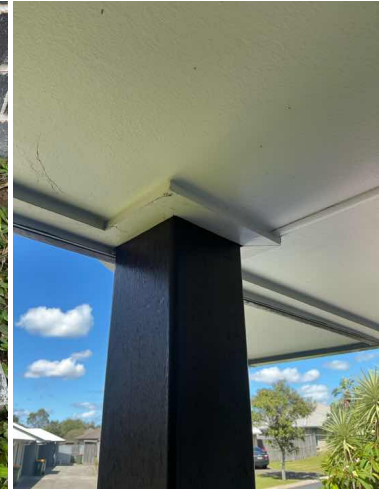
Entry Porch Area

The entry porch serviceable or in reasonable or condition for the age of this dwelling.

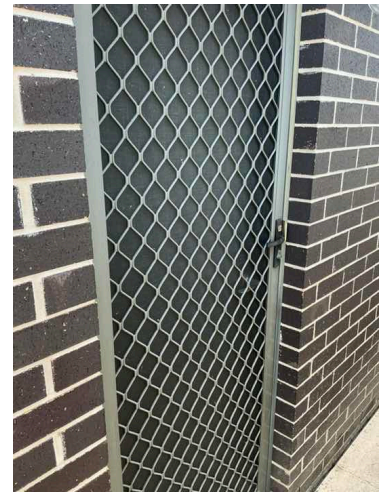
On Visual Inspection the external condition of the doors is serviceable.

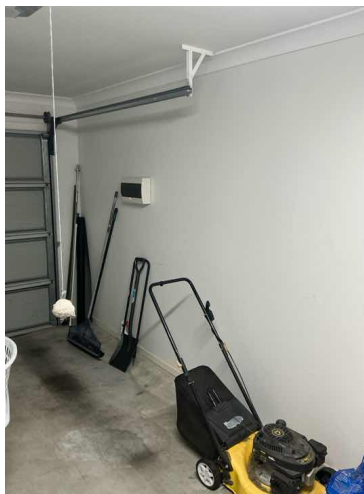
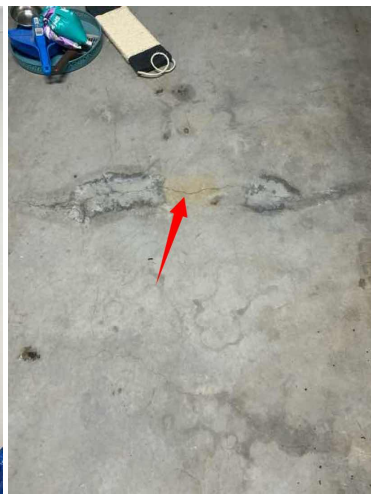
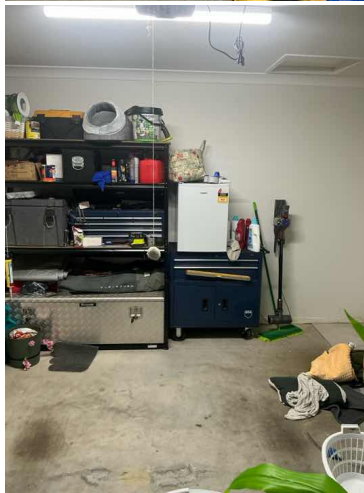
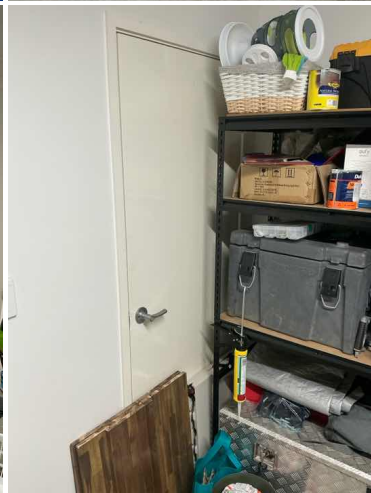
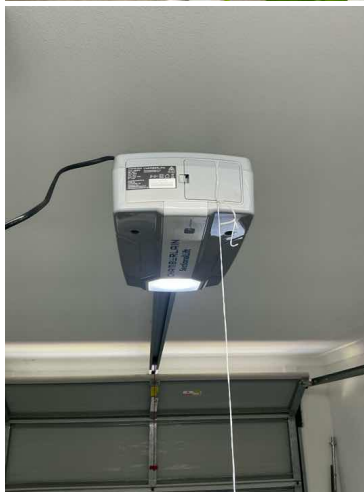
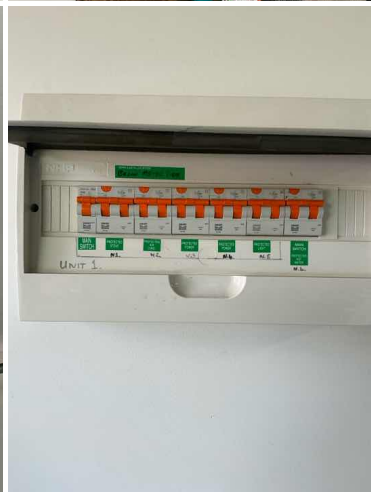
From the visible and accessible areas, the garage appears to be in a serviceable condition for the age of the property with no notable structural defects sighted.

Minor hairline slab cracks - These are considered typical. Note. Whilst these cracks appeared to be minor at the time of inspection, we strongly recommend you monitor these cracks and if worsening occurs contact a qualified concreter for further advice.

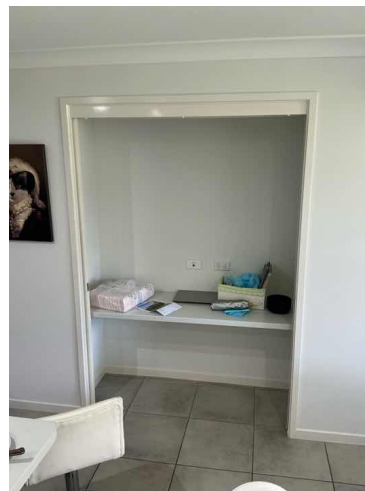
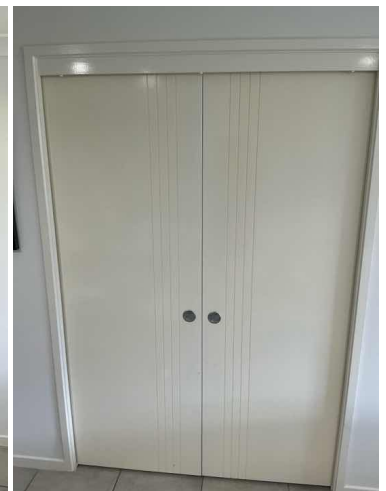
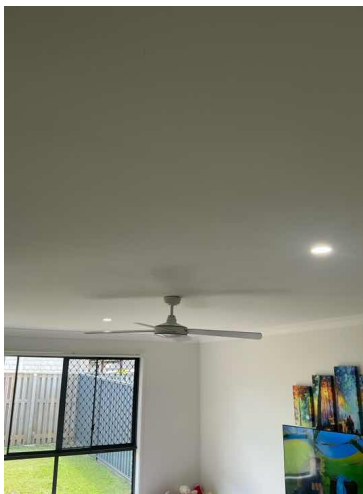
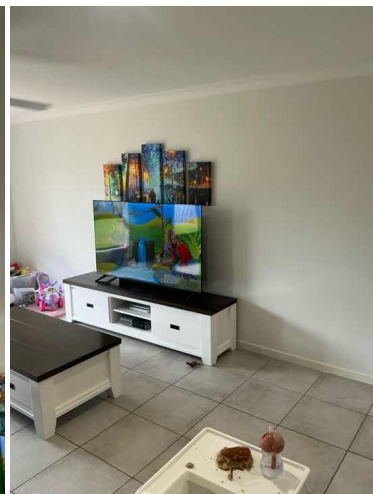
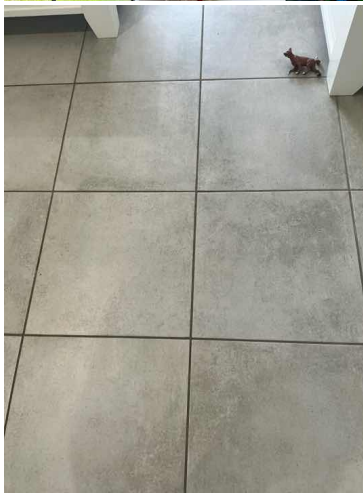
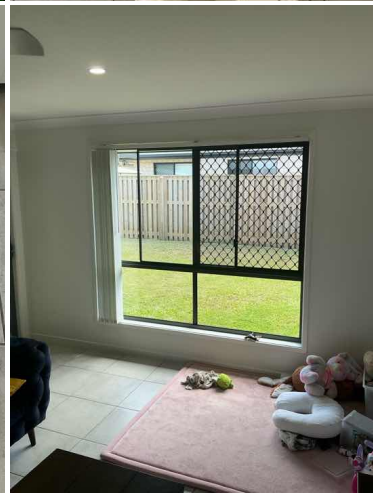
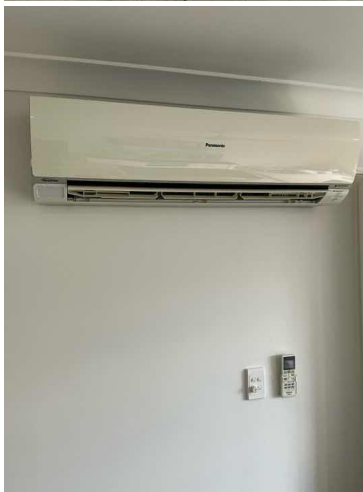
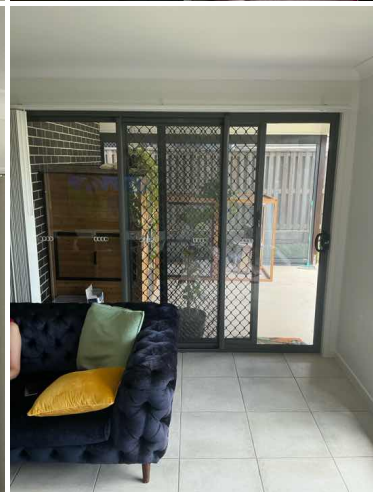
Living Room

From the visible and accessible areas, this room appears to be in a serviceable condition for the age of the property with no notable structural defects sighted.

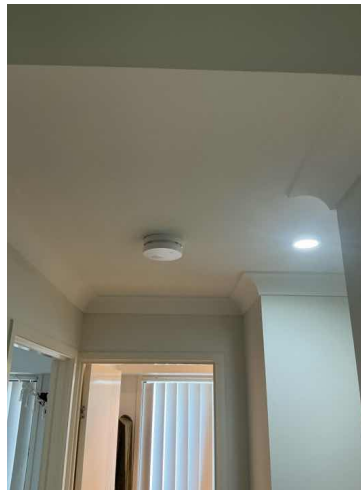
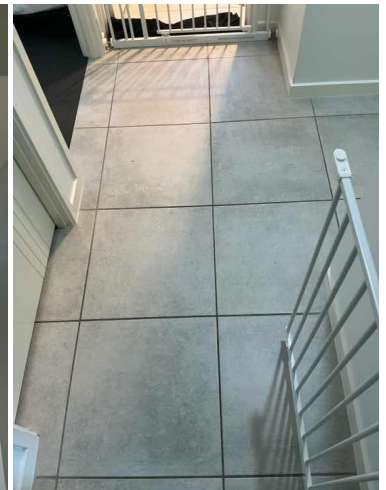
Hallway/s

From the visible and accessible areas, the hallway/ appears to be in a serviceable condition for the age of the property with no notable structural defects sighted. Linen cupboard locking mechanism to be checked and necessary maintenance carried out.

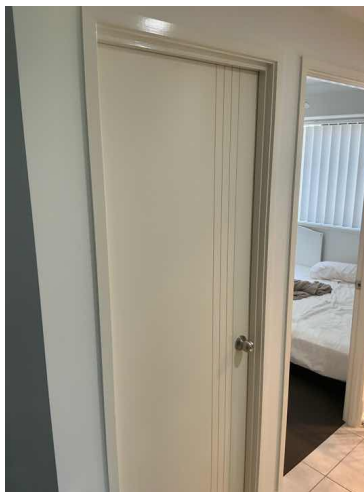
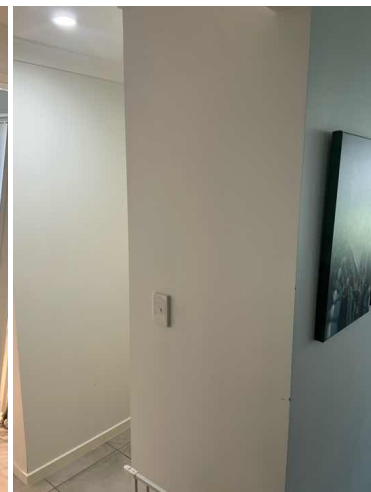
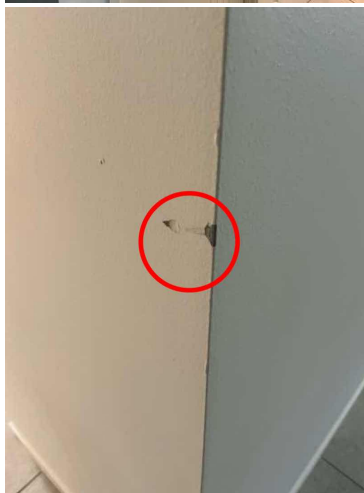
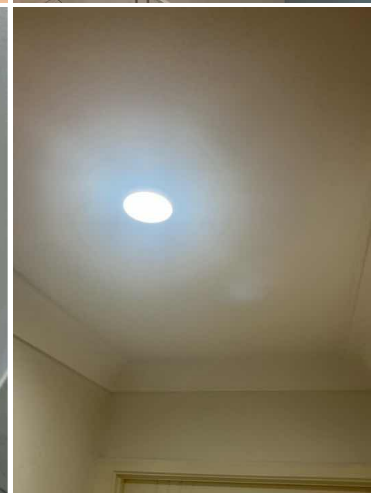
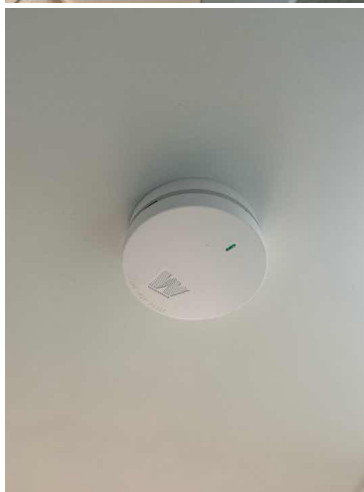
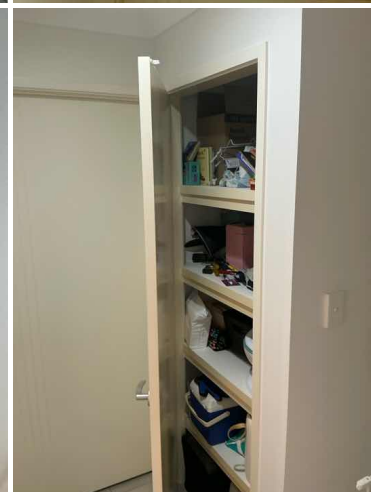
Walls

#3. Impact damage noted. Contact a qualified painter for repairs.

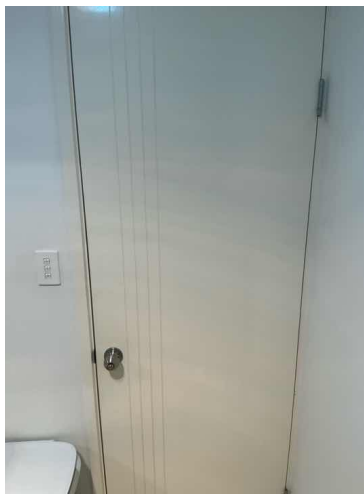
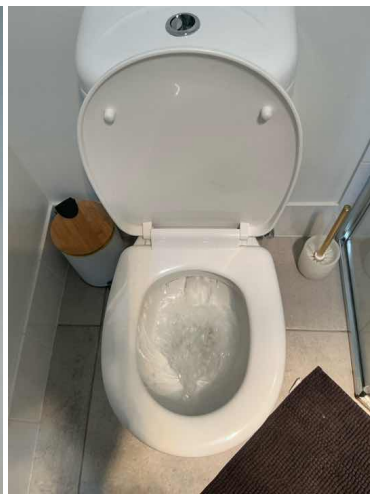
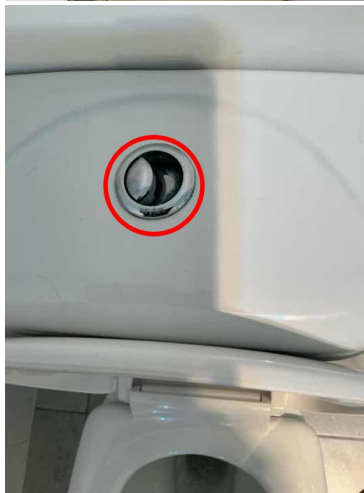
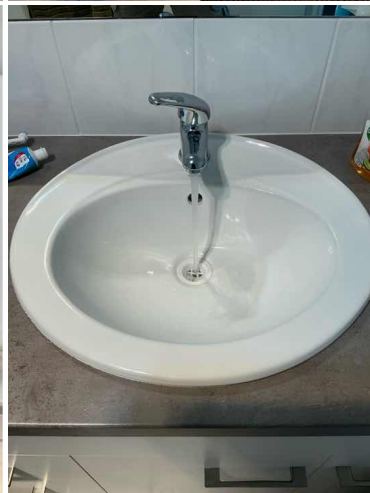
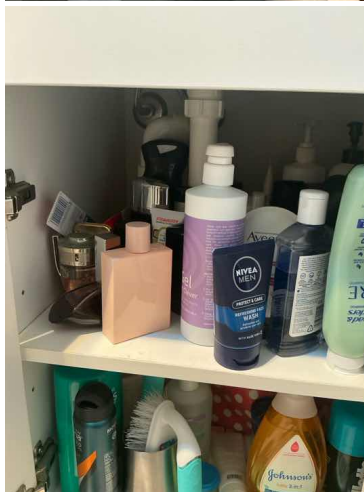
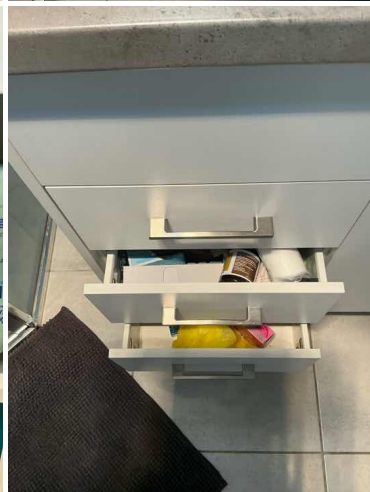
#4. On inspection, defects were present that will require further assessing and recommendations by licensed and qualified trades persons, please read below for details.

1. Cistern flush button to be repaired.
