# Property Inspection Report

25 Orchard Street,  
Caboolture South, 4510, QLD

Inspection Prepared for:  
Leonie Elchelmaier

Date of Inspection: 19/8/2026 | Time: 3:00 PM

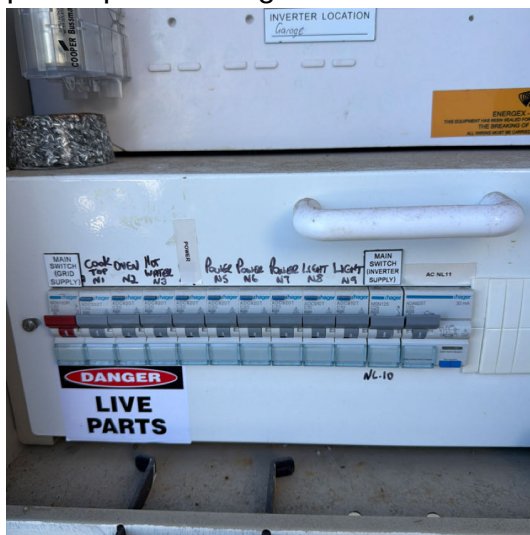
- Main Panel Location:
- East side of the house.

Observations: There are at least 2 RCD's installed which appear to protect both the power point and light circuits.

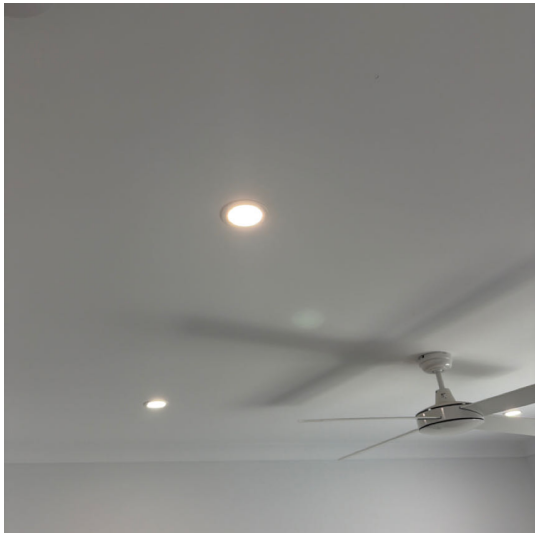
- There are plasterboard/gyprock ceilings in the property which appear functional.

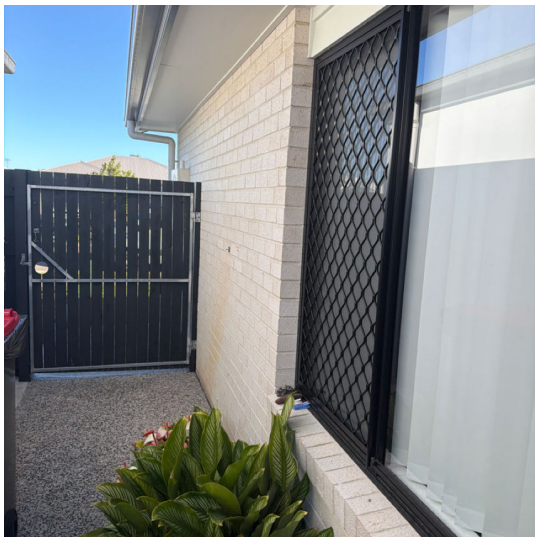
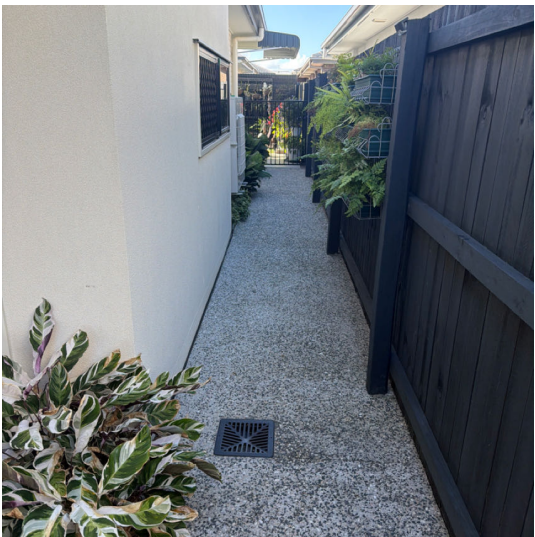
- Materials:
- Brick noted.
  - Painted wood/weatherboard cladding.
